Theodore Roosevelt Middle School

Lane_sch19A

FEMA 154 Rapid Visual Screening Score Card

Rapid Visual Screening - Senate Bill #2 - Seismic Needs Assessment
Oregon Department of Geology and Mineral Industries

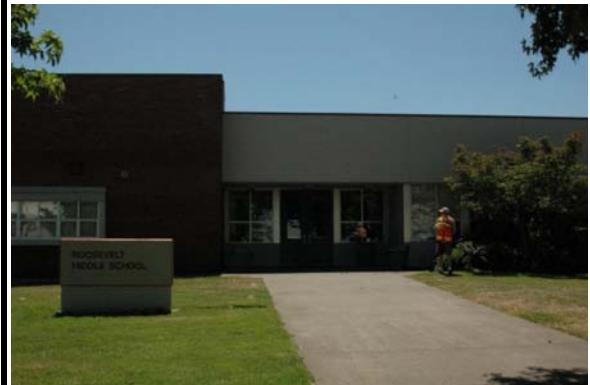
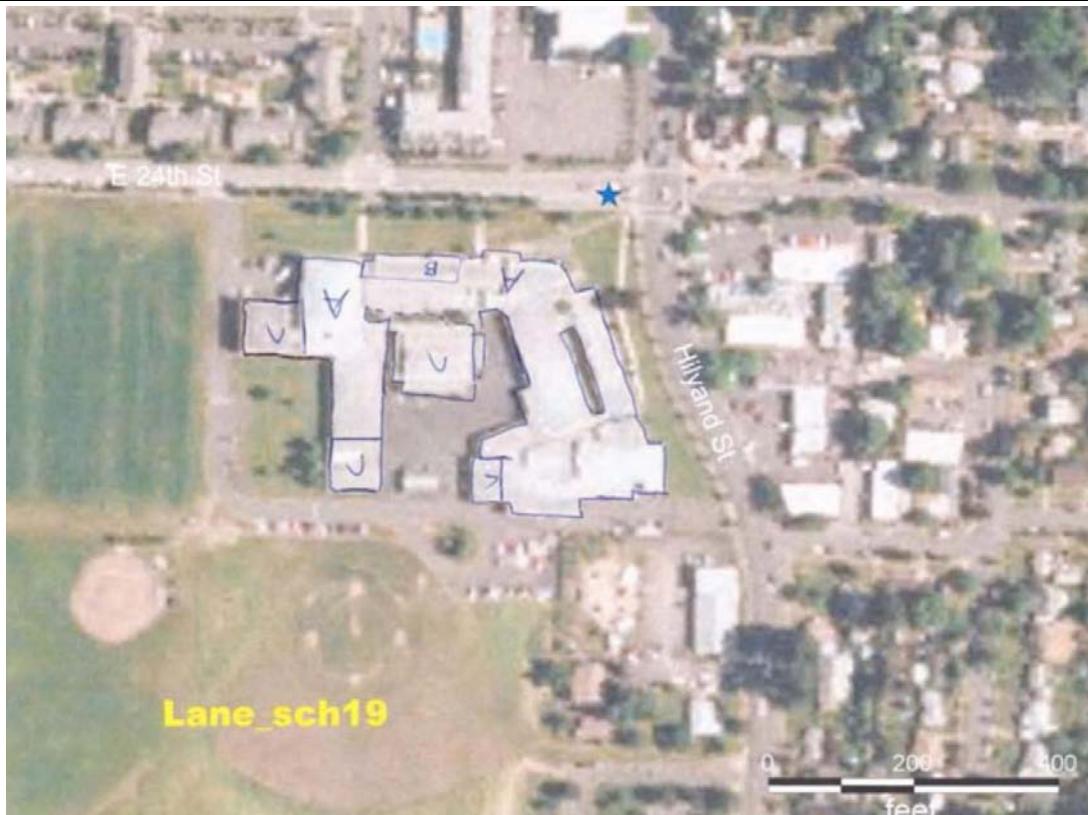
Type	Basic Score	Vert Irreg	Plan Irreg	Pre-Code	Post-Bench	Soil C	Soil D	Soil E	RVS Score
Primary	W2	3.8	-2	-0.5	0	0	0	0	0	1.3
Secondary		0	0	0	0	0	0	0	0	0
Tertiary		0	0	0	0	0	0	0	0	0

Final Type	Final Score
W2	1.3

Moderate (>1%)

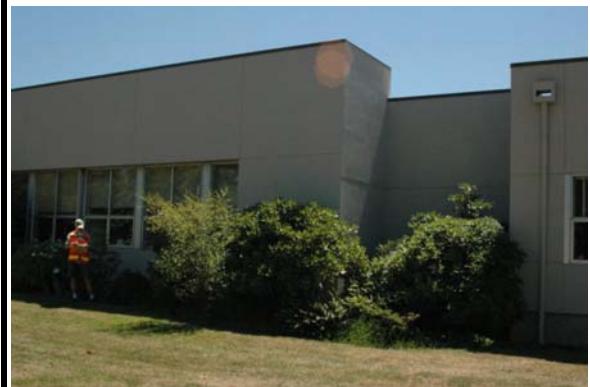
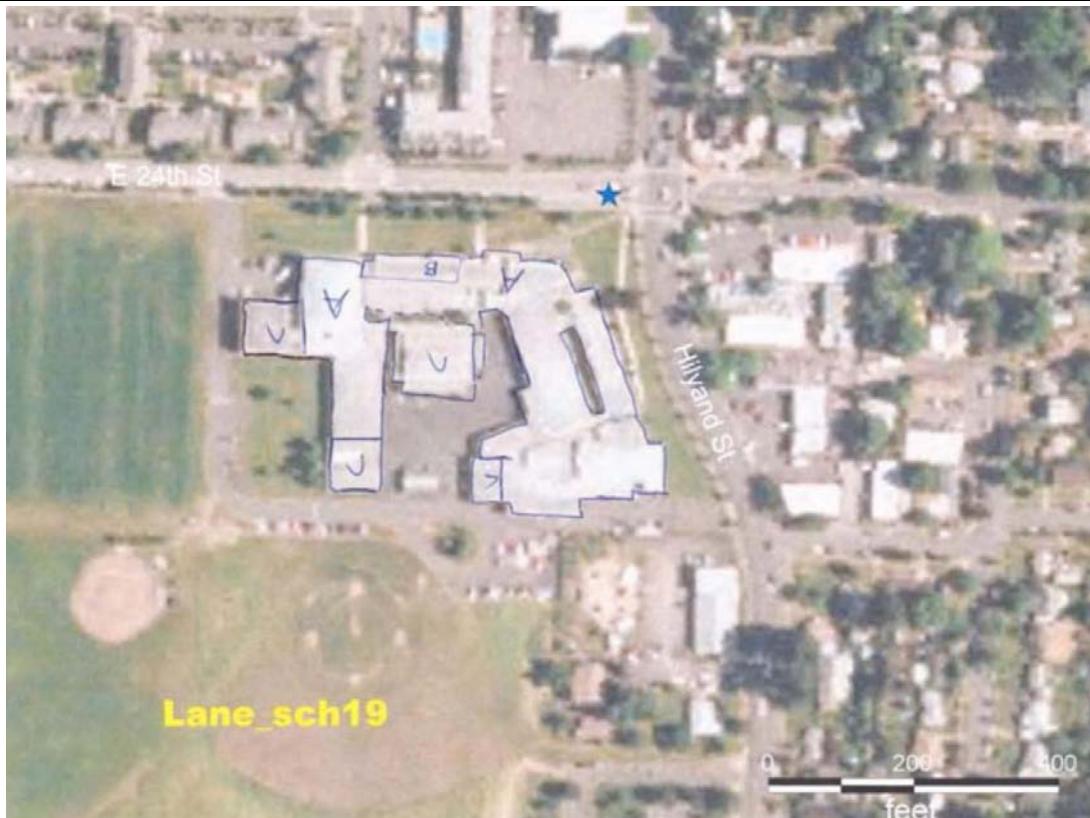
Lane_sch19B

Type	Basic Score	Vert Irreg	Plan Irreg	Pre-Code	Post-Bench	Soil C	Soil D	Soil E	RVS Score
Primary	W2	3.8	-2	-0.5	0	2.4	0	0	0	3.7
Secondary	S3	3.2	0	-0.5	0	0	0	0	0	2.7
Tertiary		0	0	0	0	0	0	0	0	0

Final Type	Final Score
S3	2.7

Low (<1%)

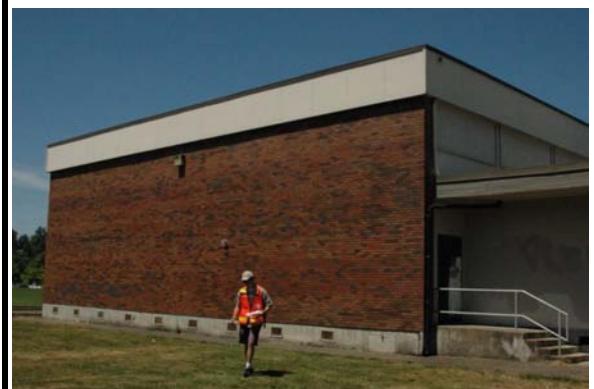
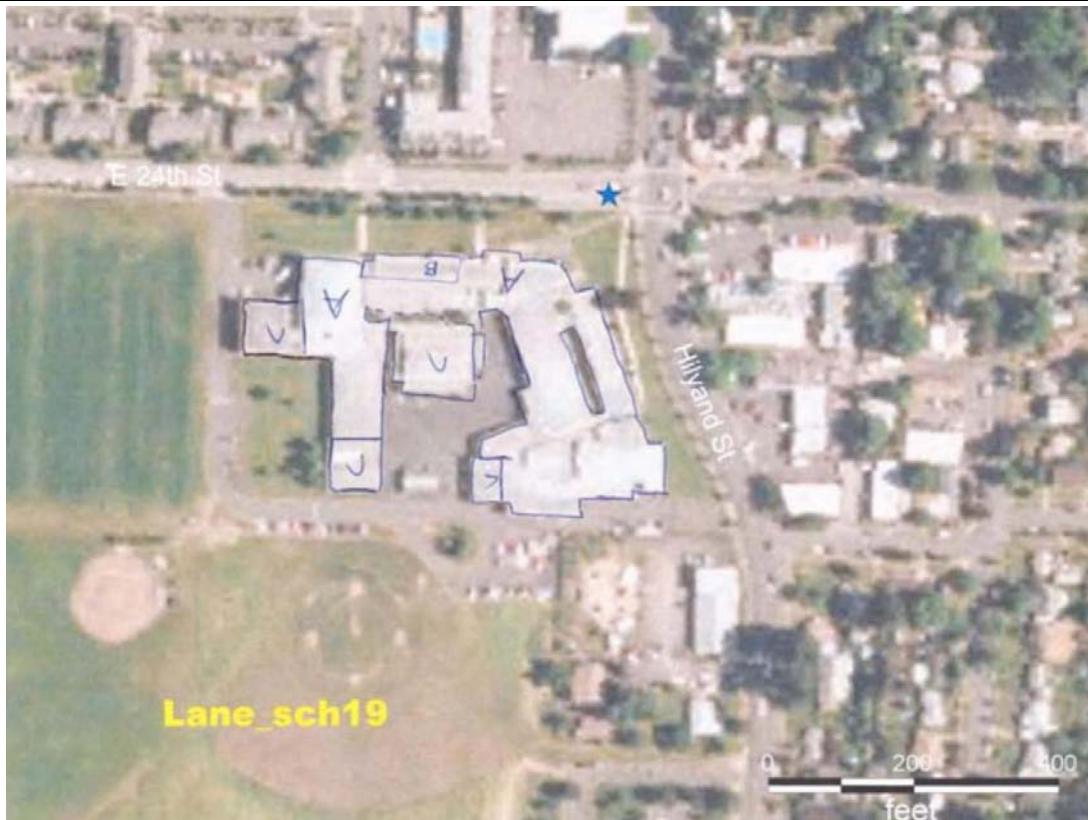
Lane_sch19C

Type	Basic Score	Vert Irreg	Plan Irreg	Pre-Code	Post-Bench	Soil C	Soil D	Soil E	RVS Score
Primary	W2	3.8	-2	0	0	0	0	0	0	1.8
Secondary	RM1	2.8	-1	0	0	0	0	0	0	1.8
Tertiary		0	0	0	0	0	0	0	0	0

Final Type	Final Score
W2	1.8

Moderate (>1%)
