# Elmira Elementary School

Fern Ridge SD 28J

## FEMA 154 Rapid Visual Screening Score Card

Rapid Visual Screening - Senate Bill #2 - Seismic Needs Assessment  
Oregon Department of Geology and Mineral Industries

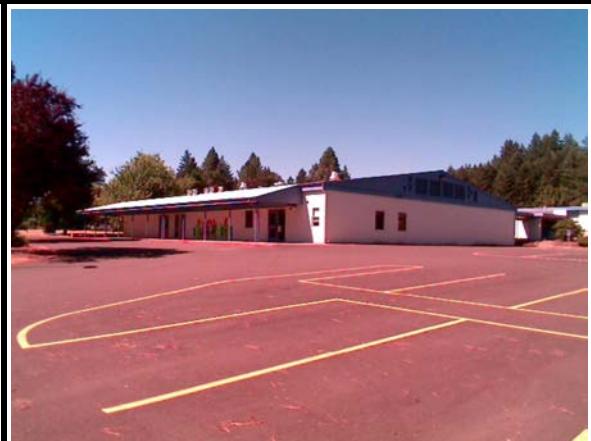
Lane\_sch44A

Type	Basic Score	Vert Irreg	Plan Irreg	Pre-Code	Post-Bench	Soil C	Soil D	Soil E	RVS Score
Primary	RM1	2.8	0	0	0	0	0	-0.6	0	2.2
Secondary		0	0	0	0	0	0	0	0	0
Tertiary		0	0	0	0	0	0	0	0	0

Final Type	Final Score
RM1	2.2

Low (<1%)

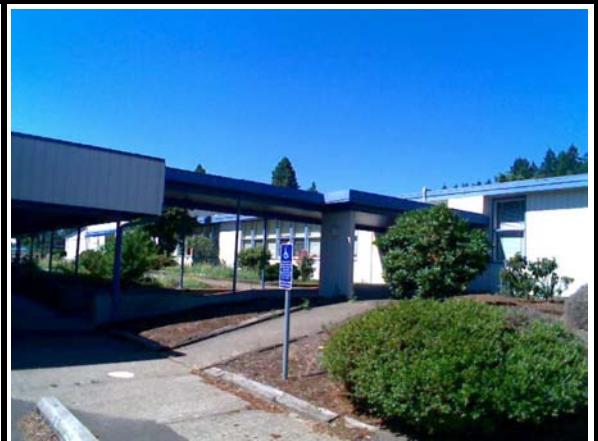
Lane\_sch44B

Type	Basic Score	Vert Irreg	Plan Irreg	Pre-Code	Post-Bench	Soil C	Soil D	Soil E	RVS Score
Primary	W2	3.8	-2	-0.5	0	0	0	-0.8	0	0.5
Secondary		0	0	0	0	0	0	0	0	0
Tertiary		0	0	0	0	0	0	0	0	0

Final Type	Final Score
W2	0.5

High (>10%)

Enrollment 287	Year Built (Field Verified) 1945	Year Built (Alt. Source) 1940	Est. Decade Built 1940
Total Area (square ft) 36486	Number of Stories 1	Basement	Pounding Potential No
Plan Irregularities Reentrant Corners: Other None None		Vertical Irregularities Steps in Elevation View: 2 to 3 Changes None None	
Falling Hazards None None None		Poor Conditions None None None

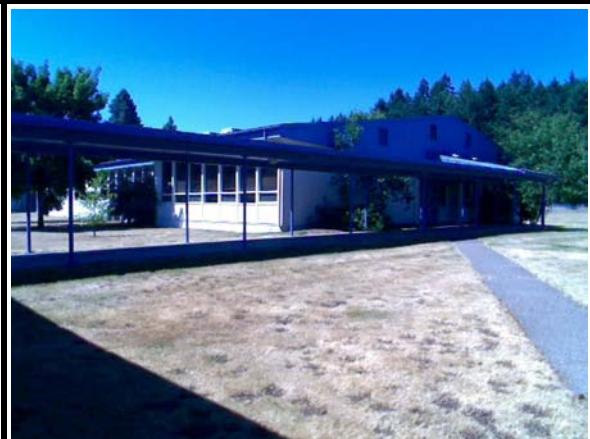
Lane\_sch44C

Enrollment 287	Year Built (Field Verified) 1945	Year Built (Alt. Source) 1945	Est. Decade Built 1980
Total Area (square ft) 36486	Number of Stories 1	Basement	Pounding Potential No
Plan Irregularities Reentrant Corners: Other None None		Vertical Irregularities Steps in Elevation View: 2 to 3 Changes None None	
Falling Hazards None None None		Poor Conditions None None None
