# Elmira High School

Fern Ridge SD 28J

## FEMA 154 Rapid Visual Screening Score Card

Rapid Visual Screening - Senate Bill #2 - Seismic Needs Assessment  
Oregon Department of Geology and Mineral Industries

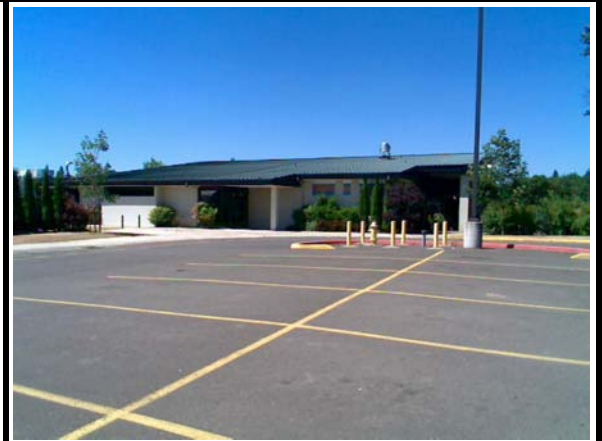
Lane\_sch47A

Seismicity Zone: High

| | Type | Basic Score | Vert Irreg | Plan Irreg | Pre-Code | Post-Bench | Soil C | Soil D | Soil E | RVS Score |
|---|---|---|---|---|---|---|---|---|---|---|
| Primary | RM1 | 2.8 | 0 | -0.5 | 0 | 0 | 0 | -0.6 | 0 | 1.7 |

Moderate (>1%)

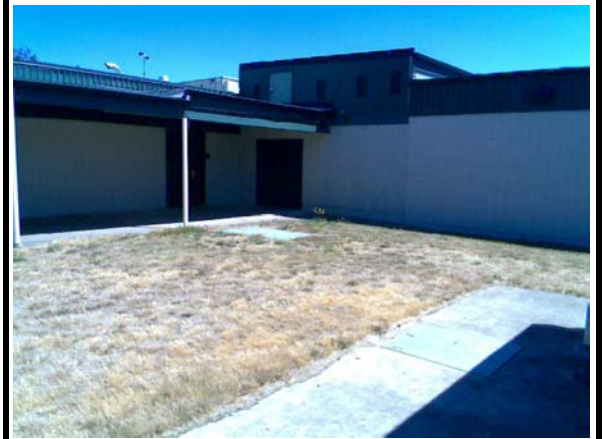
Lane\_sch47B

| | Type | Basic Score | Vert Irreg | Plan Irreg | Pre-Code | Post-Bench | Soil C | Soil D | Soil E | RVS Score |
|---|---|---|---|---|---|---|---|---|---|---|
| Primary | RM1 | 2.8 | -1 | -0.5 | 0 | 0 | 0 | -0.6 | 0 | 0.7 |
| Secondary | W2 | 3.8 | -2 | -0.5 | 0 | 0 | 0 | -0.8 | 0 | 0.5 |

High (>10%)

| Reentrant Corners: Other | Steps in Elevation View: Single Change |

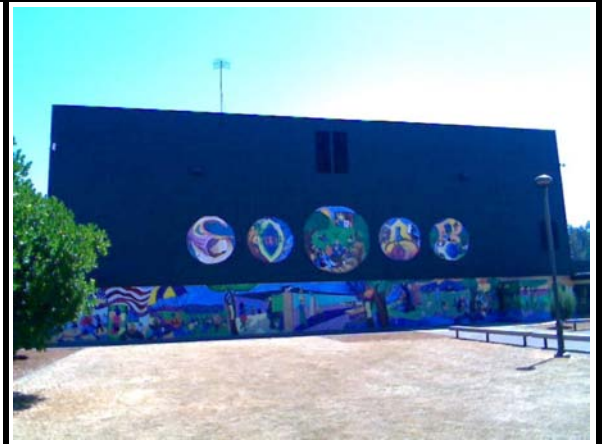
Lane\_sch47C

| | Type | Basic Score | Vert Irreg | Plan Irreg | Pre-Code | Post-Bench | Soil C | Soil D | Soil E | RVS Score |
|---|---|---|---|---|---|---|---|---|---|---|
| Primary | RM1 | 2.8 | -1 | -0.5 | 0 | 0 | 0 | -0.6 | 0 | 0.7 |
| Secondary | W2 | 3.8 | -2 | -0.5 | 0 | 0 | 0 | -0.8 | 0 | 0.5 |

High (>10%)

| Reentrant Corners: Other | Steps in Elevation View: Single Change |
