Malabon Elementary School

Bethel SD 52

Lane_sch59A

Rapid Visual Screening - Senate Bill #2 - Seismic Needs Assessment
Oregon Department of Geology and Mineral Industries

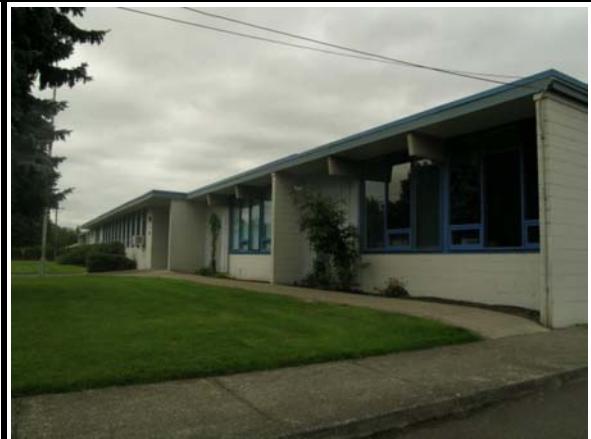
Type	Basic Score	Vert Irreg	Plan Irreg	Pre-Code	Post-Bench	Soil C	Soil D	Soil E	RVS Score
Primary	RM1	2.8	-1	-0.5	0	0	-0.4	0	0	0.9
Secondary	W2	3.8	-2	-0.5	0	0	-0.4	0	0	0.9
Tertiary		0	0	0	0	0	0	0	0	0

Final Type	Final Score
RM1	0.9

High (>10%)

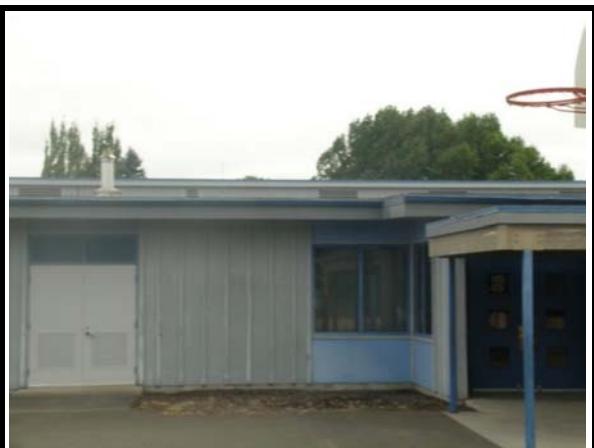
Lane_sch59B

Type	Basic Score	Vert Irreg	Plan Irreg	Pre-Code	Post-Bench	Soil C	Soil D	Soil E	RVS Score
Primary	RM1	2.8	0	-0.5	0	0	-0.4	0	0	1.9
Secondary	W2	3.8	0	-0.5	0	0	-0.4	0	0	2.9
Tertiary		0	0	0	0	0	0	0	0	0

Final Type	Final Score
RM1	1.9

Moderate (>1%)

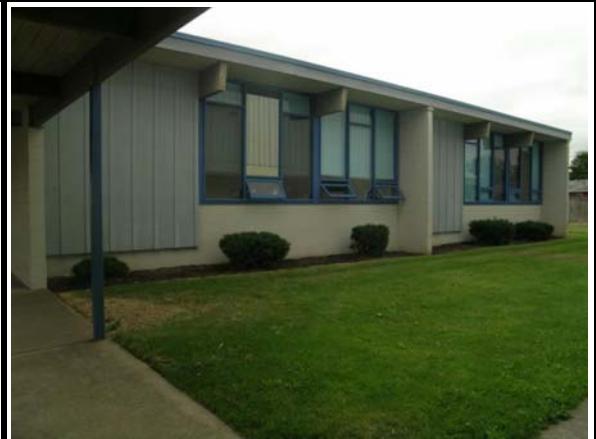
Lane_sch59C

Type	Basic Score	Vert Irreg	Plan Irreg	Pre-Code	Post-Bench	Soil C	Soil D	Soil E	RVS Score
Primary	RM1	2.8	0	0	0	0	-0.4	0	0	2.4
Secondary	W2	3.8	0	0	0	0	-0.4	0	0	3.4
Tertiary		0	0	0	0	0	0	0	0	0

Final Type	Final Score
RM1	2.4

Low (<1%)

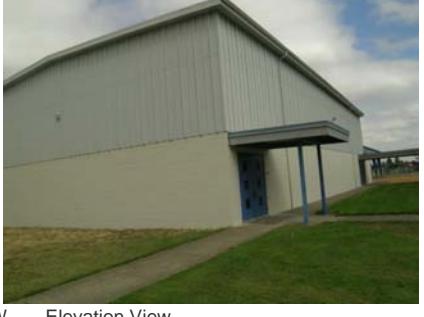
E Primary Structural Type and secondary structural type. W2 on the upper level and RM1 on the lower level		SE Primary Structural Type and secondary structural type.	
		W Elevation View

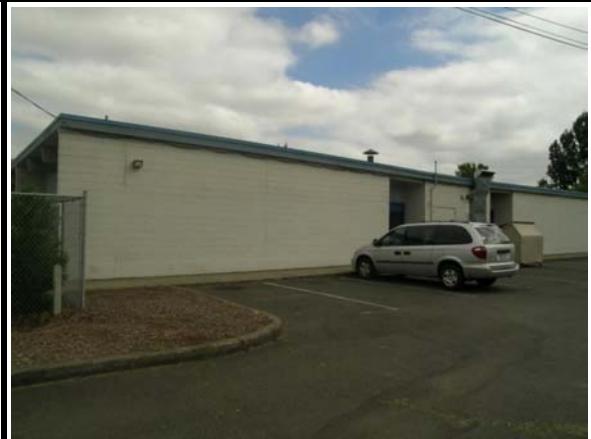
Lane_sch59D

Type	Basic Score	Vert Irreg	Plan Irreg	Pre-Code	Post-Bench	Soil C	Soil D	Soil E	RVS Score
Primary	RM1	2.8	0	0	0	0	-0.4	0	0	2.4
Secondary	W2	3.8	0	0	0	0	-0.4	0	0	3.4
Tertiary		0	0	0	0	0	0	0	0	0

Final Type	Final Score
RM1	2.4

Low (<1%)
