Shasta Middle School

Bethel SD 52

FEMA 154 Rapid Visual Screening Score Card

Rapid Visual Screening - Senate Bill #2 - Seismic Needs Assessment
Oregon Department of Geology and Mineral Industries

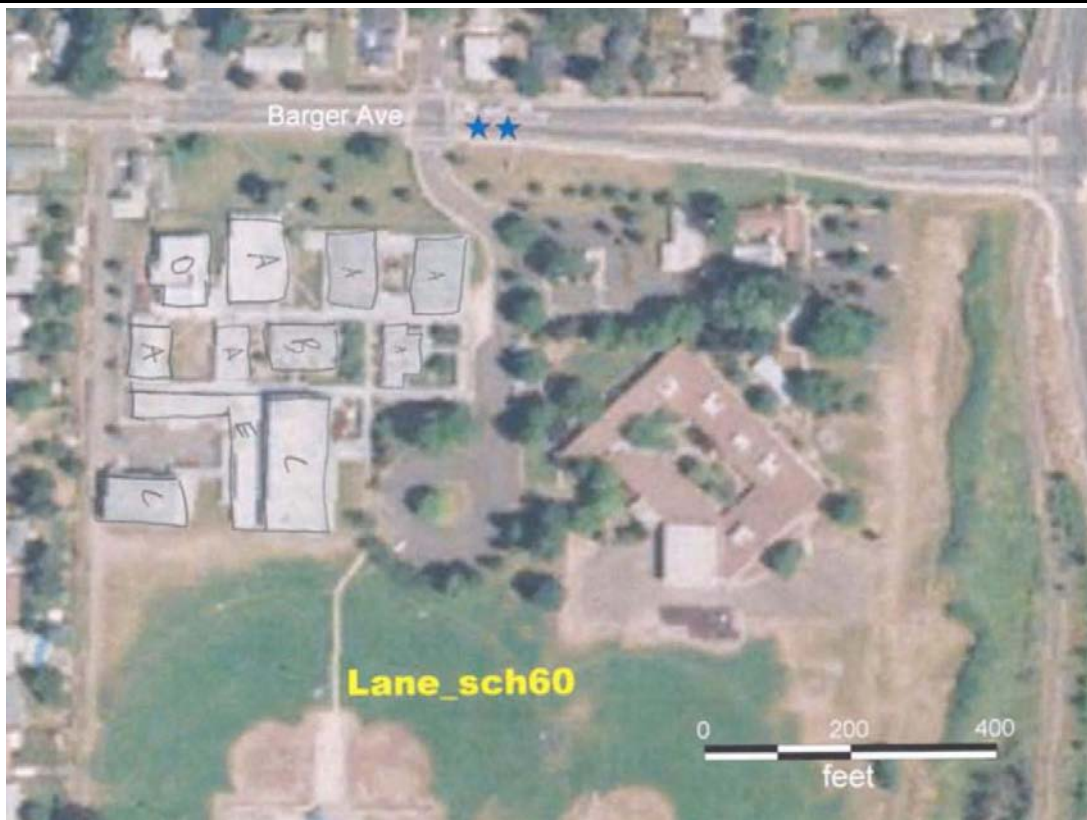
Lane_sch60A

Type	Basic Score	Vert Irreg	Plan Irreg	Pre-Code	Post-Bench	Soil C	Soil D	Soil E	RVS Score
Primary	RM1	2.8	0	0	0	0	-0.4	0	0	2.4
Secondary		0	0	0	0	0	0	0	0	0
Tertiary		0	0	0	0	0	0	0	0	0

2.4

Low (<1%)

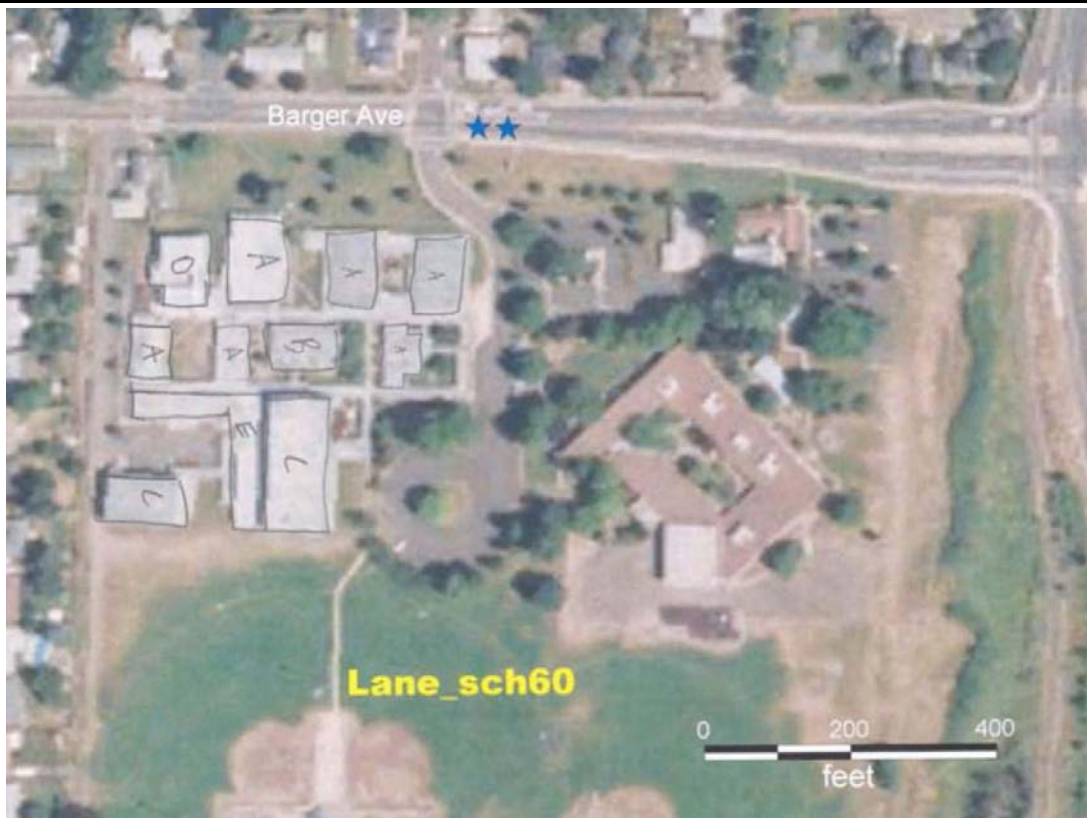
Lane_sch60B

Type	Basic Score	Vert Irreg	Plan Irreg	Pre-Code	Post-Bench	Soil C	Soil D	Soil E	RVS Score
Primary	RM1	2.8	0	0	0	0	-0.4	0	0	2.4
Secondary	W2	3.8	0	0	0	0	-0.4	0	0	3.4
Tertiary		0	0	0	0	0	0	0	0	0

2.4

Low (<1%)

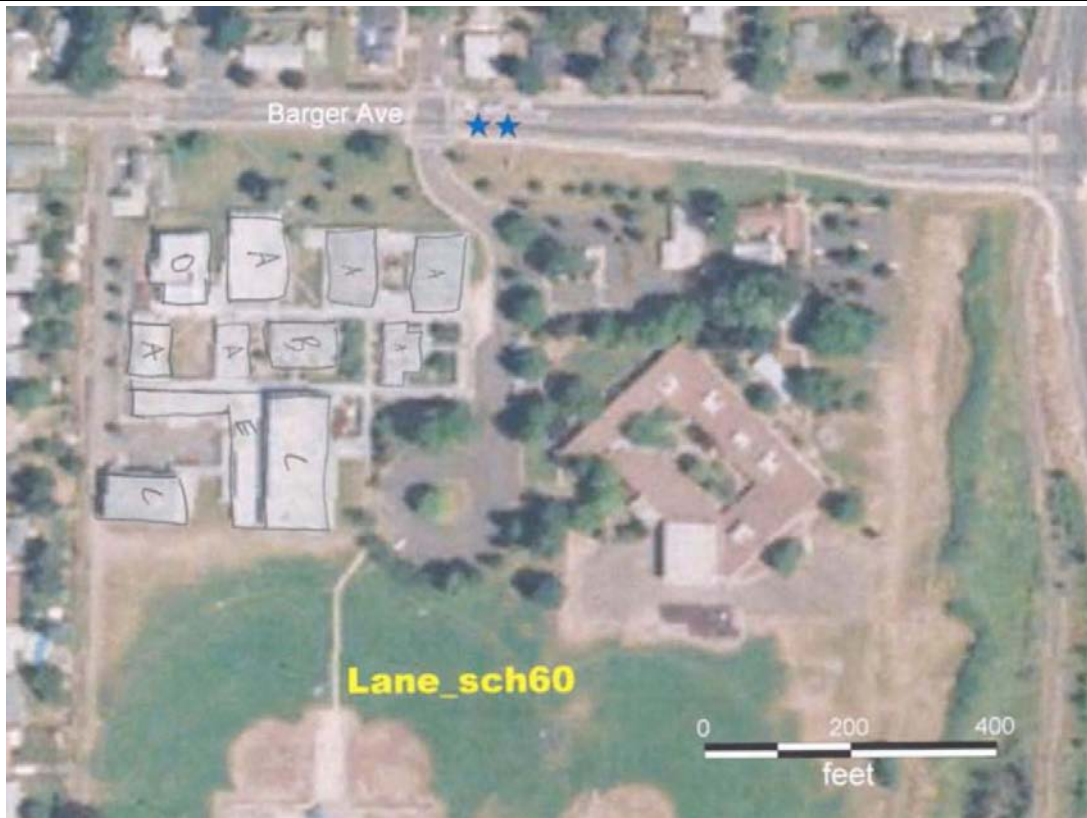
Lane_sch60C

Type	Basic Score	Vert Irreg	Plan Irreg	Pre-Code	Post-Bench	Soil C	Soil D	Soil E	RVS Score
Primary	S3	3.2	0	0	0	0	-0.4	0	0	2.8
Secondary	RM1	2.8	-1	0	0	0	-0.4	0	0	1.4
Tertiary		0	0	0	0	0	0	0	0	0

1.4

Moderate (>1%)

Plan Irregularities	Vertical Irregularities
None	Steps in Elevation View: Single Change (Adjacent Building/Entity)
None	None
None	None

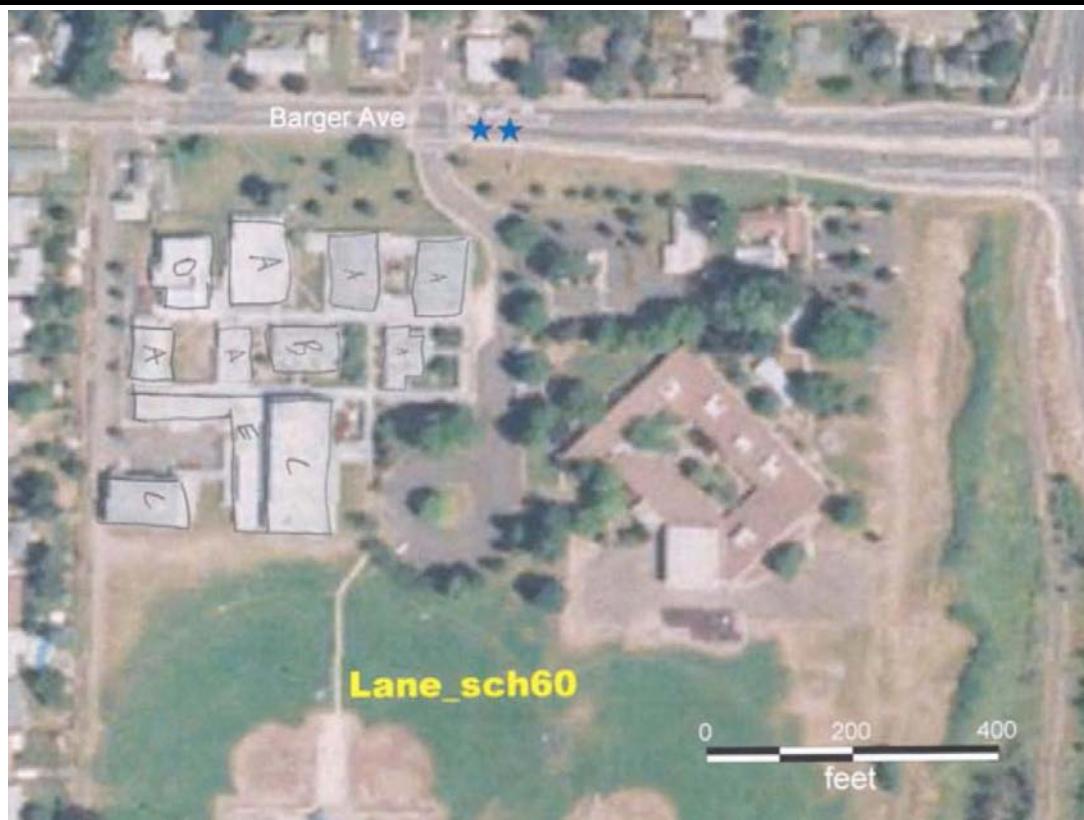
Lane_sch60D

Type	Basic Score	Vert Irreg	Plan Irreg	Pre-Code	Post-Bench	Soil C	Soil D	Soil E	RVS Score
Primary	RM1	2.8	-1	-0.5	0	0	-0.4	0	0	0.9
Secondary		0	0	0	0	0	0	0	0	0
Tertiary		0	0	0	0	0	0	0	0	0

0.9

High (>10%)

Plan Irregularities	Vertical Irregularities
Reentrant Corners: T shaped	Steps in Elevation View: 2 to 3 Changes
None	None
None	None
