Village School

Eugene SD 4J

FEMA 154 Rapid Visual Screening Score Card

Rapid Visual Screening - Senate Bill #2 - Seismic Needs Assessment
Oregon Department of Geology and Mineral Industries

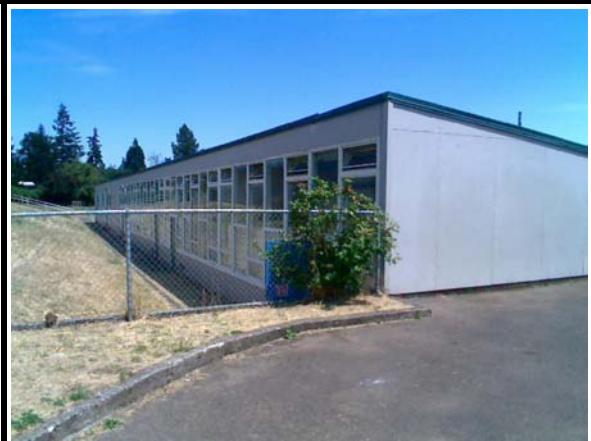
Lane_sch82A

Seismicity Zone: High

| | Type | Basic Score | Vert Irreg | Plan Irreg | Pre-Code | Post-Bench | Soil C | Soil D | Soil E | RVS Score |
|---|---|---|---|---|---|---|---|---|---|---|
| Primary | W2 | 3.8 | -2 | -0.5 | 0 | 0 | 0 | 0 | 0 | 1.3 |

| Final Type | Final Score |
|---|---|
| W2 | 1.3 |

Moderate (>1%)

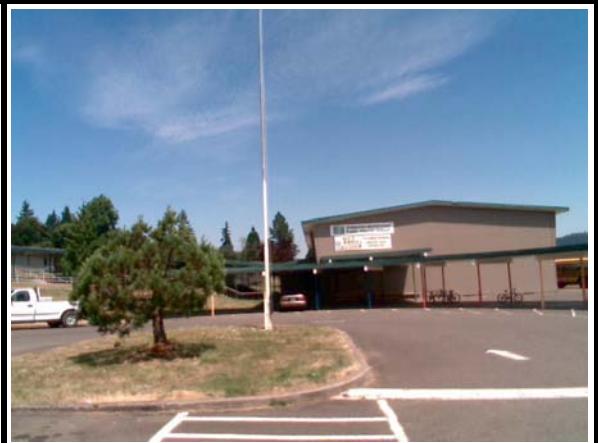
Lane_sch82B

Seismicity Zone: High

| | Type | Basic Score | Vert Irreg | Plan Irreg | Pre-Code | Post-Bench | Soil C | Soil D | Soil E | RVS Score |
|---|---|---|---|---|---|---|---|---|---|---|
| Primary | W2 | 3.8 | -2 | -0.5 | 0 | 0 | 0 | 0 | 0 | 1.3 |

| Final Type | Final Score |
|---|---|
| W2 | 1.3 |

Moderate (>1%)

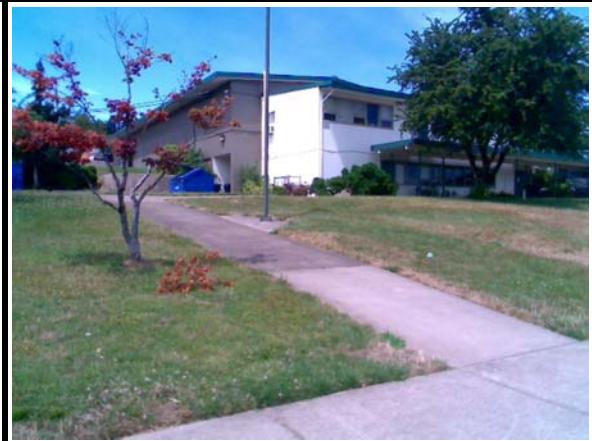
Lane_sch82C

Seismicity Zone: High

| | Type | Basic Score | Vert Irreg | Plan Irreg | Pre-Code | Post-Bench | Soil C | Soil D | Soil E | RVS Score |
|---|---|---|---|---|---|---|---|---|---|---|
| Primary | C2 | 2.8 | -1 | -0.5 | 0 | 0 | 0 | 0 | 0 | 1.3 |
| Secondary | W2 | 3.8 | -2 | -0.5 | 0 | 0 | 0 | 0 | 0 | 1.3 |

| Final Type | Final Score |
|---|---|
| C2 | 1.3 |

Moderate (>1%)
