Ridgeline Montessori

Eugene SD 4J

Lane_sch91A

FEMA 154 Rapid Visual Screening Score Card

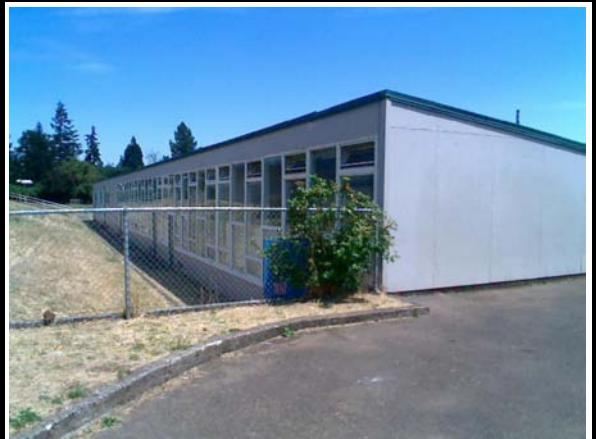
Type	Basic Score	Vert Irreg	Plan Irreg	Pre-Code	Post-Bench	Soil C	Soil D	Soil E	RVS Score
Primary	W2	3.8	-2	-0.5	0	0	0	0	0	1.3
Secondary		0	0	0	0	0	0	0	0	0
Tertiary		0	0	0	0	0	0	0	0	0

Final Type	Final Score
W2	1.3

Moderate (>1%)

Enrollment 226	Year Built (Field Verified) 1950	Year Built (Alt. Source) 1950	Est. Decade Built 1950
Total Area (square ft) 1	Number of Stories 1	Basement No	Pounding Potential No
Plan Irregularities Reentrant Corners:Other (Adjacent Build/Entity) None None		Vertical Irregularities Steps in Elevation View: Single Change (Adjacent Building/Entity) None None	
Falling Hazards None None None		Poor Conditions None None None

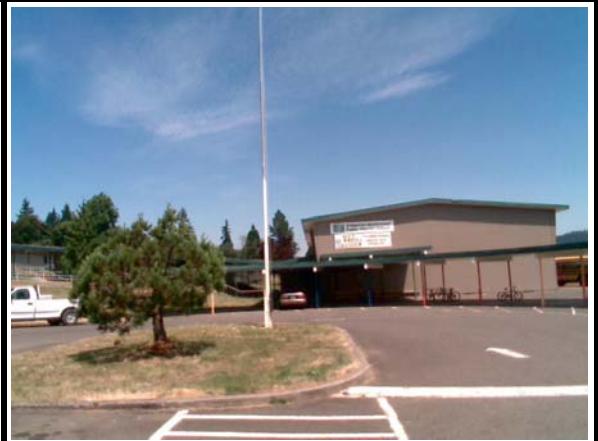
Lane_sch91B

Type	Basic Score	Vert Irreg	Plan Irreg	Pre-Code	Post-Bench	Soil C	Soil D	Soil E	RVS Score
Primary	W2	3.8	-2	-0.5	0	0	0	0	0	1.3
Secondary		0	0	0	0	0	0	0	0	0
Tertiary		0	0	0	0	0	0	0	0	0

Final Type	Final Score
W2	1.3

Moderate (>1%)

Enrollment 226	Year Built (Field Verified) 1950	Year Built (Alt. Source) 1950	Est. Decade Built 1950
Total Area (square ft) 1	Number of Stories 1	Basement No	Pounding Potential No
Plan Irregularities Reentrant Corners: Other None None		Vertical Irregularities Steps in Elevation View: Single Change None None	
Falling Hazards None None None		Poor Conditions None None None

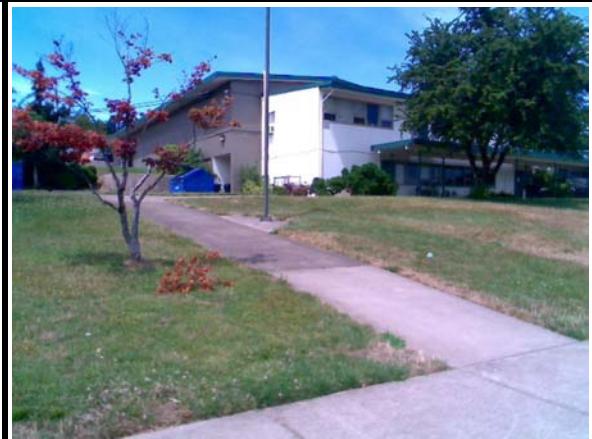
Lane_sch91C

Type	Basic Score	Vert Irreg	Plan Irreg	Pre-Code	Post-Bench	Soil C	Soil D	Soil E	RVS Score
Primary	W2	3.8	-2	-0.5	0	0	0	0	0	1.3
Secondary	C2	2.8	-1	-0.5	0	0	0	0	0	1.3
Tertiary		0	0	0	0	0	0	0	0	0

Final Type	Final Score
W2	1.3

Moderate (>1%)

Enrollment 226	Year Built (Field Verified) 	Year Built (Alt. Source) 	Est. Decade Built 1950
Total Area (square ft) 	Number of Stories 2	Basement No	Pounding Potential No
Plan Irregularities Reentrant Corners:Other (Adjacent Build/Entity) None None		Vertical Irregularities Building On Hill or Sloped Site Steps in Elevation View: Single Change (Adjacent Building/Entity) None	
Falling Hazards None None None		Poor Conditions None None None
