North Lincoln Fire & Rescue

Linc_fir03A

FEMA 154 Rapid Visual Screening Score Card

Rapid Visual Screening - Senate Bill #2 - Seismic Needs Assessment
Oregon Department of Geology and Mineral Industries

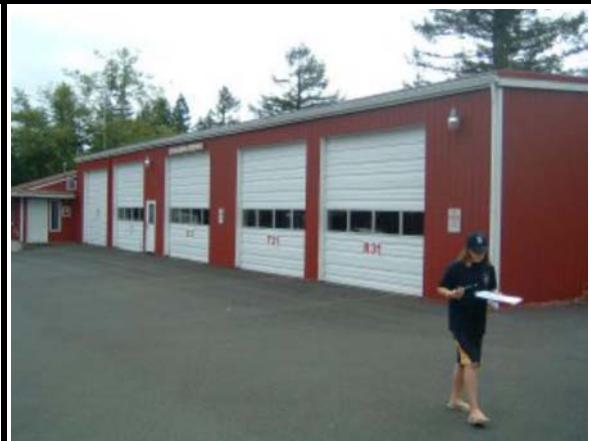
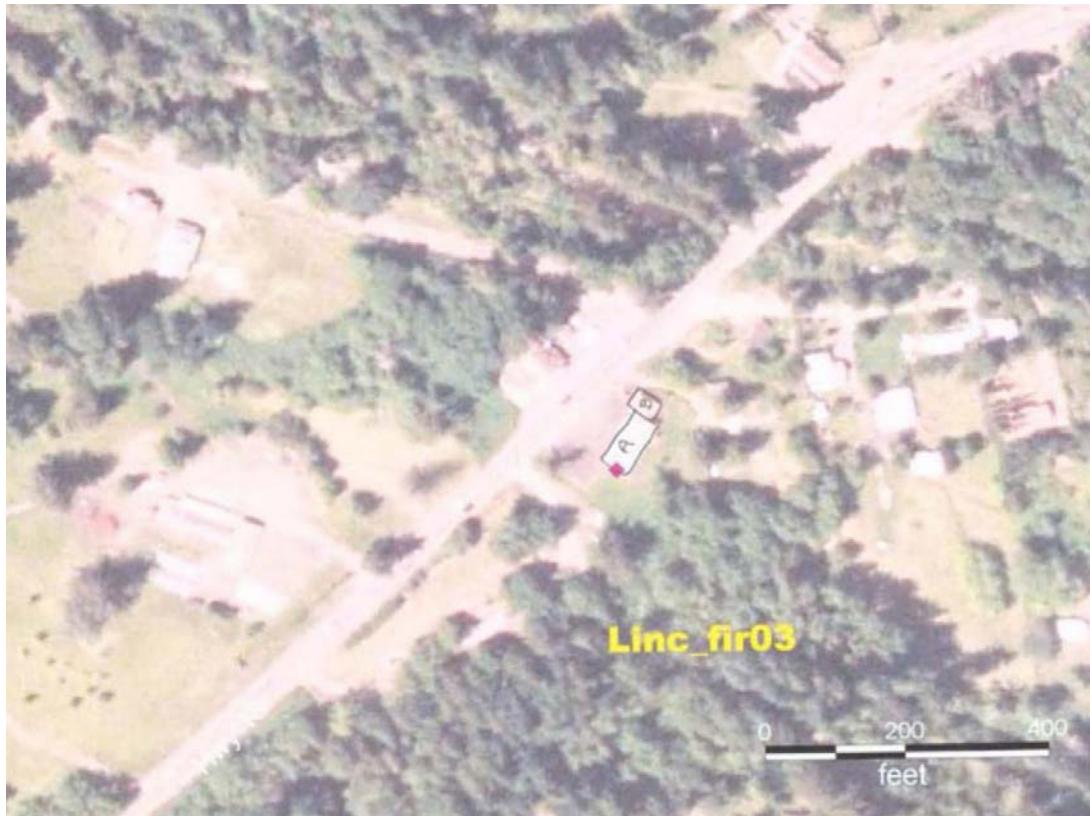
Type	Basic Score	Vert Irreg	Plan Irreg	Pre-Code	Post-Bench	Soil C	Soil D	Soil E	RVS Score
Primary	S3	3.2	0	-0.5	0	0	-0.4	0	0	2.3
Secondary		0	0	0	0	0	0	0	0	0
Tertiary		0	0	0	0	0	0	0	0	0

Final Type	Final Score
S3	2.3

Low (<1%)

Enrollment	Year Built (Field Verified)	Year Built (Alt. Source)	Est. Decade Built
			1970
Total Area (square ft)	Number of Stories	Basement	Pounding Potential
3948	1	No	No
Plan Irregularities		Vertical Irregularities	
Reentrant Corners:Other (Adjacent Build/Entity)		Steps in Elevation View: Single Change (Adjacent Building/Entity)	
None		None	
None		None	
Falling Hazards		Poor Conditions	
None		None	
None		None	
None		None

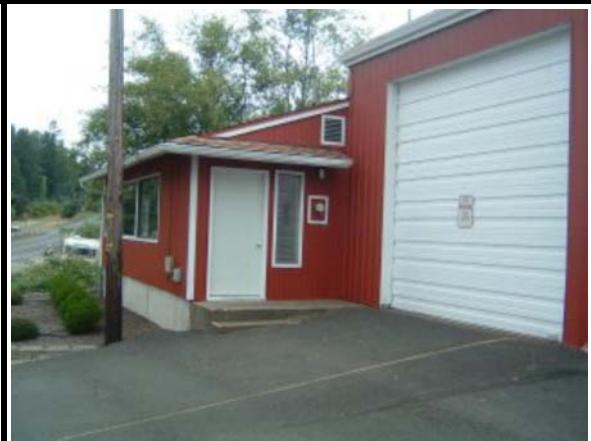
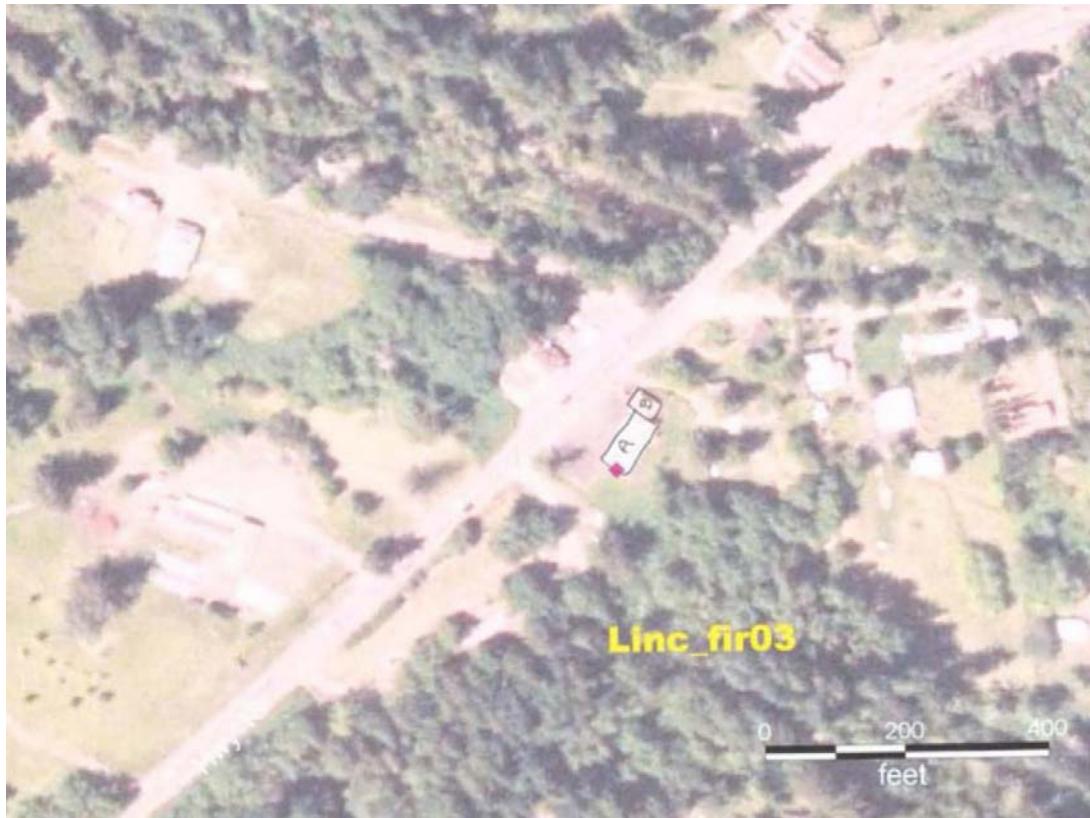
Linc_fir03B

Type	Basic Score	Vert Irreg	Plan Irreg	Pre-Code	Post-Bench	Soil C	Soil D	Soil E	RVS Score
Primary	W1	4.4	0	-0.5	0	0	0	0	0	3.9
Secondary		0	0	0	0	0	0	0	0	0
Tertiary		0	0	0	0	0	0	0	0	0

Final Type	Final Score
W1	3.9

Low (<1%)

Enrollment	Year Built (Field Verified)	Year Built (Alt. Source)	Est. Decade Built
			1970
Total Area (square ft)	Number of Stories	Basement	Pounding Potential
	1	No	No
Plan Irregularities		Vertical Irregularities	
Reentrant Corners:Other (Adjacent Build/Entity)		Steps in Elevation View: Single Change (Adjacent Building/Entity)	
None		None	
None		None	
Falling Hazards		Poor Conditions	
None		None	
None		None	
None		None
