Yachats RFPD & S. Lincoln Ambulance Service

Linc_fir08A

FEMA 154 Rapid Visual Screening Score Card

Rapid Visual Screening - Senate Bill #2 - Seismic Needs Assessment
Oregon Department of Geology and Mineral Industries

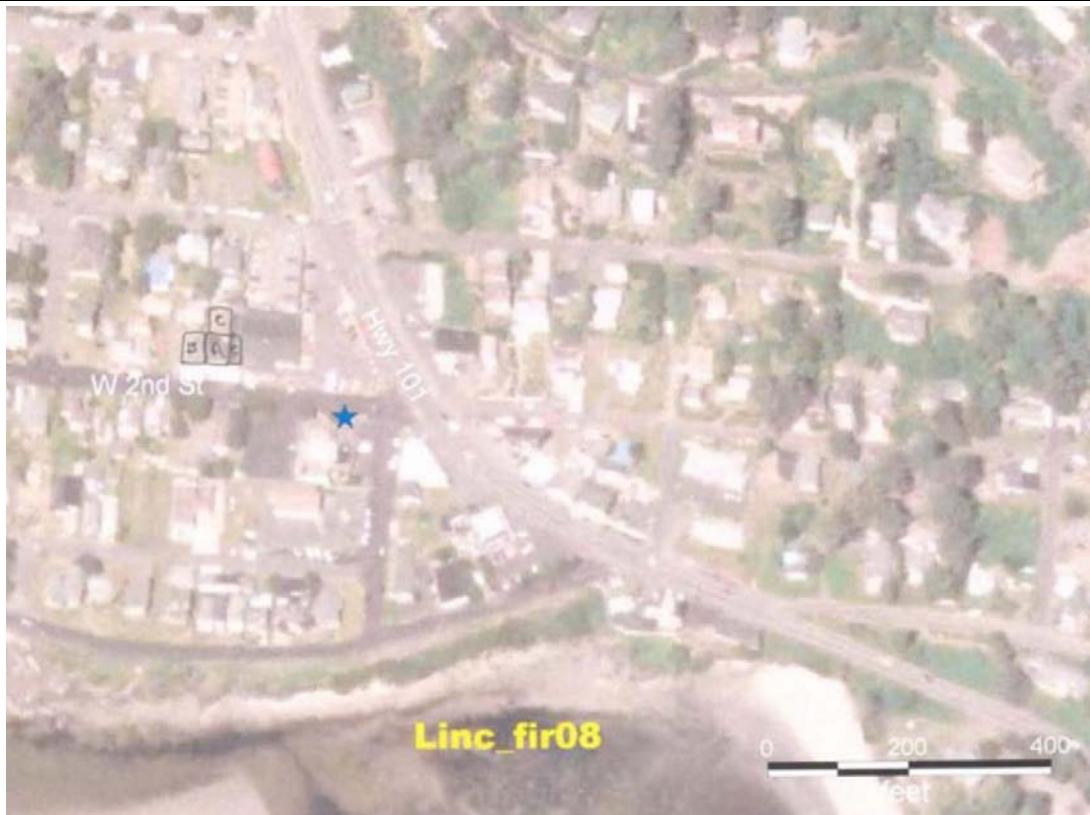
Linc_fir08A

Final Type	Final Score
W2	-0.1

Very High (100%)

Enrollment	Year Built (Field Verified)	Year Built (Alt. Source)	Est. Decade Built
			1940
Total Area (square ft)	Number of Stories	Basement	Pounding Potential
	2	No	No
Plan Irregularities		Vertical Irregularities	
Torsion: Eccentric Stiffness		Steps in Elevation View: Single Change	
Out of Plane Lateral-Force-Resistance Elements		Steps in Elevation View: 2 to 3 Changes (Adjacent Building/Entity)	
Reentrant Corners: T shaped (Adjacent Build/Entity)		None	
Falling Hazards		Poor Conditions	
None		None	
None		None	
None		None

S Vertical Irregularity Secondary out-of-plane offset also		NW Plan Irregularity Tertiary step in elevation also

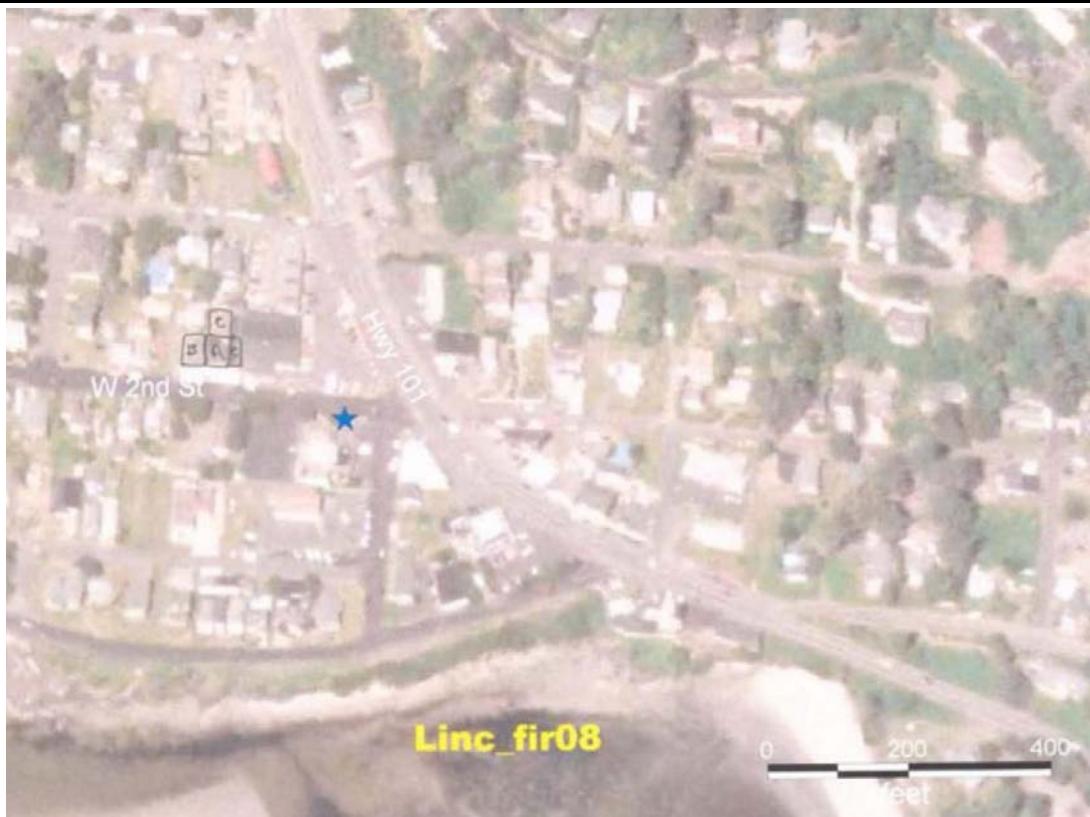
Linc_fir08B

Final Type	Final Score
W1	1.4

Moderate (>1%)

Enrollment	Year Built (Field Verified)	Year Built (Alt. Source)	Est. Decade Built
			1970
Total Area (square ft)	Number of Stories	Basement	Pounding Potential
	1	No	No
Plan Irregularities		Vertical Irregularities	
Torsion: Eccentric Stiffness		Steps in Elevation View: Single Change (Adjacent Building/Entity)	
None		None	
None		None	
Falling Hazards		Poor Conditions	
None		None	
None		None	
None		None
