Newport High School - East

Linc_sch09A

FEMA 154 Rapid Visual Screening Score Card

Rapid Visual Screening - Senate Bill #2 - Seismic Needs Assessment
Oregon Department of Geology and Mineral Industries

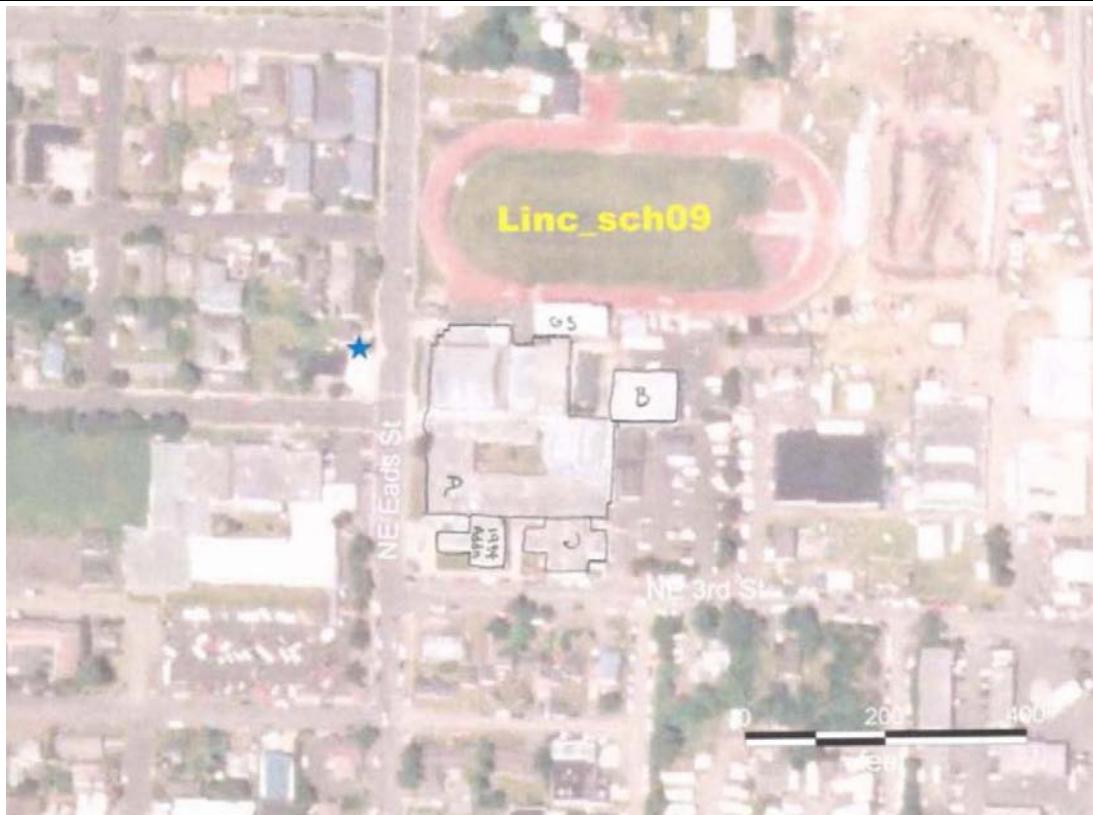
Type	Basic Score	Vert Irreg	Plan Irreg	Pre-Code	Post-Bench	Soil C	Soil D	Soil E	RVS Score
Primary	C2	2.8	-1	-0.5	0	0	0	0	0	1.3
Secondary	RM1	2.8	-1	-0.5	0	0	0	0	0	1.3
Tertiary	S3	3.2	0	-0.5	0	0	0	0	0	2.7

Final Type	Final Score
C2	1.3

Moderate (>1%)

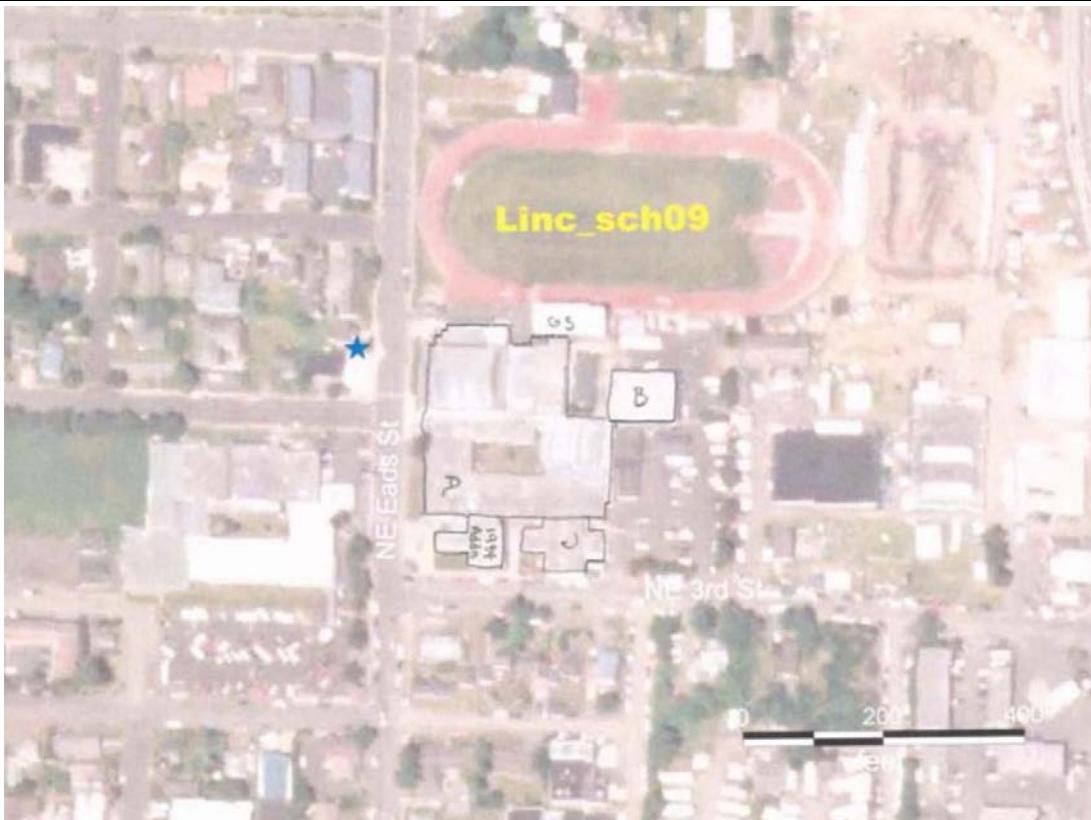
Linc_sch09B

Type	Basic Score	Vert Irreg	Plan Irreg	Pre-Code	Post-Bench	Soil C	Soil D	Soil E	RVS Score
Primary	RM1	2.8	0	0	0	0	0	0	0	2.8
Secondary		0	0	0	0	0	0	0	0	0
Tertiary		0	0	0	0	0	0	0	0	0

Final Type	Final Score
RM1	2.8

Low (<1%)

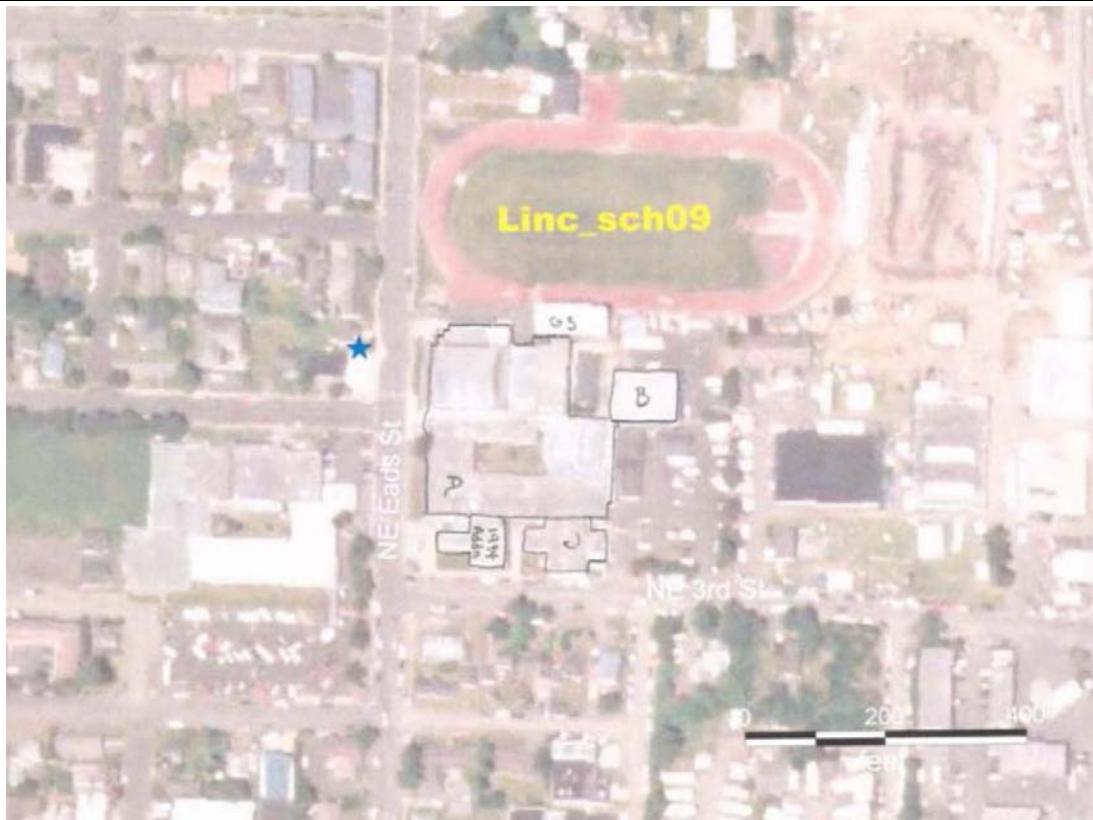
Linc_sch09C

Type	Basic Score	Vert Irreg	Plan Irreg	Pre-Code	Post-Bench	Soil C	Soil D	Soil E	RVS Score
Primary	W2	3.8	-2	-0.5	0	2.4	0	0	0	3.7
Secondary	RM1	2.8	-1	-0.5	0	0	0	0	0	1.3
Tertiary		0	0	0	0	0	0	0	0	0

Final Type	Final Score
RM1	1.3

Moderate (>1%)
