Toledo High School

Lincoln County SD

FEMA 154 Rapid Visual Screening Score Card

Rapid Visual Screening - Senate Bill #2 - Seismic Needs Assessment
 Oregon Department of Geology and Mineral Industries

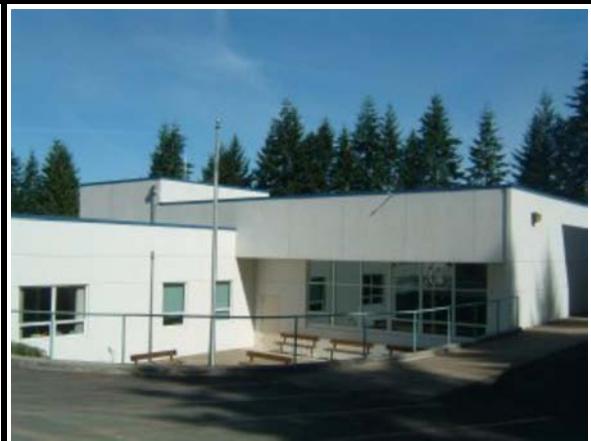
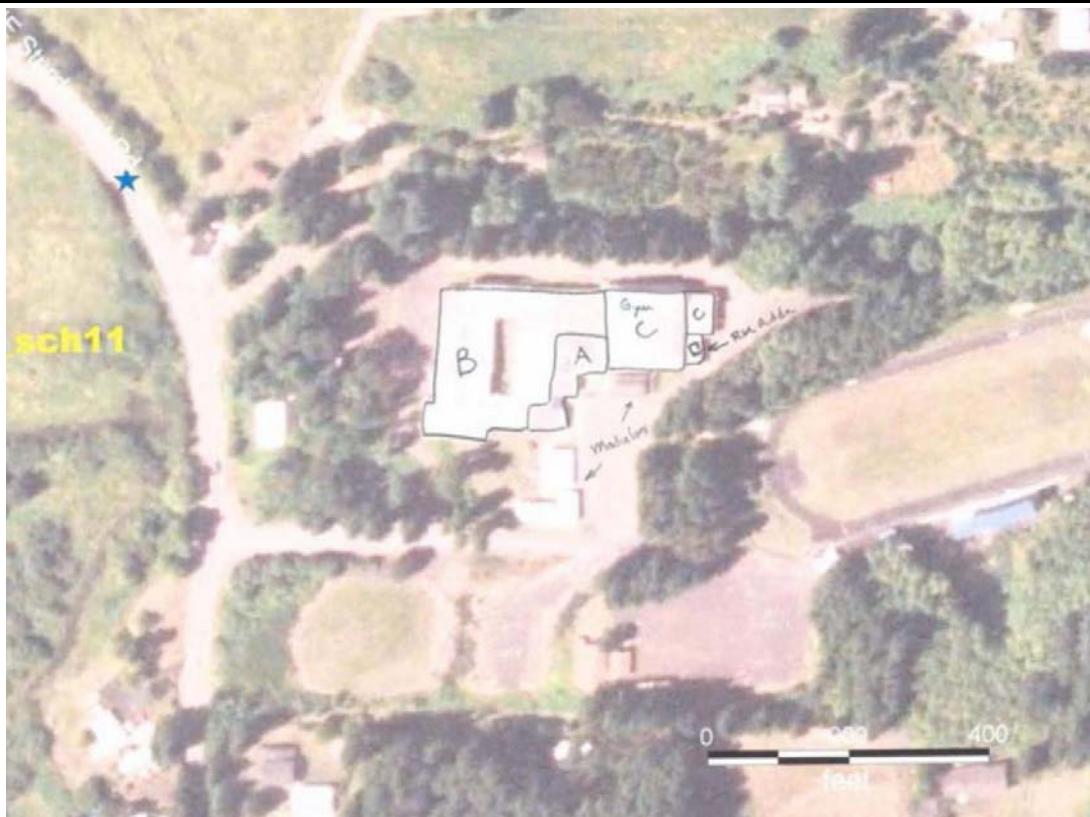
Linc_sch11A

Type	Basic Score	Vert Irreg	Plan Irreg	Pre-Code	Post-Bench	Soil C	Soil D	Soil E	RVS Score
Primary	PC1	2.6	0	-0.5	0	0	-0.4	0	0	1.7
Secondary		0	0	0	0	0	0	0	0	0
Tertiary		0	0	0	0	0	0	0	0	0

Final Type	Final Score
PC1	1.7

Moderate (>1%)

Enrollment 410	Year Built (Field Verified) 1997	Year Built (Alt. Source) 1955	Est. Decade Built 1990
Total Area (square ft) 80744	Number of Stories 1	Basement	Pounding Potential No
Plan Irregularities Reentrant Corners: Other None None		Vertical Irregularities Steps in Elevation View: 2 to 3 Changes Steps in Elevation View: 2 to 3 Changes (Adjacent Building/Entity) Building On Hill or Sloped Site	
Falling Hazards None None None		Poor Conditions None None None

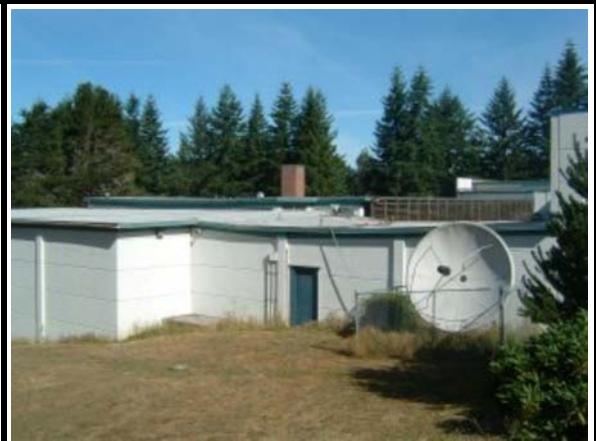
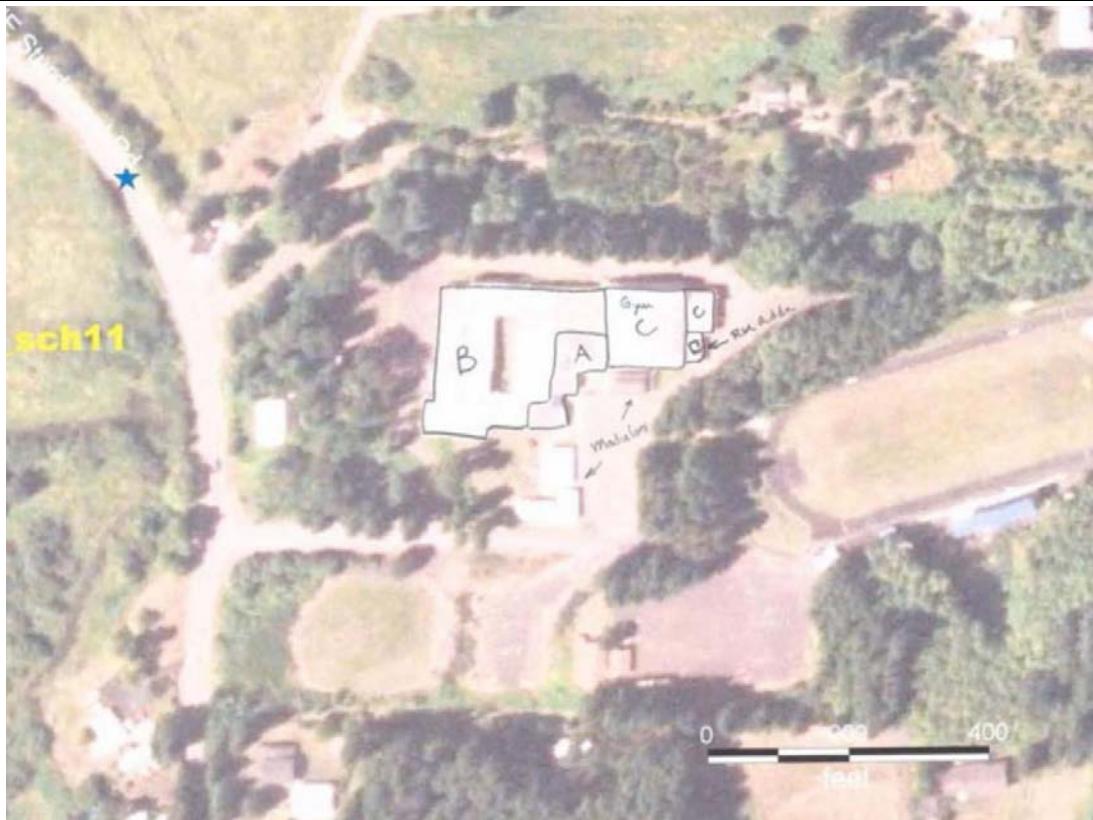
Linc_sch11B

Type	Basic Score	Vert Irreg	Plan Irreg	Pre-Code	Post-Bench	Soil C	Soil D	Soil E	RVS Score
Primary	C2	2.8	-1	-0.5	0	0	-0.4	0	0	0.9
Secondary		0	0	0	0	0	0	0	0	0
Tertiary		0	0	0	0	0	0	0	0	0

Final Type	Final Score
C2	0.9

High (>10%)

Enrollment 410	Year Built (Field Verified) 1955	Year Built (Alt. Source) 1955	Est. Decade Built 1950
Total Area (square ft) 80744	Number of Stories 2	Basement	Pounding Potential No
Plan Irregularities Reentrant Corners: Other None None		Vertical Irregularities Steps in Elevation View: Very Irregular Changes Steps in Elevation View: 2 to 3 Changes (Adjacent Building/Entity) Building On Hill or Sloped Site	
Falling Hazards Unreinforced Chimneys None None		Poor Conditions None None None

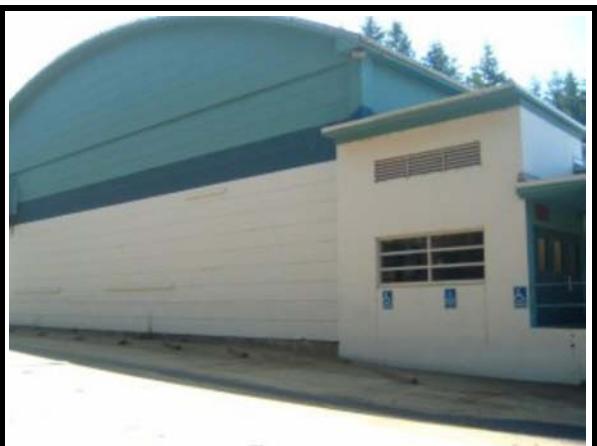
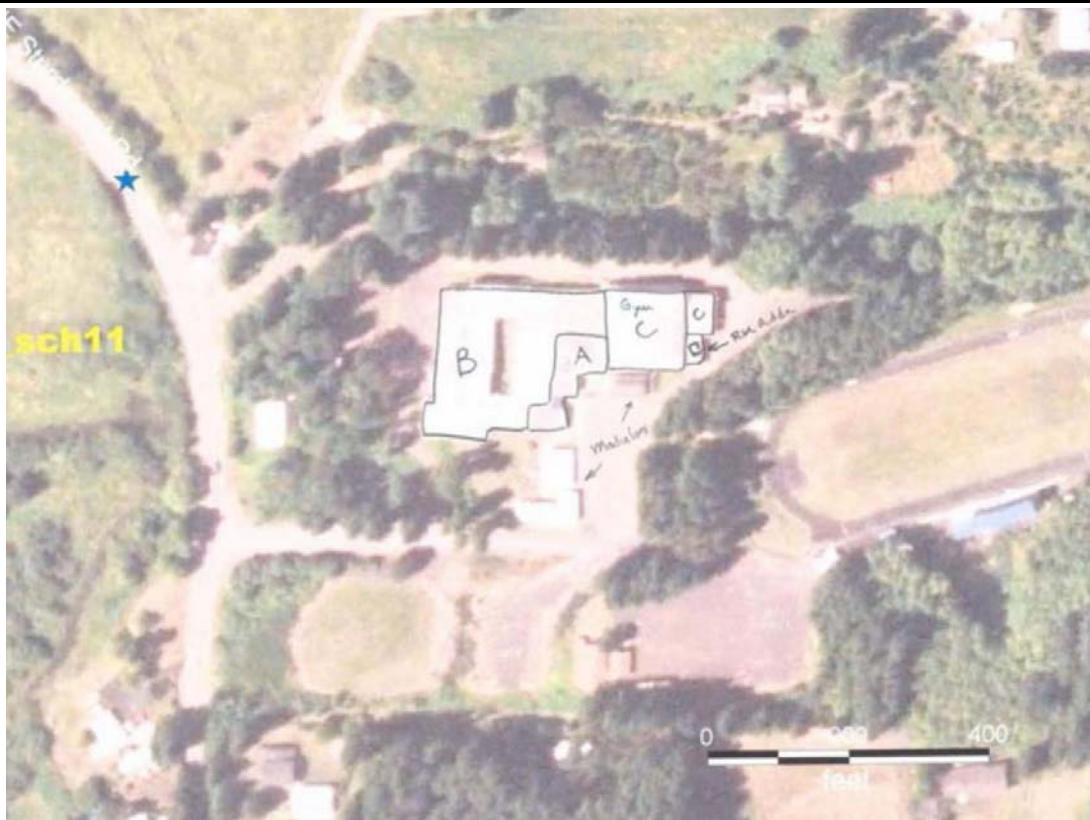
Linc_sch11C

Type	Basic Score	Vert Irreg	Plan Irreg	Pre-Code	Post-Bench	Soil C	Soil D	Soil E	RVS Score
Primary	W2	3.8	-2	-0.5	0	0	-0.4	0	0	0.9
Secondary	C2	2.8	-1	-0.5	0	0	-0.4	0	0	0.9
Tertiary	RM1	2.8	-1	-0.5	0	0	-0.4	0	0	0.9

Final Type	Final Score
W2	0.9

High (>10%)

Enrollment 410	Year Built (Field Verified) 1955	Year Built (Alt. Source) 1955	Est. Decade Built 1950
Total Area (square ft) 80744	Number of Stories 2	Basement	Pounding Potential No
Plan Irregularities Reentrant Corners: Other None None		Vertical Irregularities Steps in Elevation View: 2 to 3 Changes Steps in Elevation View: 2 to 3 Changes (Adjacent Building/Entity) Building On Hill or Sloped Site	
Falling Hazards None None None		Poor Conditions None None None
