Eddyville Charter School

Lincoln County SD

FEMA 154 Rapid Visual Screening Score Card

Rapid Visual Screening - Senate Bill #2 - Seismic Needs Assessment
Oregon Department of Geology and Mineral Industries

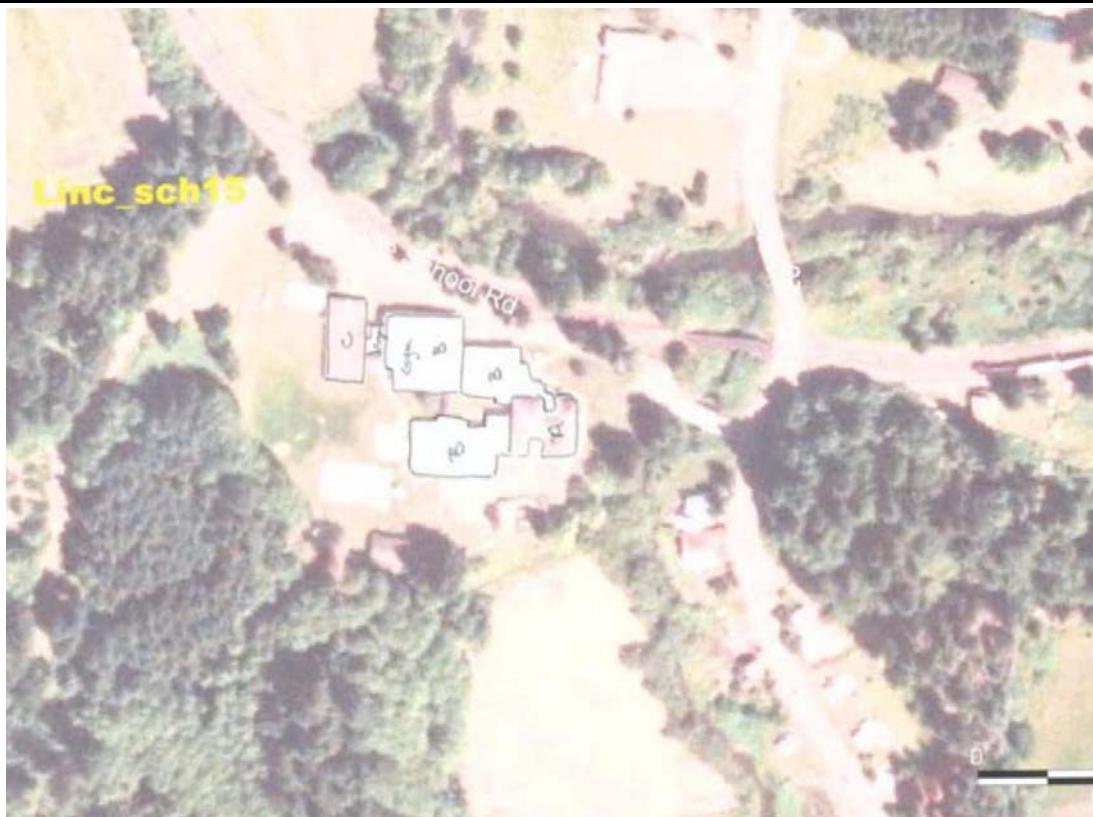
Linc_sch15A

Type	Basic Score	Vert Irreg	Plan Irreg	Pre-Code	Post-Bench	Soil C	Soil D	Soil E	RVS Score
Primary	W2	3.8	-2	-0.5	-1	0	-0.4	0	0	-0.1
Secondary		0	0	0	0	0	0	0	0	0
Tertiary		0	0	0	0	0	0	0	0	0

Final Type	Final Score
W2	-0.1

Very High (100%)

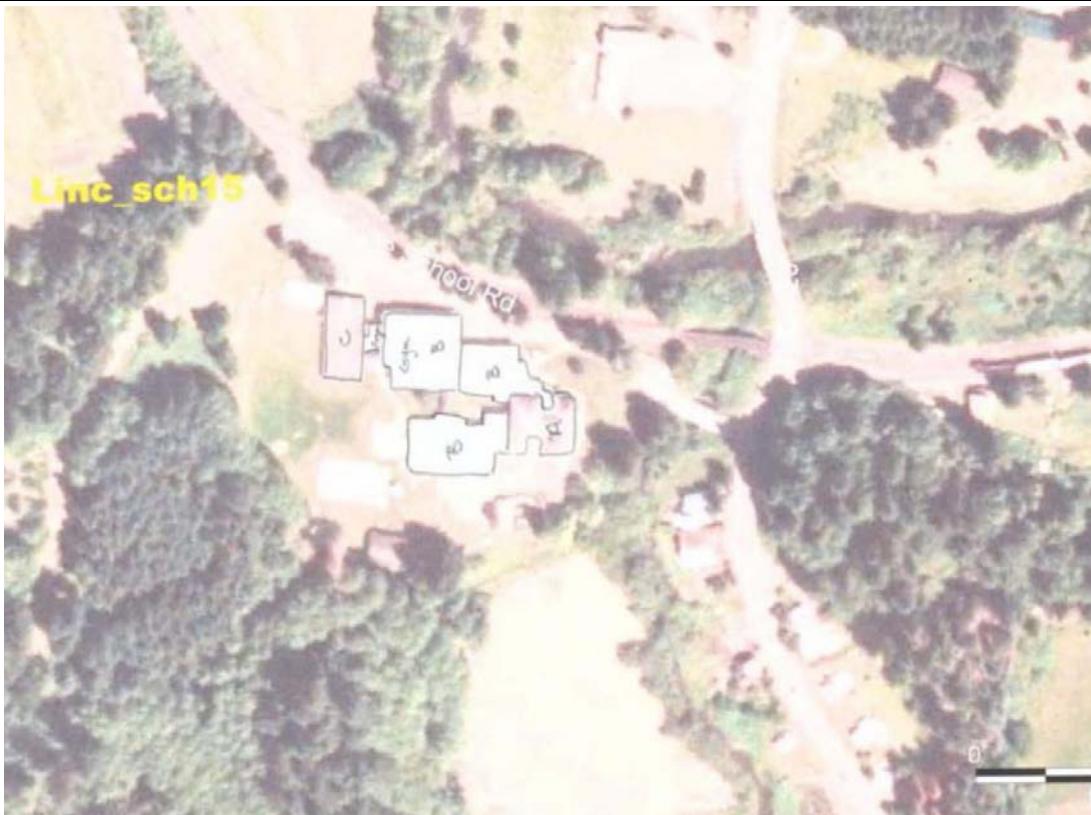
Linc_sch15B

Type	Basic Score	Vert Irreg	Plan Irreg	Pre-Code	Post-Bench	Soil C	Soil D	Soil E	RVS Score
Primary	W2	3.8	-2	-0.5	0	0	-0.4	0	0	0.9
Secondary	RM1	2.8	-1	-0.5	0	0	-0.4	0	0	0.9
Tertiary		0	0	0	0	0	0	0	0	0

Final Type	Final Score
W2	0.9

High (>10%)

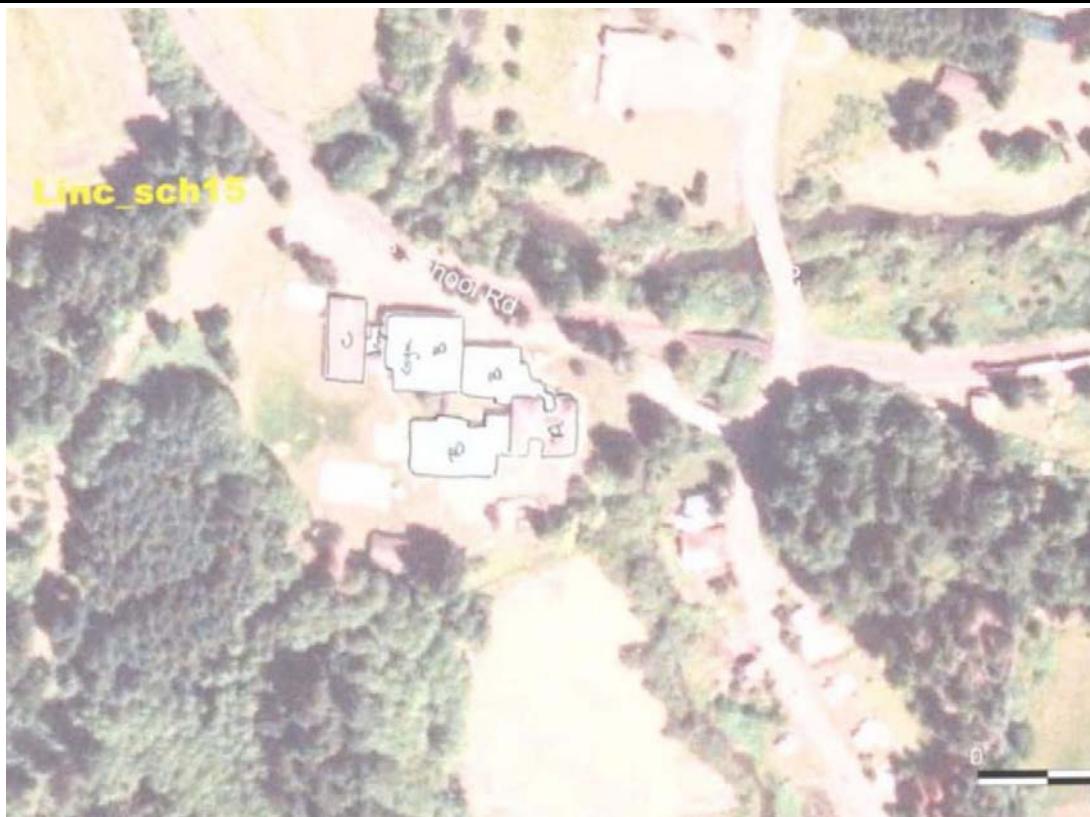
Linc_sch15C

Type	Basic Score	Vert Irreg	Plan Irreg	Pre-Code	Post-Bench	Soil C	Soil D	Soil E	RVS Score
Primary	W2	3.8	0	0	0	2.4	-0.4	0	0	5.8
Secondary		0	0	0	0	0	0	0	0	0
Tertiary		0	0	0	0	0	0	0	0	0

Final Type	Final Score
W2	5.8

Low (<1%)
