# Newport High School - West

Linc\_sch22A

Rapid Visual Screening - Senate Bill #2 - Seismic Needs Assessment  
Oregon Department of Geology and Mineral Industries

Linc\_sch22B

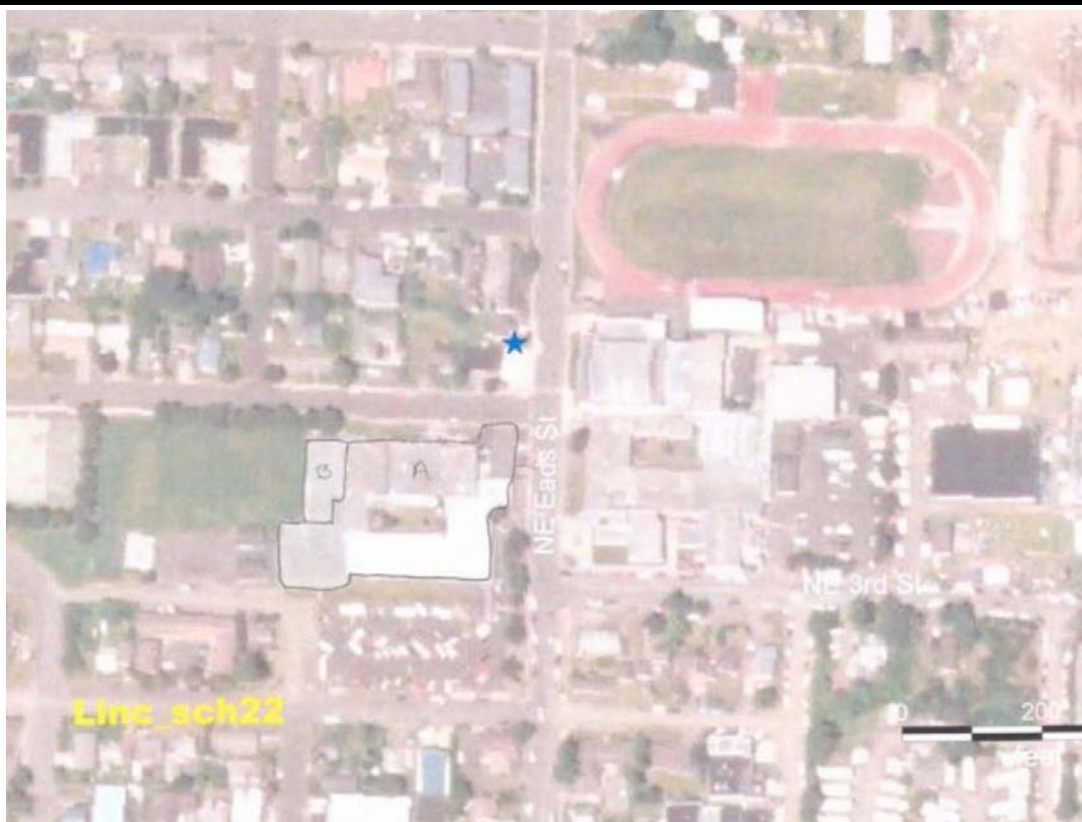
Plan Irregularities	Vertical Irregularities
Reentrant Corners: Other	Steps in Elevation View: Very Irregular Changes
Reentrant Corners: L Shaped	Steps in Elevation View: 2 to 3 Changes (Adjacent Building/Entity)
None	None

Falling Hazards	Poor Conditions
Unreinforced Chimneys	None
None	None
None	None

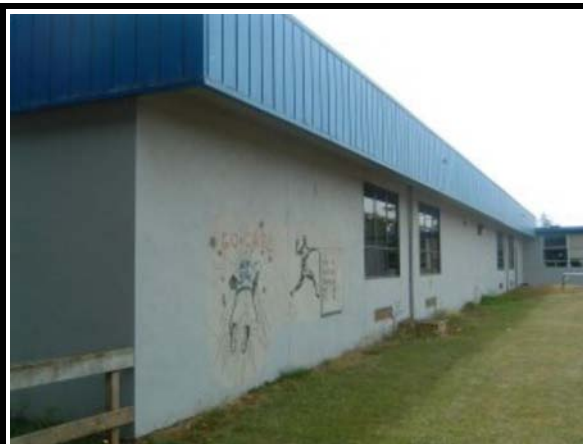
Falling Hazards	Poor Conditions
None	None
None	None
None	None
