Service Center

Linn-Benton CC

Linn_coc07A

Rapid Visual Screening - Senate Bill #2 - Seismic Needs Assessment
Oregon Department of Geology and Mineral Industries

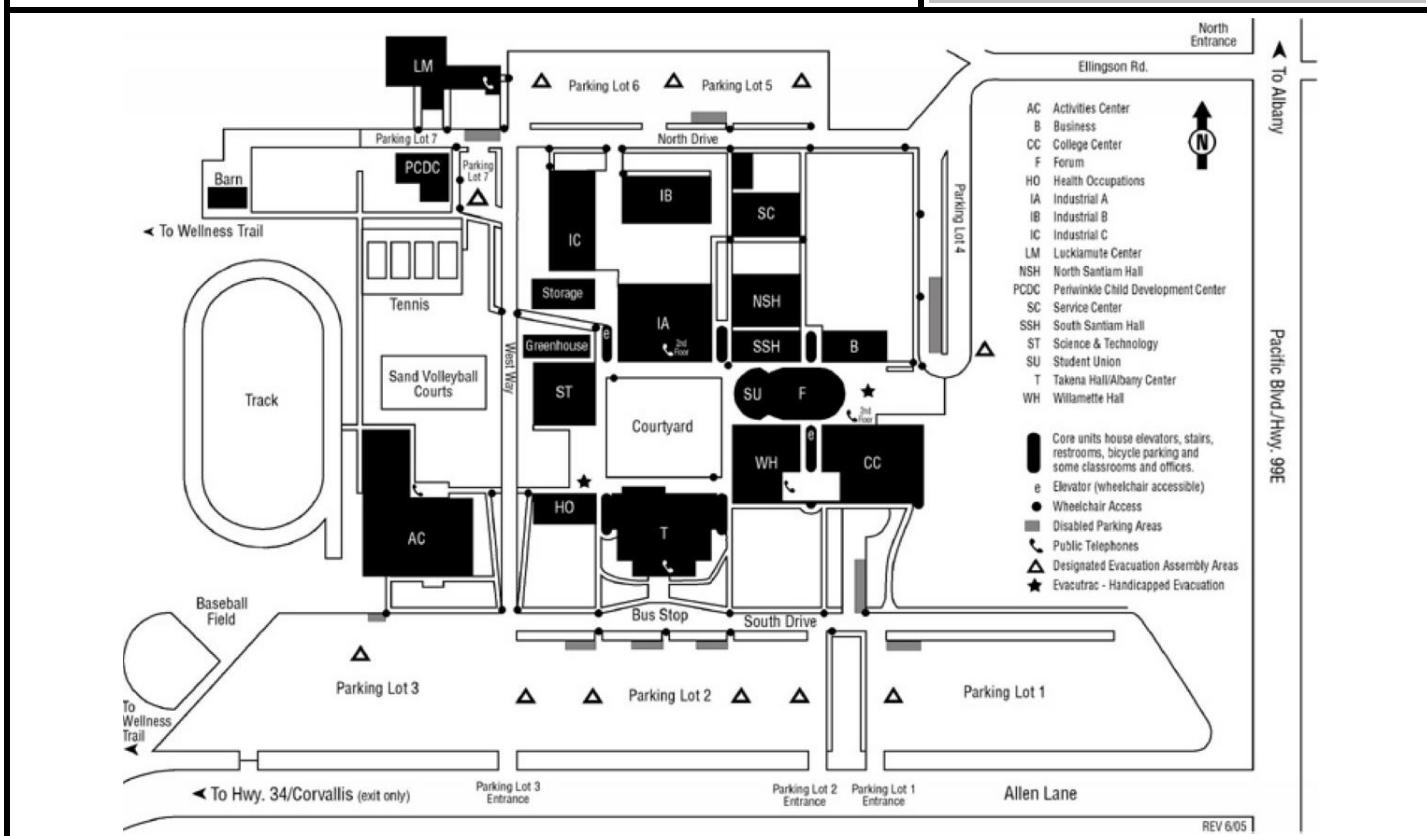
Final Type	Final Score
C1	-0.1

FEMA-154 Collapse Potential

Very High (100%)

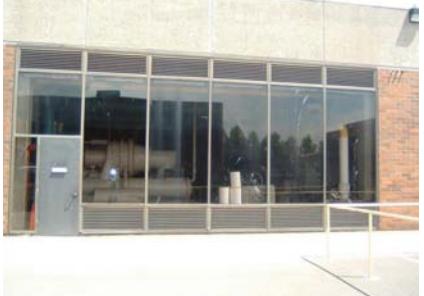
S General Site

Enrollment	Year Built (Field Verified)	Year Built (Alt. Source)	Est. Decade Built
	1973	1973	1970
Total Area (square ft)	Number of Stories	Basement	Pounding Potential
12423	1	No	No
Plan Irregularities		Vertical Irregularities	
None		None	
Falling Hazards		Poor Conditions	
None			
None			
None
