# Tangent RFPD

Linn\_fir08A

## FEMA 154 Rapid Visual Screening Score Card

Rapid Visual Screening - Senate Bill #2 - Seismic Needs Assessment  
Oregon Department of Geology and Mineral Industries

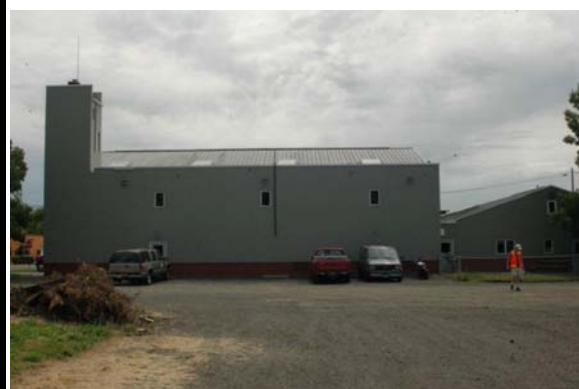
Seismicity Zone: High

| | Type | Basic Score | Vert Irreg | Plan Irreg | Pre-Code | Post-Bench | Soil C | Soil D | Soil E | RVS Score |
|---|---|---|---|---|---|---|---|---|---|---|
| Primary | W2 | 3.8 | -2 | 0 | 0 | 2.4 | 0 | -0.8 | 0 | 3.4 |

3.4

Low (<1%)
