# Scio RFPD

## FEMA 154 Rapid Visual Screening Score Card

Rapid Visual Screening - Senate Bill #2 - Seismic Needs Assessment  
Oregon Department of Geology and Mineral Industries

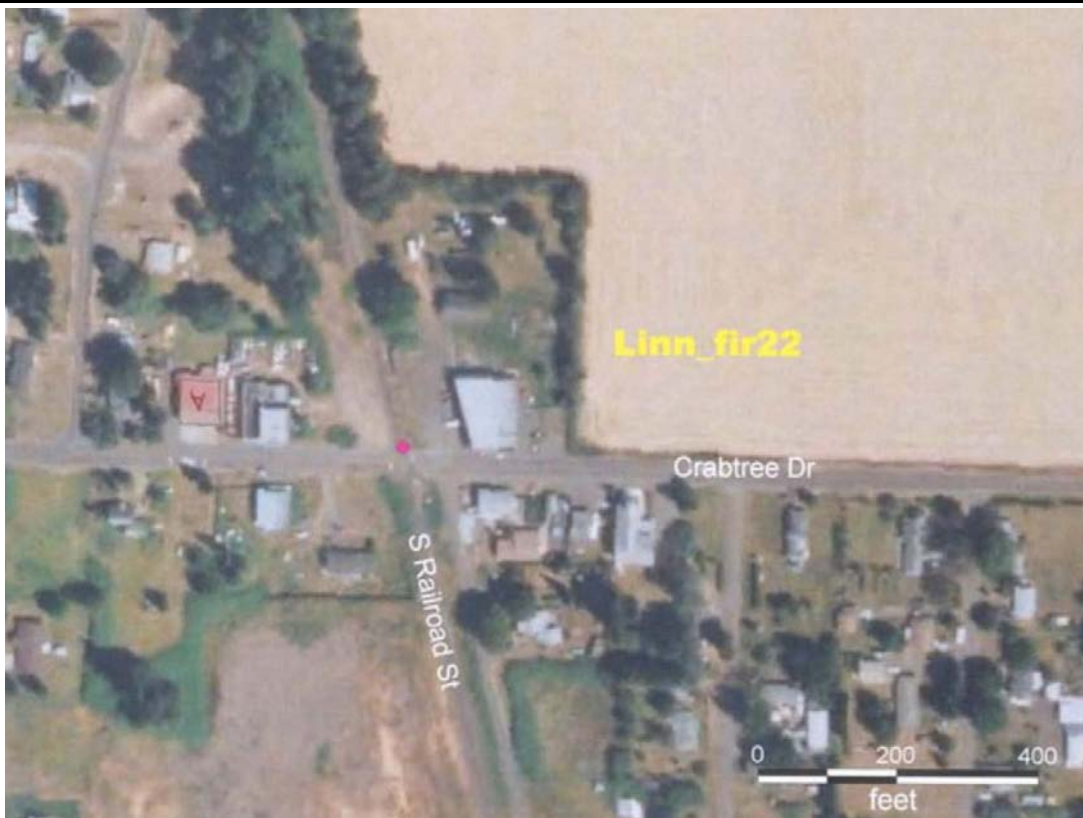
Type	Basic Score	Vert Irreg	Plan Irreg	Pre-Code	Post-Bench	Soil C	Soil D	Soil E	RVS Score
Primary	RM1	3.6	0	-0.5	0	0	0	-1.2	0	1.9
Secondary		0	0	0	0	0	0	0	0	0
Tertiary		0	0	0	0	0	0	0	0	0

Moderate (>1%)
