| 354 Smith St. | | |

FEMA 154 Rapid Visual Screening Score Card

Linn County Sheriff's Office

Rapid Visual Screening - Senate Bill #2 - Seismic Needs Assessment
Oregon Department of Geology and Mineral Industries

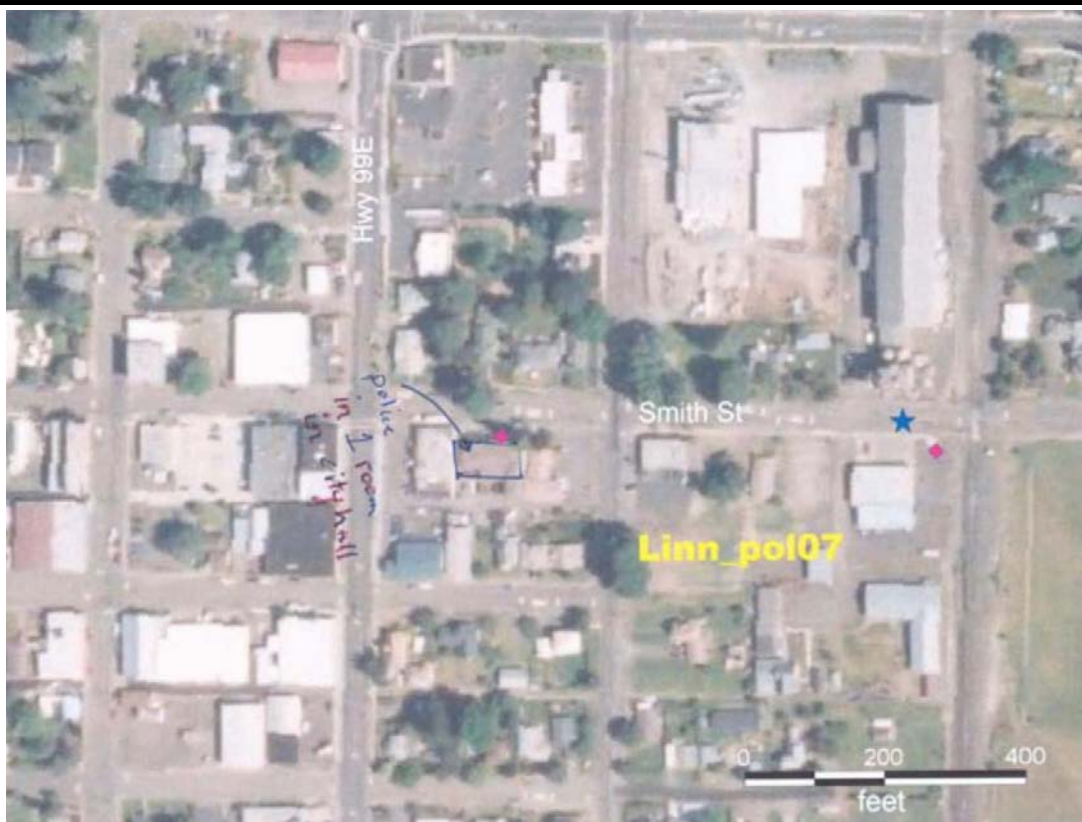
| | Type | Basic Score | Vert Irreg | Plan Irreg | Pre-Code | Post-Bench | Soil C | Soil D | Soil E | RVS Score |
|---|---|---|---|---|---|---|---|---|---|---|
| Primary | C2 | 2.8 | 0 | -0.5 | -1 | 0 | 0 | -0.6 | 0 | 0.7 |

FEMA-154 Collapse Potential

High (>10%)
