Albany Police Department

Linn_pol10A

FEMA 154 Rapid Visual Screening Score Card

Rapid Visual Screening - Senate Bill #2 - Seismic Needs Assessment
Oregon Department of Geology and Mineral Industries

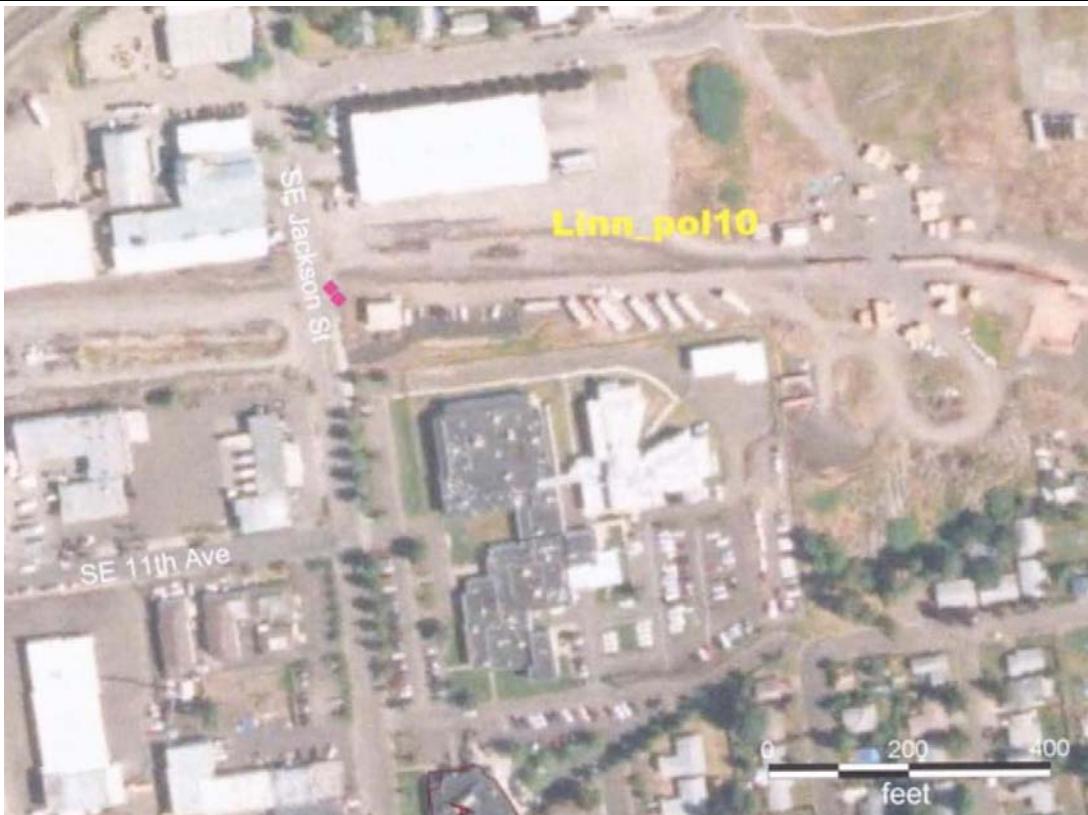
Type	Basic Score	Vert Irreg	Plan Irreg	Pre-Code	Post-Bench	Soil C	Soil D	Soil E	RVS Score
Primary	RM1	2.8	0	-0.5	0	0	0	-0.6	0	1.7
Secondary		0	0	0	0	0	0	0	0	0
Tertiary		0	0	0	0	0	0	0	0	0

Final Type	Final Score
RM1	1.7

Moderate (>1%)
