# Harrisburg High School

Linn\_sch29A

## FEMA 154 Rapid Visual Screening Score Card

Rapid Visual Screening - Senate Bill #2 - Seismic Needs Assessment  
Oregon Department of Geology and Mineral Industries

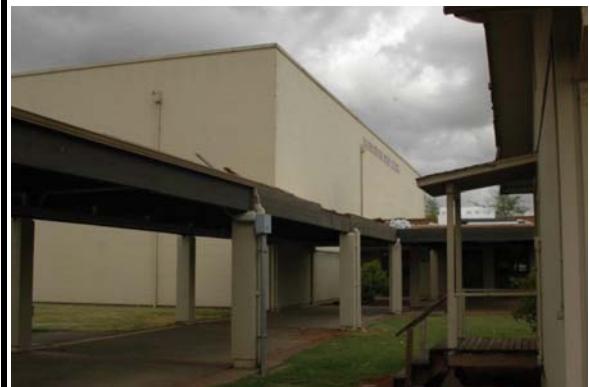
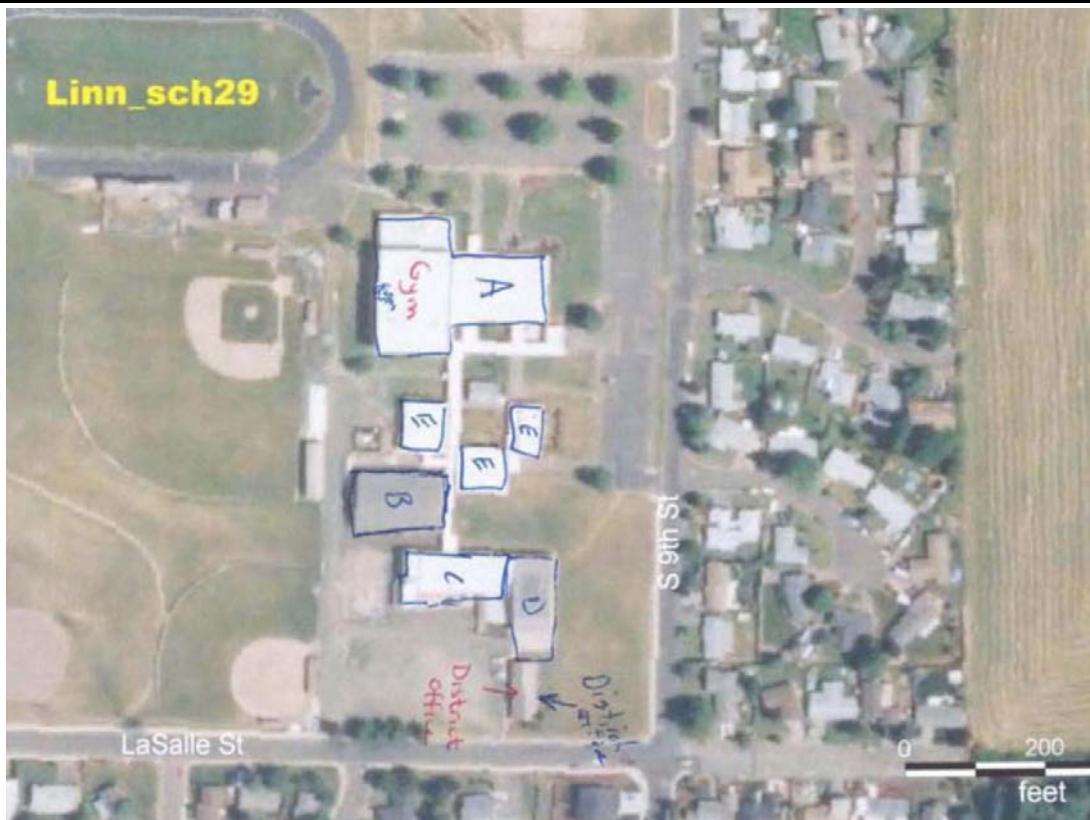
Final Type	Final Score
RM1	0.7

High (>10%)

Enrollment 275	Year Built (Field Verified) 1973	Year Built (Alt. Source) 1973	Est. Decade Built 1970
Total Area (square ft) 69826	Number of Stories 1	Basement	Pounding Potential No
Plan Irregularities Reentrant Corners: T shaped None None		Vertical Irregularities Steps in Elevation View: Single Change None None	
Falling Hazards Parapets: General None None		Poor Conditions None None None

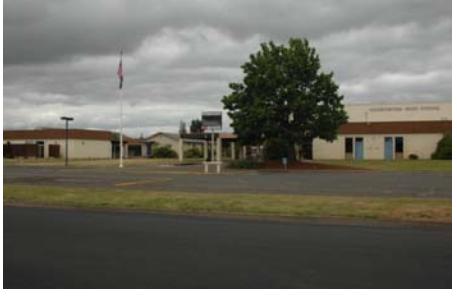
W Vertical Irregularity Primary shorter section on left	NE Plan Irregularity Primary	E General Site

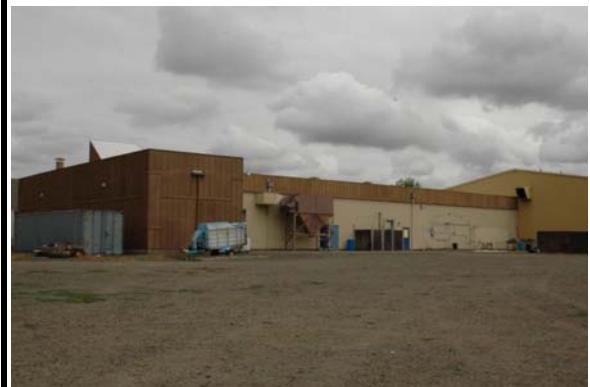
Linn\_sch29C

Final Type	Final Score
W2	0.5

High (>10%)

Enrollment 275	Year Built (Field Verified) 1973	Year Built (Alt. Source) 1970	Est. Decade Built 1970
Total Area (square ft) 69826	Number of Stories 1	Basement	Pounding Potential No
Plan Irregularities Reentrant Corners:T shaped (Adjacent Build/Entity) None None		Vertical Irregularities Steps in Elevation View: Single Change (Adjacent Building/Entity) None None	
Falling Hazards None None None		Poor Conditions None None None
