Harrisburg Middle School

Harrisburg SD 7J

FEMA 154 Rapid Visual Screening Score Card

Rapid Visual Screening - Senate Bill #2 - Seismic Needs Assessment
Oregon Department of Geology and Mineral Industries

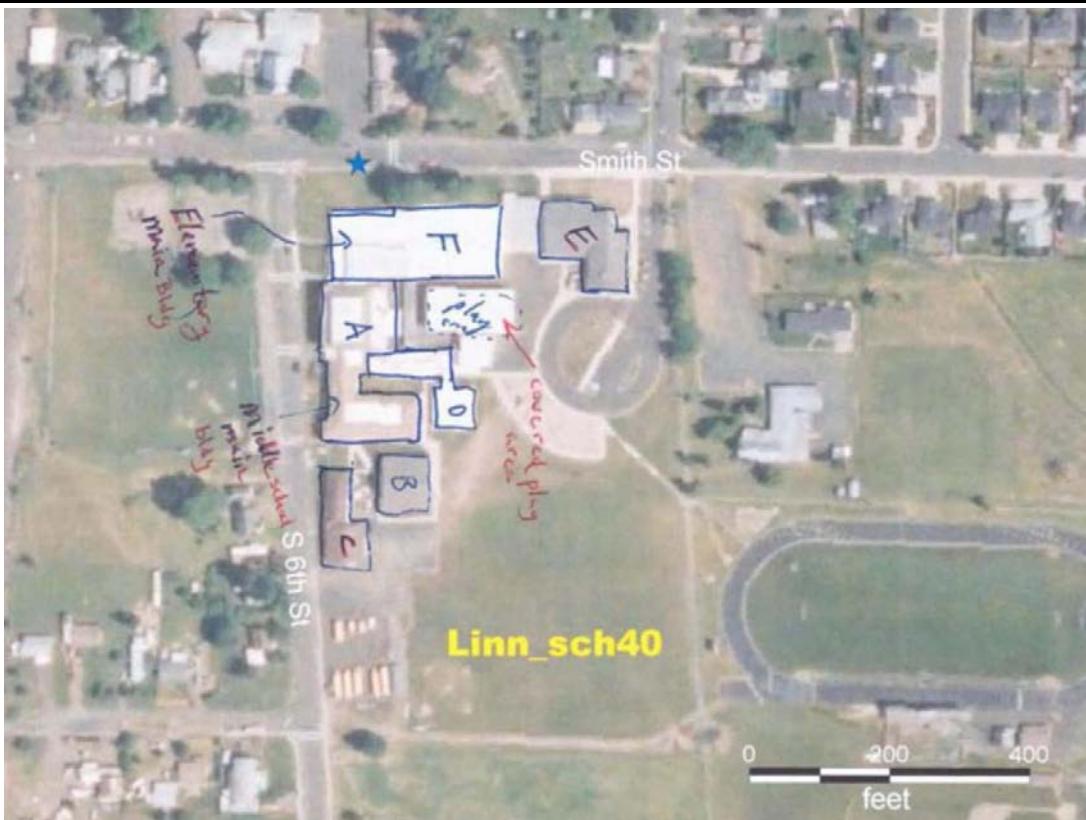
Linn_sch40A

Type	Basic Score	Vert Irreg	Plan Irreg	Pre-Code	Post-Bench	Soil C	Soil D	Soil E	RVS Score
Primary	C2	2.8	-1	-0.5	-1	0	0	-0.6	0	-0.3
Secondary		0	0	0	0	0	0	0	0	0
Tertiary		0	0	0	0	0	0	0	0	0

Final Type	Final Score
C2	-0.3

Very High (100%)

Enrollment 189	Year Built (Field Verified) 1936	Year Built (Alt. Source) 1936	Est. Decade Built 1930
Total Area (square ft) 25493	Number of Stories 1	Basement	Pounding Potential No
Plan Irregularities		Vertical Irregularities	
Reentrant Corners: Other None		Steps in Elevation View: Single Change Steps in Elevation View: 2 to 3 Changes (Adjacent Building/Entity) None	
Falling Hazards None None None		Poor Conditions Cracks None None

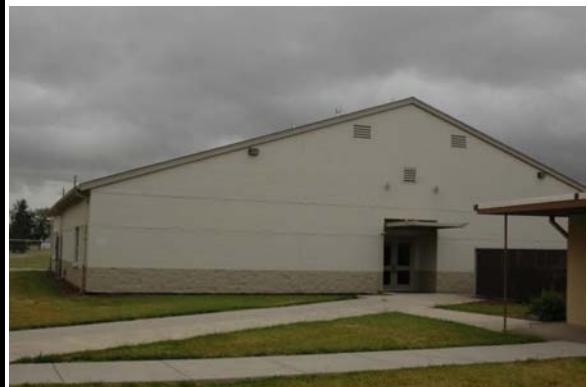
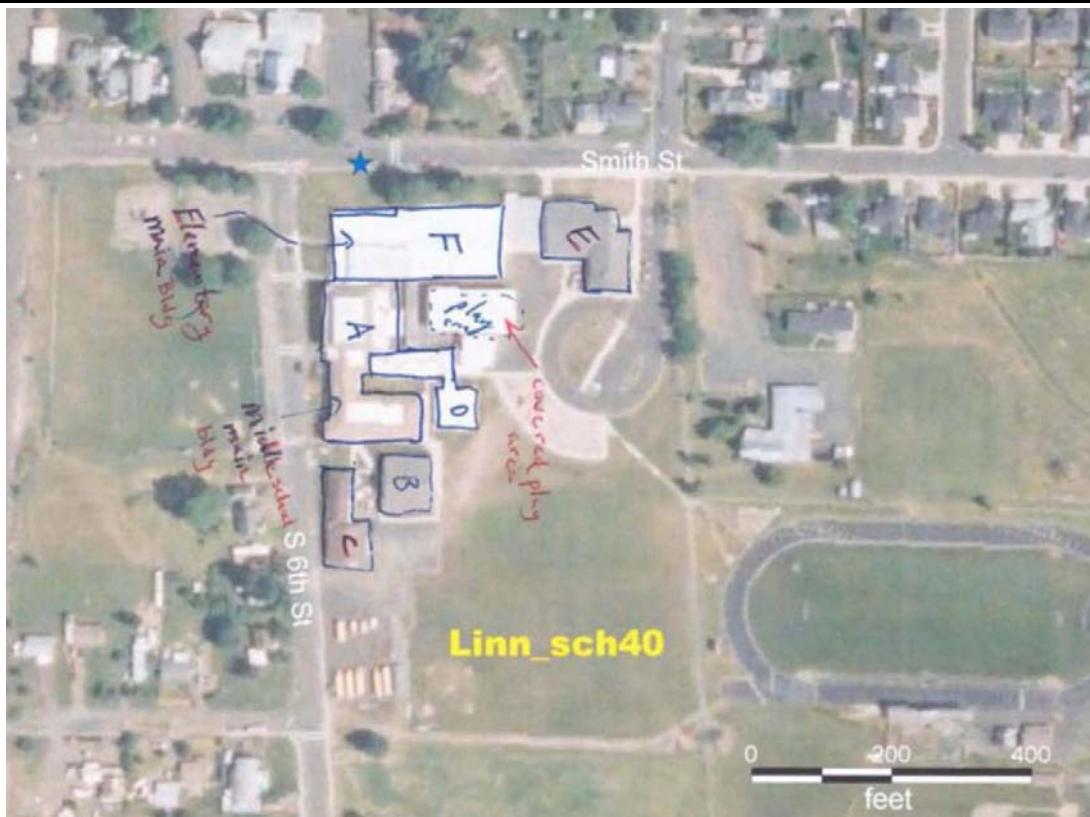
Linn_sch40B

Type	Basic Score	Vert Irreg	Plan Irreg	Pre-Code	Post-Bench	Soil C	Soil D	Soil E	RVS Score
Primary	RM1	2.8	0	0	0	0	0	-0.6	0	2.2
Secondary		0	0	0	0	0	0	0	0	0
Tertiary		0	0	0	0	0	0	0	0	0

Final Type	Final Score
RM1	2.2

Low (<1%)

Enrollment 189	Year Built (Field Verified) 1993	Year Built (Alt. Source) 1936	Est. Decade Built 1990
Total Area (square ft)	Number of Stories 1	Basement	Pounding Potential No
Plan Irregularities None None None		Vertical Irregularities None None None	
Falling Hazards None None None		Poor Conditions None None None

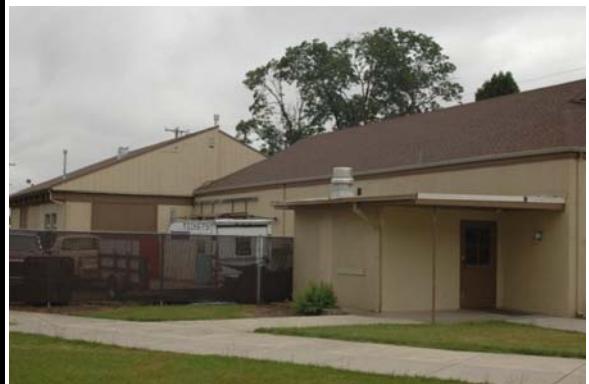
Linn_sch40C

Type	Basic Score	Vert Irreg	Plan Irreg	Pre-Code	Post-Bench	Soil C	Soil D	Soil E	RVS Score
Primary	RM1	2.8	0	-0.5	0	0	0	-0.6	0	1.7
Secondary	C2	2.8	0	-0.5	0	0	0	-0.6	0	1.7
Tertiary		0	0	0	0	0	0	0	0	0

Final Type	Final Score
RM1	1.7

Moderate (>1%)

Enrollment 189	Year Built (Field Verified) 1936	Year Built (Alt. Source) 1936	Est. Decade Built 1950
Total Area (square ft)	Number of Stories 1	Basement	Pounding Potential No
Plan Irregularities		Vertical Irregularities	
Out of Plane Lateral-Force-Resistance Elements		None	
Reentrant Corners: L Shaped		None	
None		None	
Falling Hazards		Poor Conditions	
None		None	
None		None	
None		None

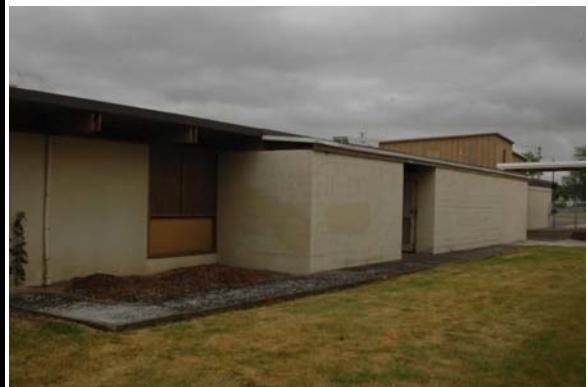
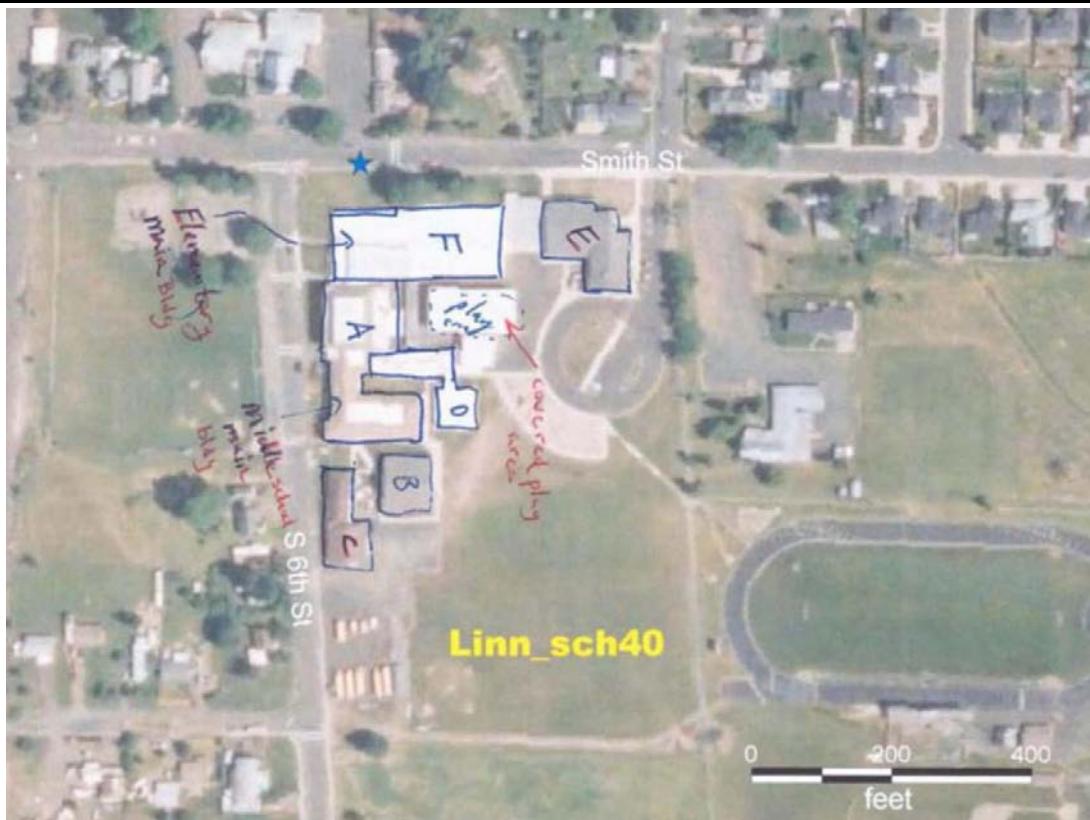
Linn_sch40D

Type	Basic Score	Vert Irreg	Plan Irreg	Pre-Code	Post-Bench	Soil C	Soil D	Soil E	RVS Score
Primary	RM1	2.8	-1	-0.5	0	0	0	-0.6	0	0.7
Secondary		0	0	0	0	0	0	0	0	0
Tertiary		0	0	0	0	0	0	0	0	0

Final Type	Final Score
RM1	0.7

High (>10%)

Enrollment 189	Year Built (Field Verified) 1936	Year Built (Alt. Source) 1970	Est. Decade Built 1970
Total Area (square ft)	Number of Stories 1	Basement	Pounding Potential No
Plan Irregularities Reentrant Corners: L Shaped None None		Vertical Irregularities Steps in Elevation View: Single Change None None	
Falling Hazards None None None		Poor Conditions None None None

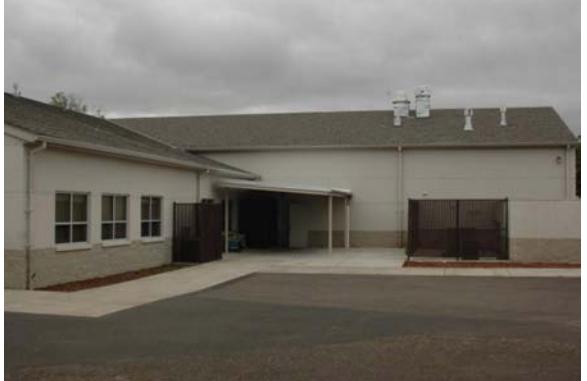
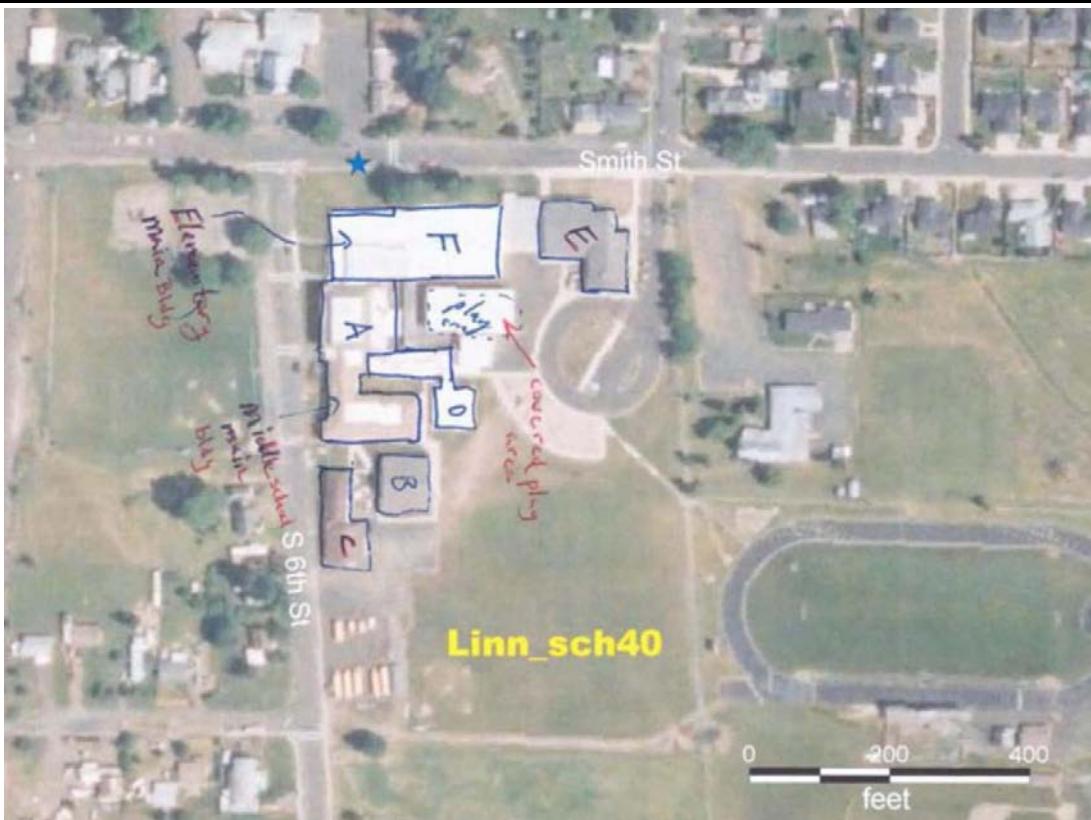
Linn_sch40E

Type	Basic Score	Vert Irreg	Plan Irreg	Pre-Code	Post-Bench	Soil C	Soil D	Soil E	RVS Score
Primary	RM1	2.8	0	-0.5	0	0	0	-0.6	0	1.7
Secondary		0	0	0	0	0	0	0	0	0
Tertiary		0	0	0	0	0	0	0	0	0

Final Type	Final Score
RM1	1.7

Moderate (>1%)

Enrollment 189	Year Built (Field Verified) 1993	Year Built (Alt. Source) 1936	Est. Decade Built 1990
Total Area (square ft)	Number of Stories 1	Basement	Pounding Potential No
Plan Irregularities Reentrant Corners: Other None None		Vertical Irregularities None None None	
Falling Hazards None None None		Poor Conditions None None None

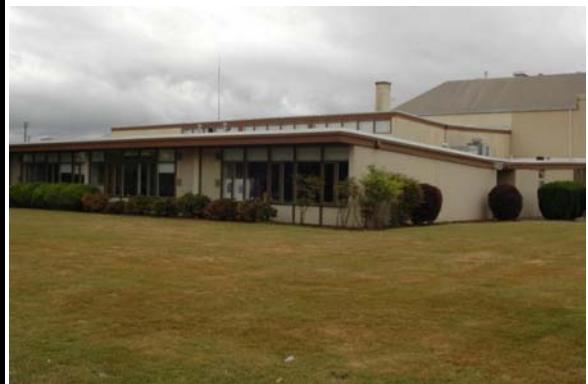
Linn_sch40F

Enrollment 189	Year Built (Field Verified) 1959	Year Built (Alt. Source) 1936	Est. Decade Built 1950
Total Area (square ft)	Number of Stories 1	Basement	Pounding Potential No
Plan Irregularities None None None		Vertical Irregularities Steps in Elevation View: Single Change Steps in Elevation View: 2 to 3 Changes (Adjacent Building/Entity) None	
Falling Hazards None None None		Poor Conditions None None None
