# Scio Middle School

| RVS in 2006 | | 6/30/2006 | |

## FEMA 154 Rapid Visual Screening Score Card

Rapid Visual Screening - Senate Bill #2 - Seismic Needs Assessment  
Oregon Department of Geology and Mineral Industries

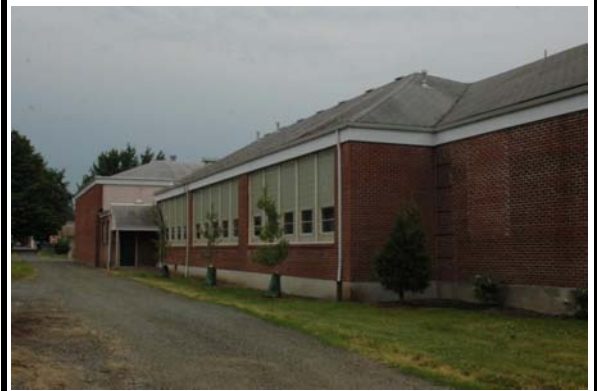
E    Falling Hazard  
Also shows inside of 'U'
