May Roberts Elementary School

Malh_sch02A

FEMA 154 Rapid Visual Screening Score Card

Rapid Visual Screening - Senate Bill #2 - Seismic Needs Assessment
Oregon Department of Geology and Mineral Industries

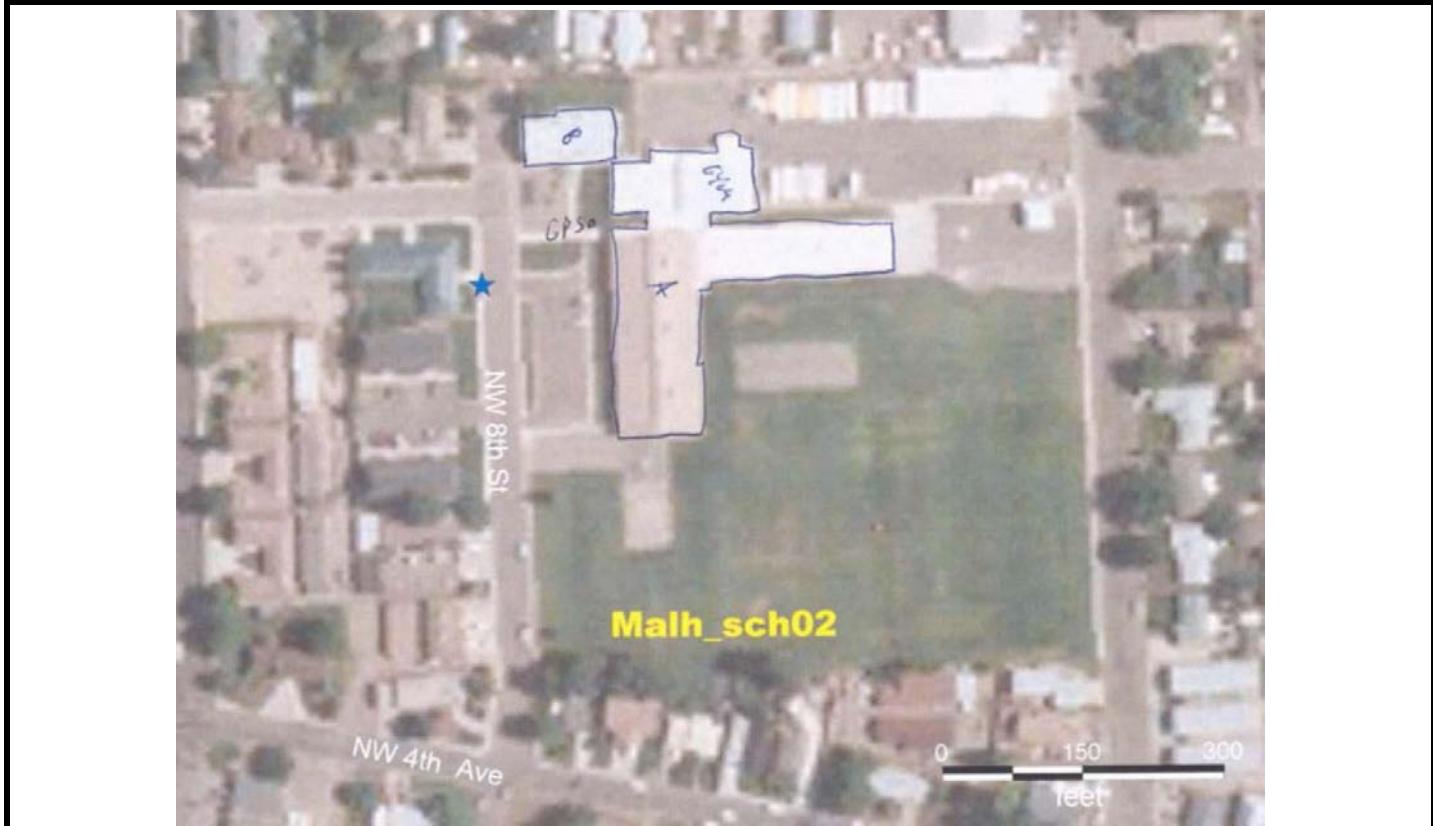
Type	Basic Score	Vert Irreg	Plan Irreg	Pre-Code	Post-Bench	Soil C	Soil D	Soil E	RVS Score
Primary	RM1	3.6	-2	-0.5	0	0	0	-1.2	0	-0.1
Secondary	W2	4.8	-3	-0.5	0	0	0	-1.2	0	0.1
Tertiary		0	0	0	0	0	0	0	0	0

Final Type	Final Score
RM1	-0.1

Very High (100%)

Enrollment 365	Year Built (Field Verified) 1970	Year Built (Alt. Source) 1970	Est. Decade Built 1960
Total Area (square ft) 33653	Number of Stories 1	Basement	Pounding Potential No
Plan Irregularities Reentrant Corners: L Shaped None None		Vertical Irregularities Steps in Elevation View: Single Change None None	
Falling Hazards None None None		Poor Conditions None None None

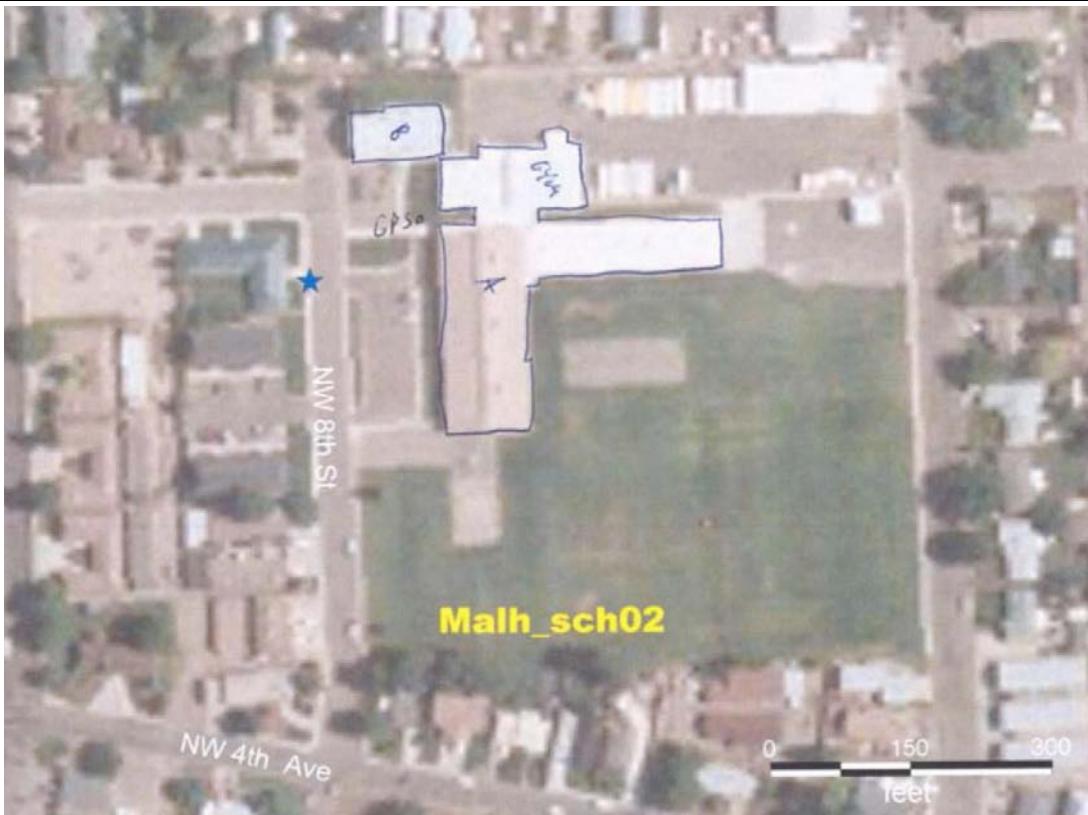
Malh_sch02B

Type	Basic Score	Vert Irreg	Plan Irreg	Pre-Code	Post-Bench	Soil C	Soil D	Soil E	RVS Score
Primary	W1	5.2	0	0	0	0	0	-0.6	0	4.6
Secondary	S1	3.6	0	0	0	0	0	-1	0	2.6
Tertiary		0	0	0	0	0	0	0	0	0

Final Type	Final Score
S1	2.6

Low (<1%)

Enrollment 365	Year Built (Field Verified) 1970	Year Built (Alt. Source) 1970	Est. Decade Built 1950
Total Area (square ft) 33653	Number of Stories 1	Basement	Pounding Potential No
Plan Irregularities None None None		Vertical Irregularities None None None	
Falling Hazards None None None		Poor Conditions None None None
