Ontario High School

Malh_sch05A

FEMA 154 Rapid Visual Screening Score Card

Rapid Visual Screening - Senate Bill #2 - Seismic Needs Assessment
Oregon Department of Geology and Mineral Industries

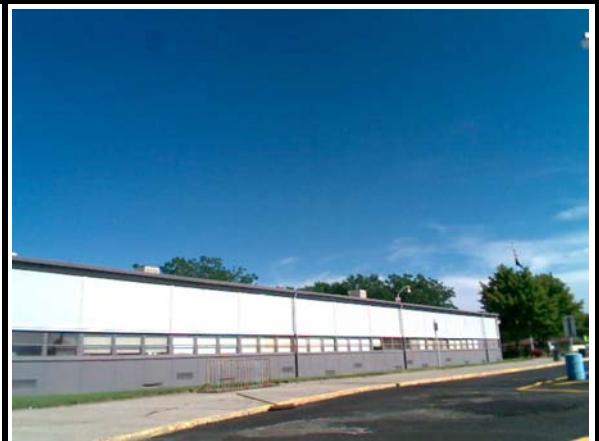
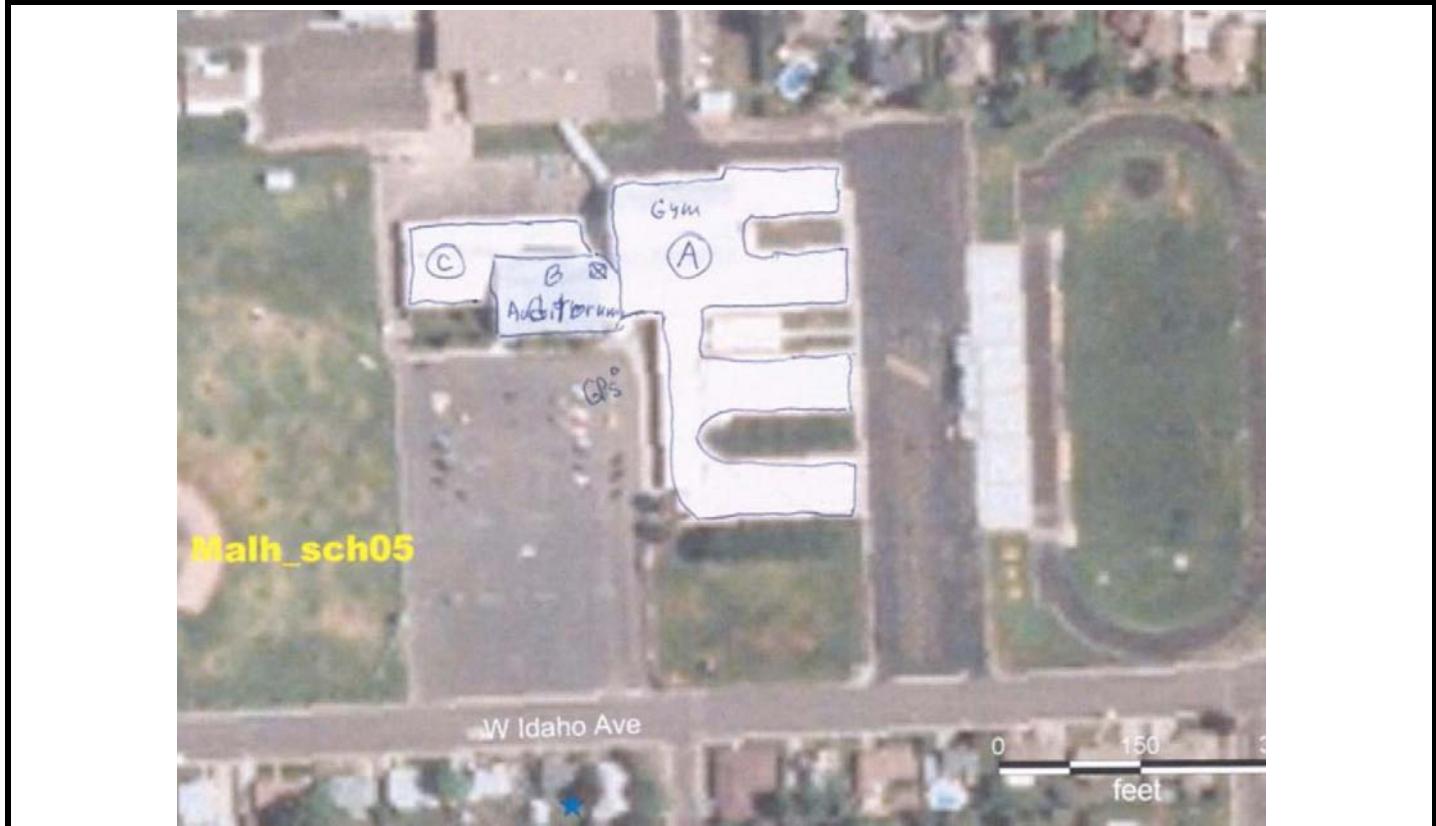
Type	Basic Score	Vert Irreg	Plan Irreg	Pre-Code	Post-Bench	Soil C	Soil D	Soil E	RVS Score
Primary	C2	3.6	-2	-0.5	0	0	0	-1.2	0	-0.1
Secondary		0	0	0	0	0	0	0	0	0
Tertiary		0	0	0	0	0	0	0	0	0

-0.1

Very High (100%)

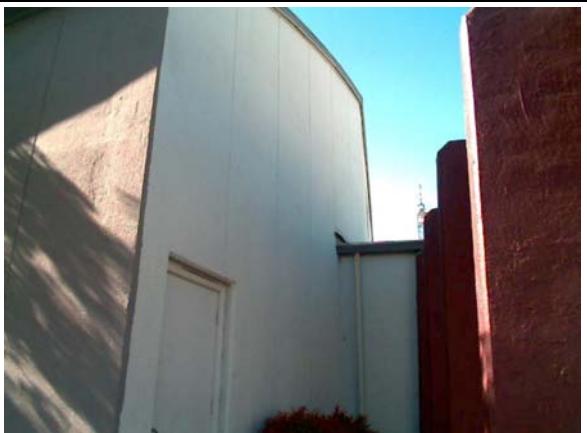
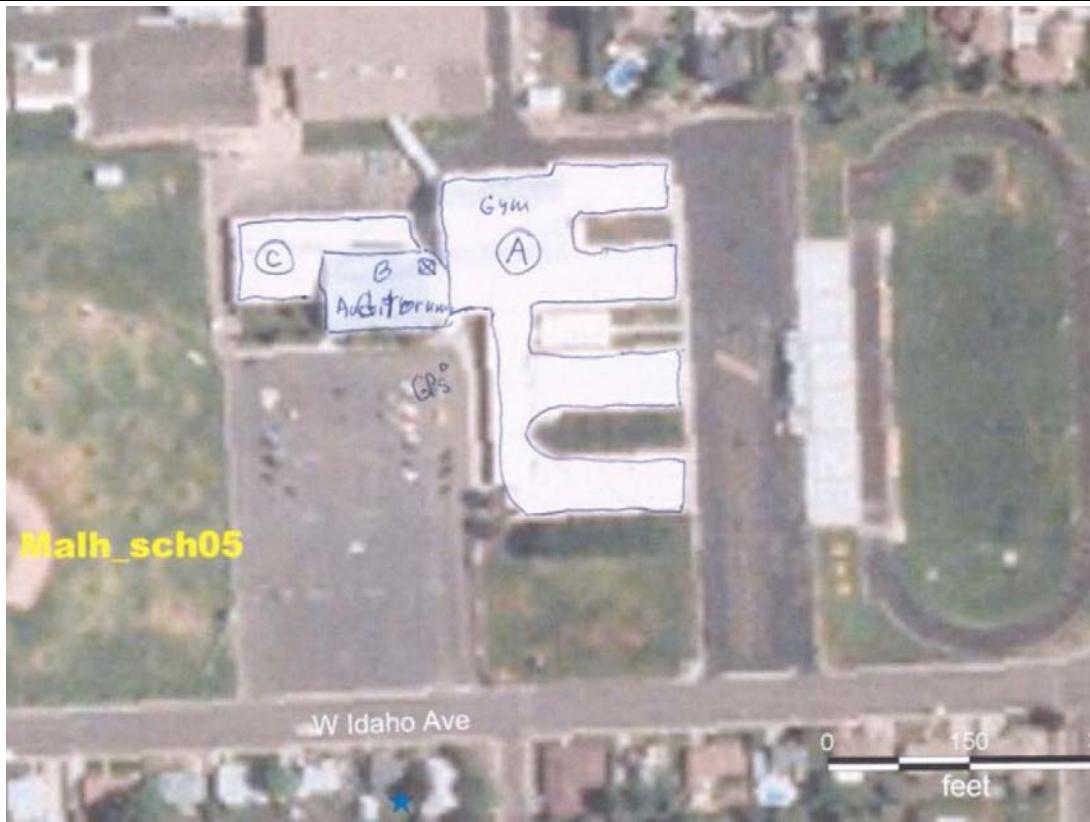
Malh_sch05B

Type	Basic Score	Vert Irreg	Plan Irreg	Pre-Code	Post-Bench	Soil C	Soil D	Soil E	RVS Score
Primary	C2	3.6	-2	-0.5	0	0	0	-1.2	0	-0.1
Secondary		0	0	0	0	0	0	0	0	0
Tertiary		0	0	0	0	0	0	0	0	0

Final Type	Final Score
C2	-0.1

Very High (100%)

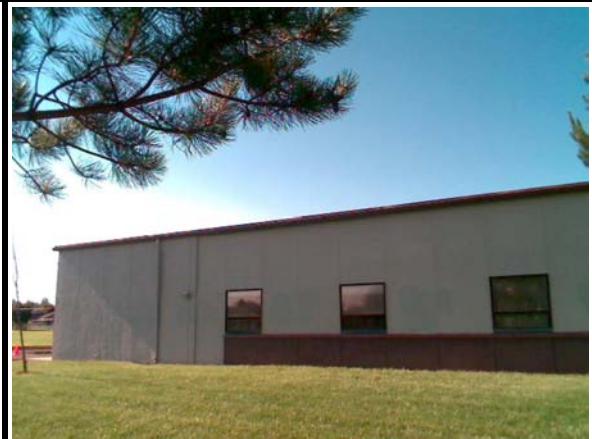
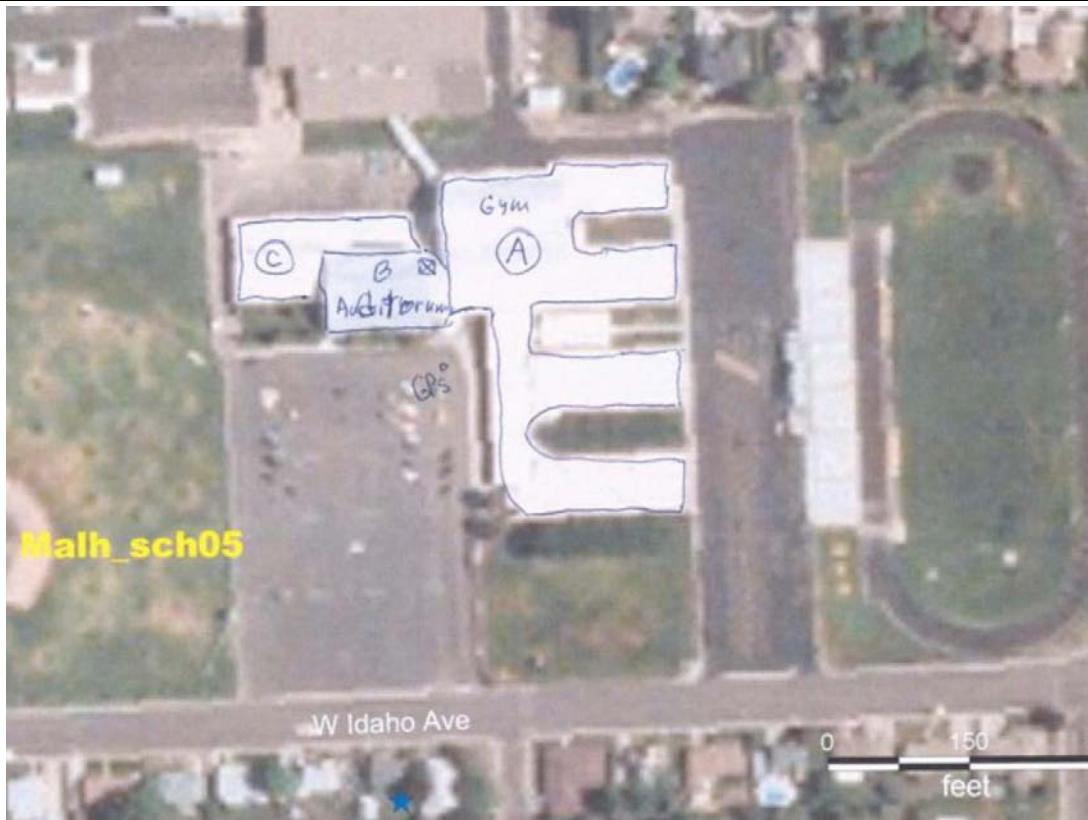
Malh_sch05C

Type	Basic Score	Vert Irreg	Plan Irreg	Pre-Code	Post-Bench	Soil C	Soil D	Soil E	RVS Score
Primary	C2	3.6	-2	-0.5	0	0	0	-1.2	0	-0.1
Secondary		0	0	0	0	0	0	0	0	0
Tertiary		0	0	0	0	0	0	0	0	0

Final Type	Final Score
C2	-0.1

Very High (100%)

Enrollment 784	Year Built (Field Verified) 1980	Year Built (Alt. Source) 1980	Est. Decade Built 1970
Total Area (square ft) 87681	Number of Stories 1	Basement	Pounding Potential No
Plan Irregularities Reentrant Corners:L shaped (Adjacent Build/Entity) None None		Vertical Irregularities Steps in Elevation View: Single Change (Adjacent Building/Entity) None None	
Falling Hazards Other: Smokestack None None		Poor Conditions None None None
