Vale Elementary School

Vale SD 84

FEMA 154 Rapid Visual Screening Score Card

Rapid Visual Screening - Senate Bill #2 - Seismic Needs Assessment
Oregon Department of Geology and Mineral Industries

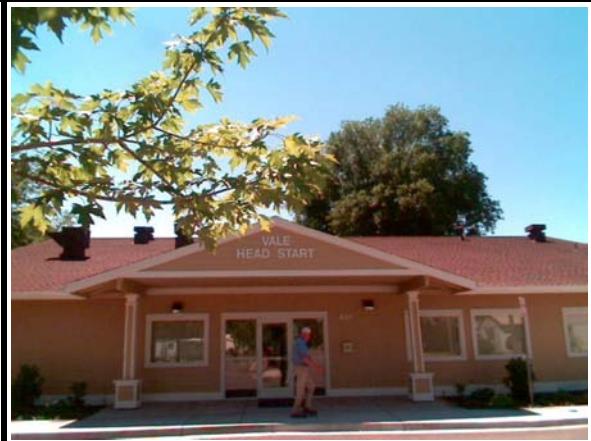
Malh_sch06A

| | Type | Basic Score | Vert Irreg | Plan Irreg | Pre-Code | Post-Bench | Soil C | Soil D | Soil E | RVS Score |
|---|---|---|---|---|---|---|---|---|---|---|
| Primary | W2 | 4.8 | 0 | 0 | 0 | 1.6 | 0 | -1.2 | 0 | 5.2 |

| Final Type | Final Score |
|---|---|
| W2 | 5.2 |

Low (<1%)

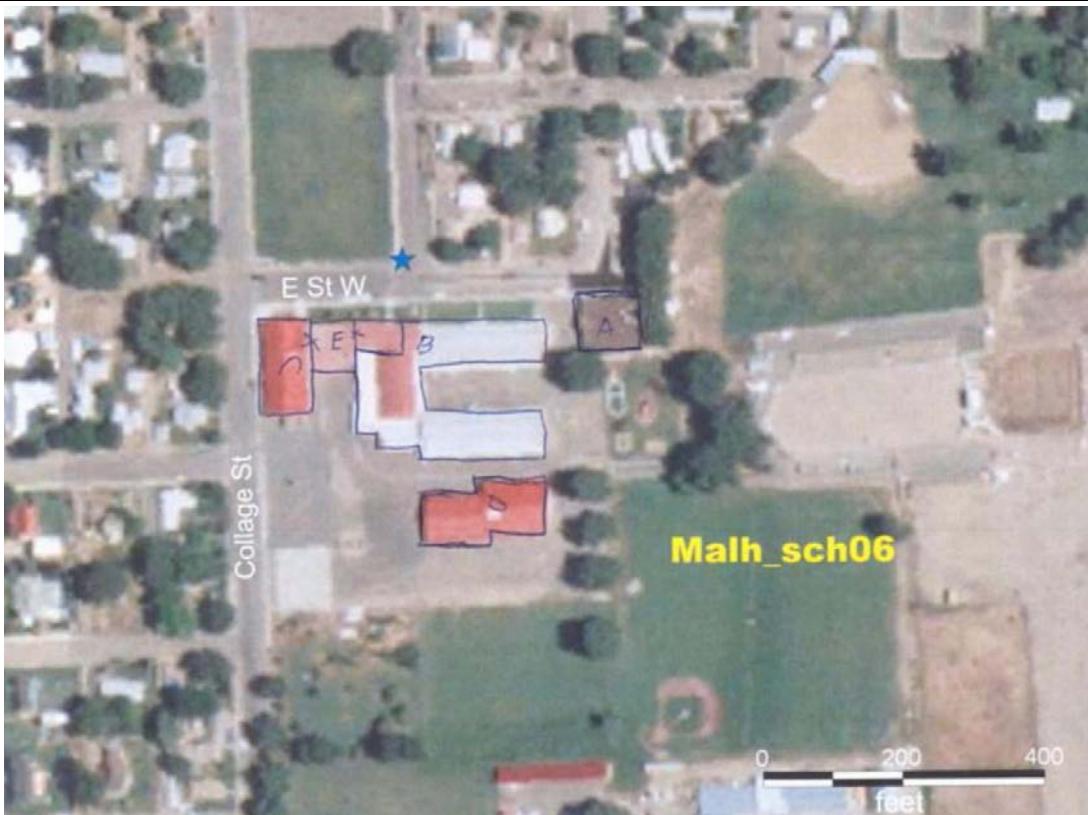
Malh_sch06A

| Plan Irregularities None None None | | Vertical Irregularities None None None | |
| Falling Hazards None None None | | Poor Conditions None None None | |

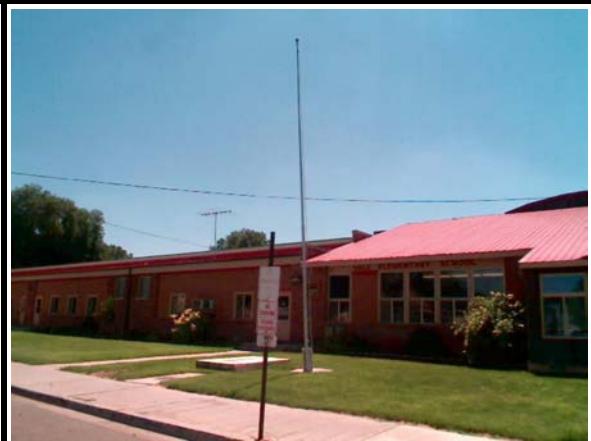
Malh_sch06B

| | Type | Basic Score | Vert Irreg | Plan Irreg | Pre-Code | Post-Bench | Soil C | Soil D | Soil E | RVS Score |
|---|---|---|---|---|---|---|---|---|---|---|
| Primary | W2 | 4.8 | -3 | -0.5 | 0 | 0 | 0 | -1.2 | 0 | 0.1 |
| Secondary | C2 | 3.6 | -2 | -0.5 | 0 | 0 | 0 | -1.2 | 0 | -0.1 |
| Tertiary | URM | 3.4 | -1.5 | -0.5 | 0 | 0 | 0 | -0.8 | 0 | 0.6 |

| Final Type | Final Score |
|---|---|
| C2 | -0.1 |

Very High (100%)

| Plan Irregularities Reentrant Corners: U shaped Reentrant Corners: L Shaped (Adjacent Build/Entity) None | | Vertical Irregularities Steps in Elevation View: Single Change None None | |
| Falling Hazards Other: Smokestack Other: General Other: Brick Veneer | | Poor Conditions None None None | |

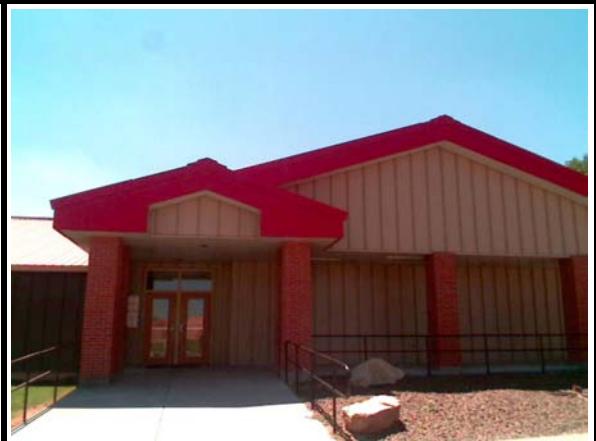
Malh_sch06C

| | Type | Basic Score | Vert Irreg | Plan Irreg | Pre-Code | Post-Bench | Soil C | Soil D | Soil E | RVS Score |
|---|---|---|---|---|---|---|---|---|---|---|
| Primary | RM1 | 3.6 | 0 | -0.5 | 0 | 2 | 0 | -1.2 | 0 | 3.9 |
| Secondary | W2 | 4.8 | 0 | -0.5 | 0 | 1.6 | 0 | -1.2 | 0 | 4.7 |

| Final Type | Final Score |
|---|---|
| RM1 | 3.9 |

Low (<1%)

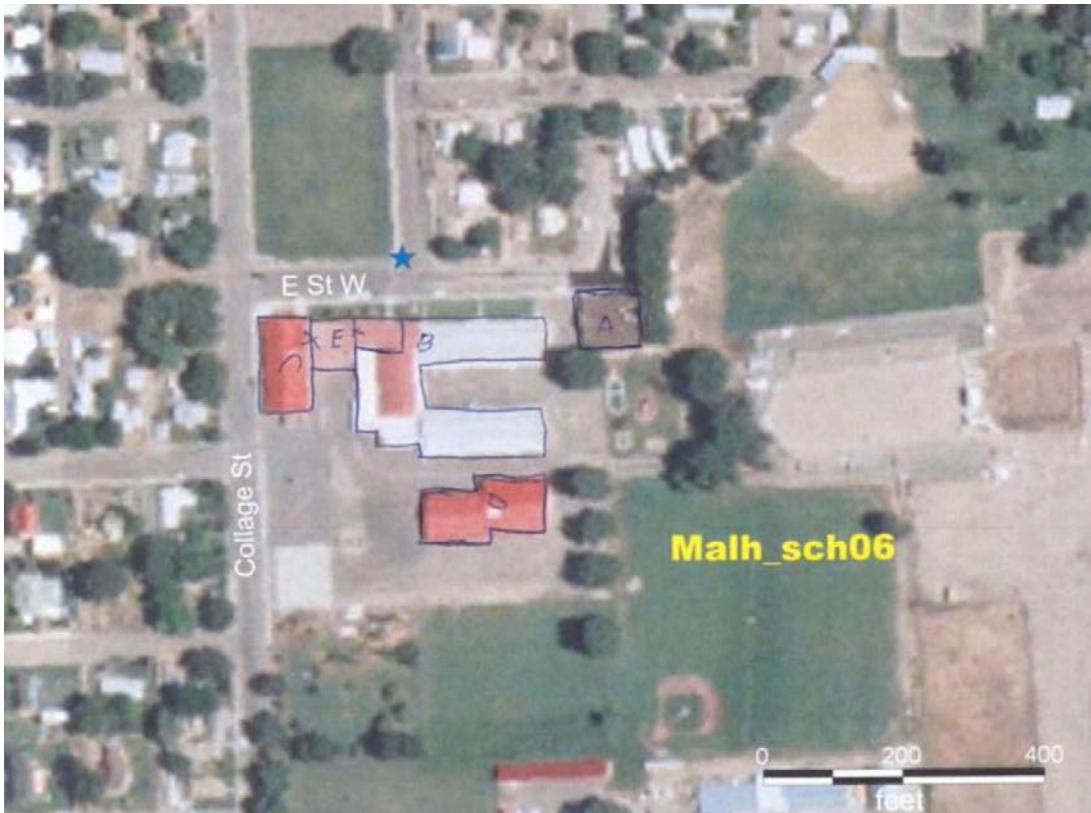
Malh_sch06C

| Plan Irregularities Reentrant Corners:L shaped (Adjacent Build/Entity) None None | | Vertical Irregularities None None None | |
| Falling Hazards Other: Brick Veneer None None | | Poor Conditions None None None | |

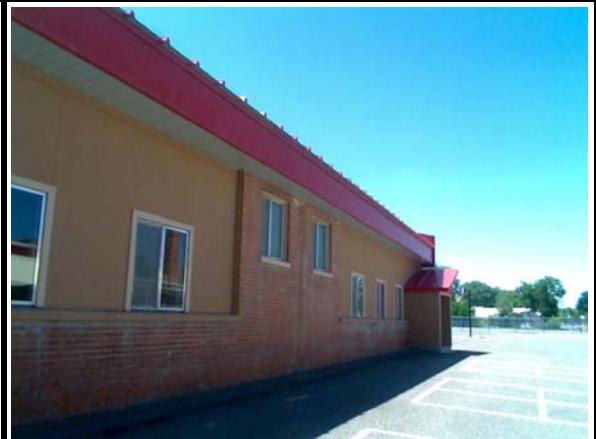
Malh_sch06D

| | Type | Basic Score | Vert Irreg | Plan Irreg | Pre-Code | Post-Bench | Soil C | Soil D | Soil E | RVS Score |
|---|---|---|---|---|---|---|---|---|---|---|
| Primary | C2 | 3.6 | 0 | -0.5 | 0 | 0 | 0 | -1.2 | 0 | 1.9 |
| Secondary | W2 | 4.8 | 0 | -0.5 | 0 | 0 | 0 | -1.2 | 0 | 3.1 |
