Nyssa High School

Malh_sch09A

Building Type School	County Malheur	
Street 824 Adrian Blvd		
City Nyssa	State OR	Zip 97913
Latitude 43.87456	Longitude 117.00564	
Tracking Code RVS in 2006	Inspection Date 6/30/2006

Rapid Visual Screening - Senate Bill #2 - Seismic Needs Assessment
Oregon Department of Geology and Mineral Industries

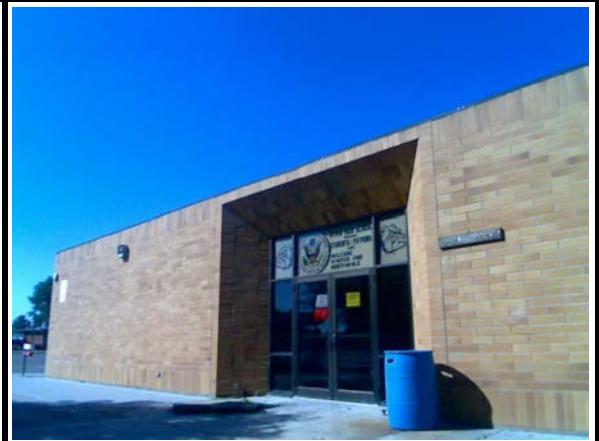
Type	Basic Score	Vert Irreg	Plan Irreg	Pre-Code	Post-Bench	Soil C	Soil D	Soil E	RVS Score
Primary	RM1	3.6	0	-0.5	0	0	0	-1.2	0	1.9
Secondary	C2	3.6	0	-0.5	0	0	0	-1.2	0	1.9
Tertiary		0	0	0	0	0	0	0	0	0

Final Type	Final Score
RM1	1.9

Moderate (>1%)

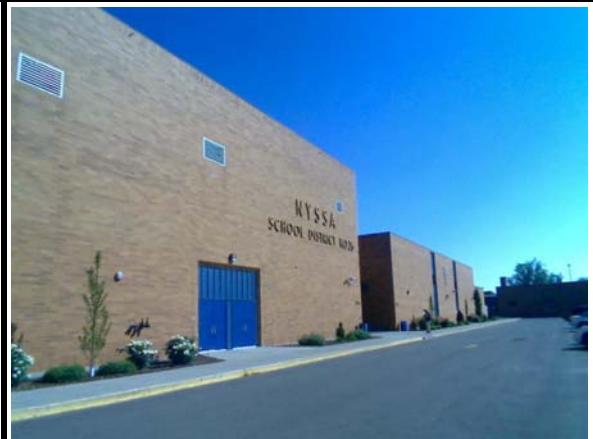
Malh_sch09B

Type	Basic Score	Vert Irreg	Plan Irreg	Pre-Code	Post-Bench	Soil C	Soil D	Soil E	RVS Score
Primary	RM1	3.6	-2	-0.5	0	0	0	-1.2	0	-0.1
Secondary	C2	3.6	-2	-0.5	0	0	0	-1.2	0	-0.1
Tertiary		0	0	0	0	0	0	0	0	0

Final Type	Final Score
RM1	-0.1

Very High (100%)

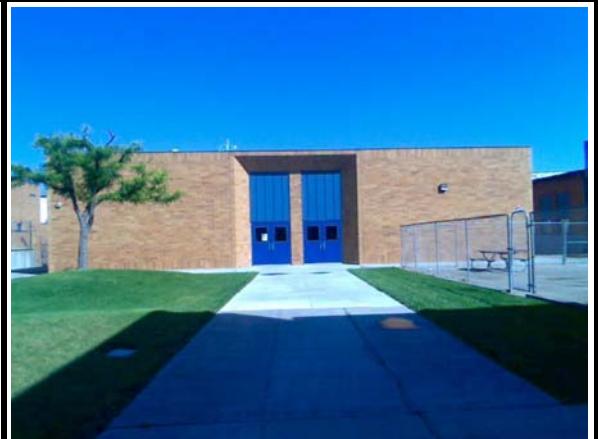
Malh_sch09C

Type	Basic Score	Vert Irreg	Plan Irreg	Pre-Code	Post-Bench	Soil C	Soil D	Soil E	RVS Score
Primary	RM1	3.6	0	0	0	0	0	-1.2	0	2.4
Secondary	C2	3.6	0	0	0	0	0	-1.2	0	2.4
Tertiary		0	0	0	0	0	0	0	0	0

Final Type	Final Score
RM1	2.4

Low (<1%)
