Vale High School

Malh_sch11A

FEMA 154 Rapid Visual Screening Score Card

Rapid Visual Screening - Senate Bill #2 - Seismic Needs Assessment
Oregon Department of Geology and Mineral Industries

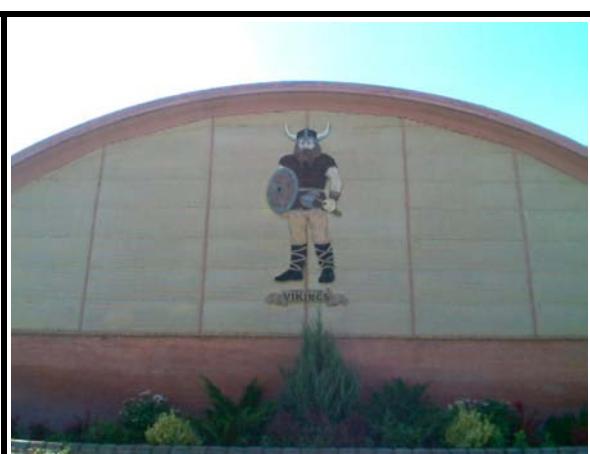
Final Type	Final Score
RM1	0.4

High (>10%)

Enrollment 335	Year Built (Field Verified) 1958	Year Built (Alt. Source) 1958	Est. Decade Built 1950
Total Area (square ft) 71503	Number of Stories 1	Basement	Pounding Potential Yes
Plan Irregularities None None None		Vertical Irregularities Steps in Elevation View: Single Change None None	
Falling Hazards Parapets: General Other: Brick Veneer None		Poor Conditions None None None

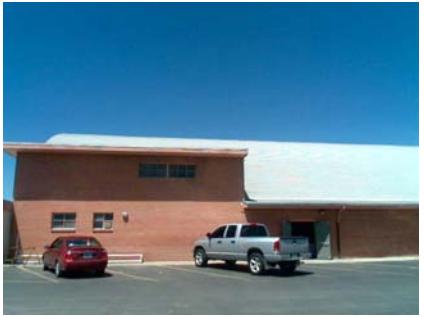
S Primary Structural Type inside gym wood structure		S Elevation View

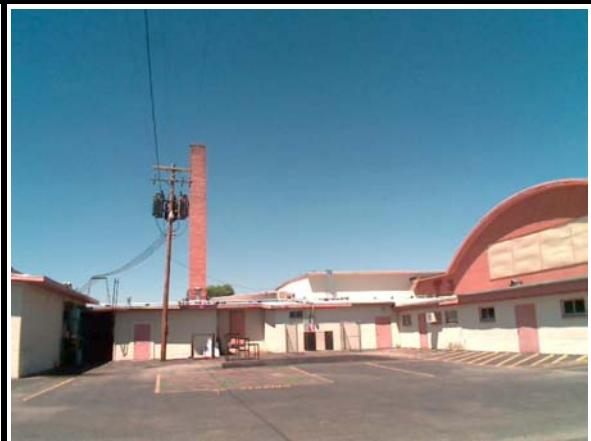
Malh_sch11B

Final Type	Final Score
RM1	-0.1

Very High (100%)

Enrollment 335	Year Built (Field Verified) 1958	Year Built (Alt. Source) 1958	Est. Decade Built 1960
Total Area (square ft) 71503	Number of Stories 1	Basement	Pounding Potential Yes
Plan Irregularities Reentrant Corners: L Shaped None None		Vertical Irregularities Steps in Elevation View: Single Change (Adjacent Building/Entity) None None	
Falling Hazards Other: Smokestack None None		Poor Conditions None None None

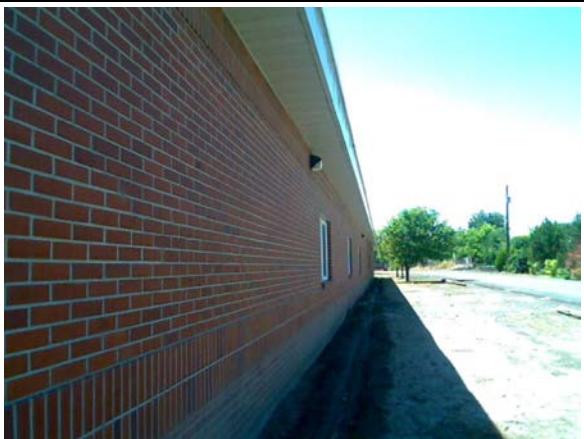
Malh_sch11C

Final Type	Final Score
RM1	2.4

Low (<1%)

Enrollment 335	Year Built (Field Verified) 1958	Year Built (Alt. Source) 1958	Est. Decade Built 1990
Total Area (square ft) 71503	Number of Stories 1	Basement	Pounding Potential Yes
Plan Irregularities None None None		Vertical Irregularities Internal Discontinuous Diaphram (large internal opening) None None	
Falling Hazards None None None		Poor Conditions None None None
