Idanha-Detroit RFPD

Mari_fir40A

FEMA 154 Rapid Visual Screening Score Card

Rapid Visual Screening - Senate Bill #2 - Seismic Needs Assessment
Oregon Department of Geology and Mineral Industries

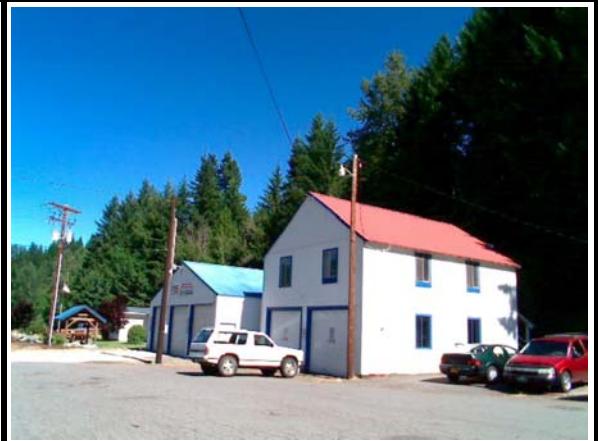
Seismicity Zone: Moderate

Type	Basic Score	Vert Irreg	Plan Irreg	Pre-Code	Post-Bench	Soil C	Soil D	Soil E	RVS Score
Primary	W1	5.2	0	-0.5	0	0	0	-0.6	0	4.1
Secondary		0	0	0	0	0	0	0	0	0
Tertiary		0	0	0	0	0	0	0	0	0

Final Type	Final Score
W1	4.1

Low (<1%)

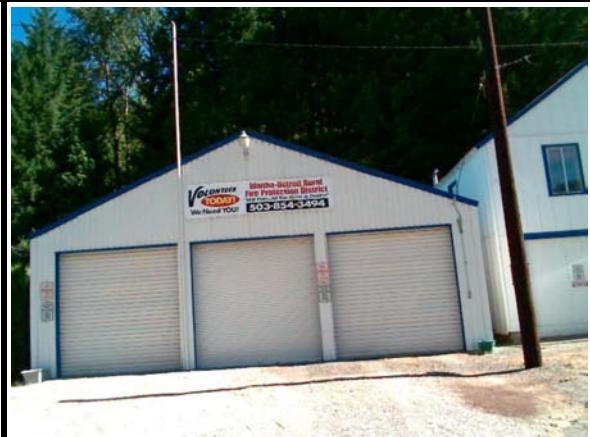
Mari_fir40B

Seismicity Zone: Moderate

Type	Basic Score	Vert Irreg	Plan Irreg	Pre-Code	Post-Bench	Soil C	Soil D	Soil E	RVS Score
Primary	S3	3.8	0	0	0	0	0	-1	0	2.8
Secondary		0	0	0	0	0	0	0	0	0
Tertiary		0	0	0	0	0	0	0	0	0

Final Type	Final Score
S3	2.8

Low (<1%)
