Boardman RFPD

Morr_fir02A

Building Type Fire - RFPD	County Morrow	
Street 300 SW Wilson Ln		
City Boardman	State OR	Zip 97818
Latitude 45.82822	Longitude 119.70599	
Tracking Code RVS in 2006	Inspection Date 7/25/2006

FEMA 154 Rapid Visual Screening Score Card

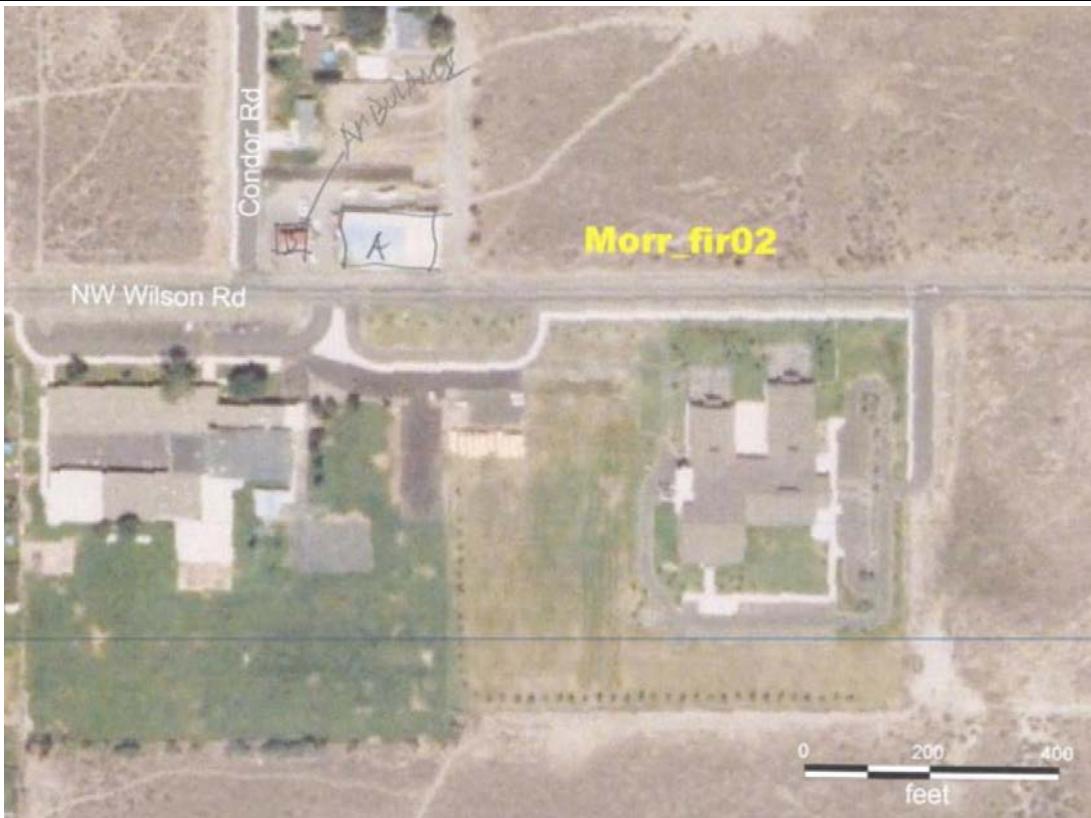
Type	Basic Score	Vert Irreg	Plan Irreg	Pre-Code	Post-Bench	Soil C	Soil D	Soil E	RVS Score
Primary	S3	3.8	0	0	0	0	-0.6	0	0	3.2
Secondary		0	0	0	0	0	0	0	0	0
Tertiary		0	0	0	0	0	0	0	0	0

Final Type	Final Score
S3	3.2

Low (<1%)

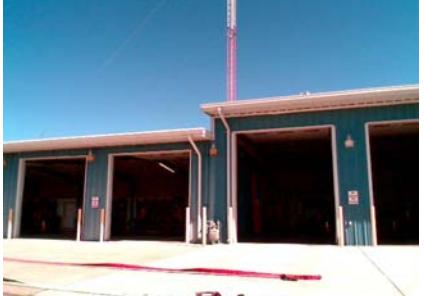
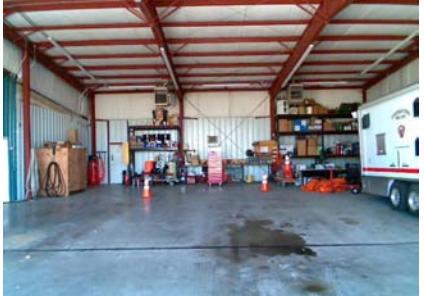
Enrollment	Year Built (Field Verified)	Year Built (Alt. Source)	Est. Decade Built
			1980
Total Area (square ft)	Number of Stories	Basement	Pounding Potential
	1	No	No
Plan Irregularities		Vertical Irregularities	
None		Steps in Elevation View: Single Change	
None		None	
None		None	
Falling Hazards		Poor Conditions	
None		None	
None		None	
None		None

S	Vertical Irregularity Primary	S	Primary Structural Type

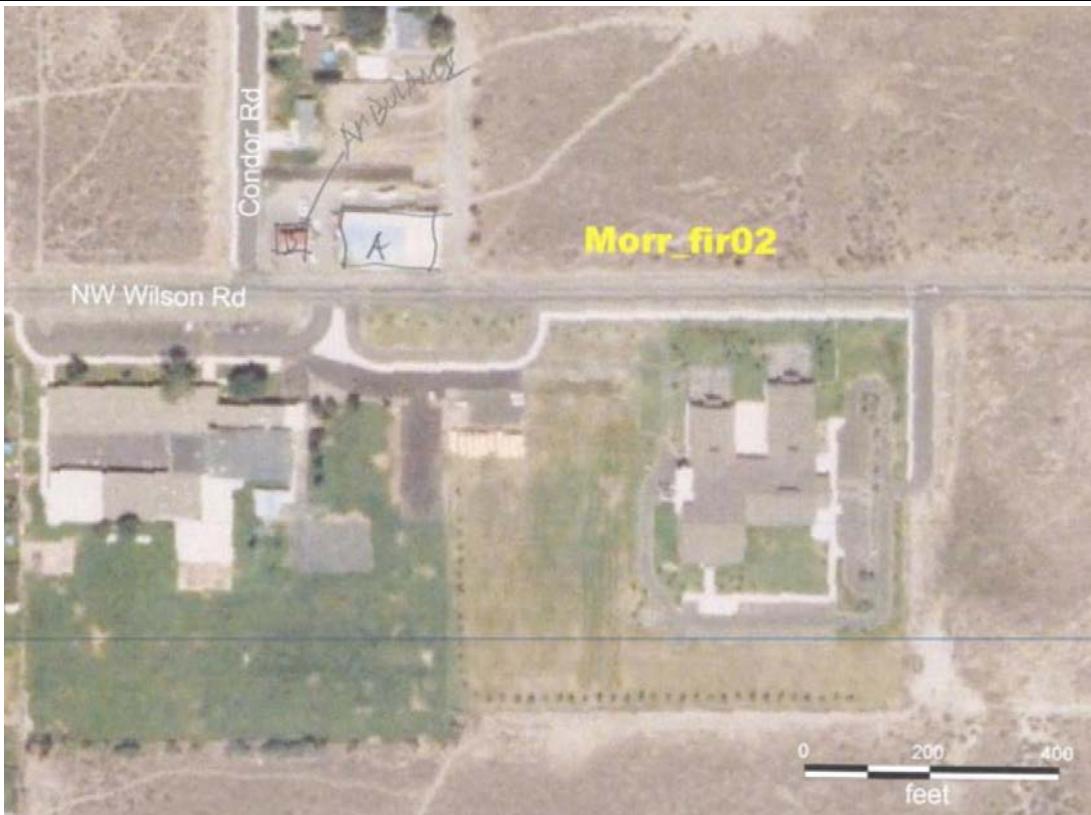
Type	Basic Score	Vert Irreg	Plan Irreg	Pre-Code	Post-Bench	Soil C	Soil D	Soil E	RVS Score
Primary	S3	3.8	0	0	0	0	-0.6	0	0	3.2
Secondary		0	0	0	0	0	0	0	0	0
Tertiary		0	0	0	0	0	0	0	0	0

Final Type	Final Score
S3	3.2

Low (<1%)
