Ione School

Morr_sch05A

FEMA 154 Rapid Visual Screening Score Card

Rapid Visual Screening - Senate Bill #2 - Seismic Needs Assessment
Oregon Department of Geology and Mineral Industries

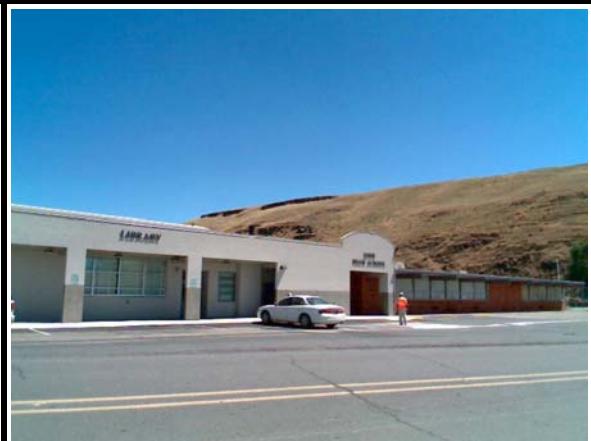
Final Type	Final Score
RM1	0.3

High (>10%)

Enrollment 174	Year Built (Field Verified) 1961	Year Built (Alt. Source) 1961	Est. Decade Built 1960
Total Area (square ft) 55405	Number of Stories 1	Basement	Pounding Potential No
Plan Irregularities Reentrant Corners:L shaped (Adjacent Build/Entity) None None		Vertical Irregularities Steps in Elevation View: Single Change (Adjacent Building/Entity) None None	
Falling Hazards None None None		Poor Conditions None None None

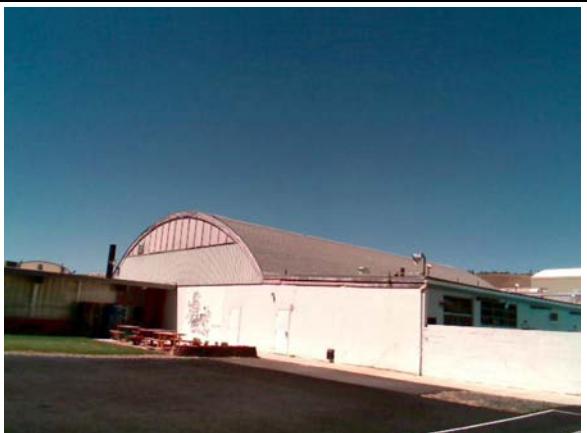
Morr_sch05B

Final Type	Final Score
C2	0.3

Enrollment 174	Year Built (Field Verified) 1961	Year Built (Alt. Source) 1961	Est. Decade Built 1960
Total Area (square ft) 55405	Number of Stories 1	Basement	Pounding Potential No
Plan Irregularities Reentrant Corners:L shaped (Adjacent Build/Entity) None None		Vertical Irregularities Steps in Elevation View: 2 to 3 Changes Steps in Elevation View: Single Change (Adjacent Building/Entity) None	
Falling Hazards None None None		Poor Conditions None None None
