# Portland Police Bureau Sunshine Division Office

## FEMA 154 Rapid Visual Screening Score Card

Rapid Visual Screening - Senate Bill #2 - Seismic Needs Assessment  
Oregon Department of Geology and Mineral Industries

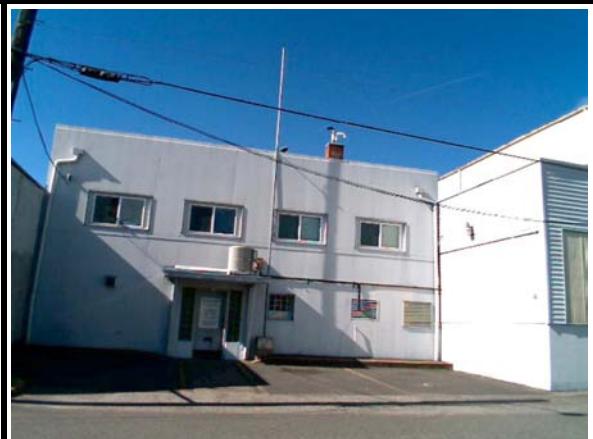
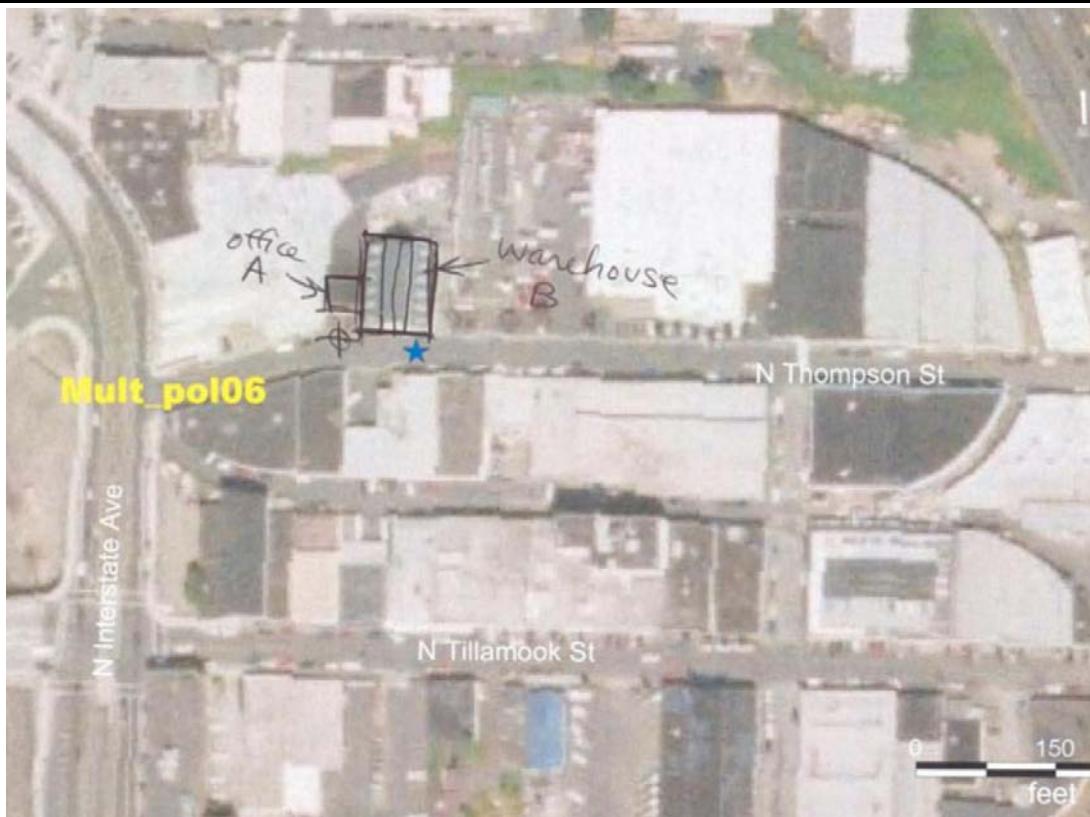
Mult\_pol06A

Type	Basic Score	Vert Irreg	Plan Irreg	Pre-Code	Post-Bench	Soil C	Soil D	Soil E	RVS Score
Primary	C2	2.8	0	-0.5	-1	0	-0.4	0	0	0.9
Secondary		0	0	0	0	0	0	0	0	0
Tertiary		0	0	0	0	0	0	0	0	0

Final Type	Final Score
C2	0.9

High (>10%)

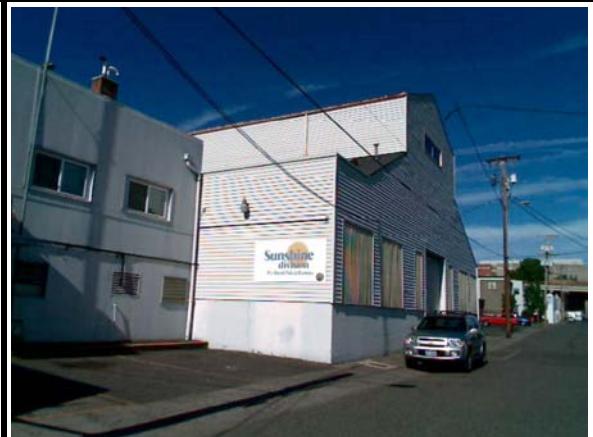
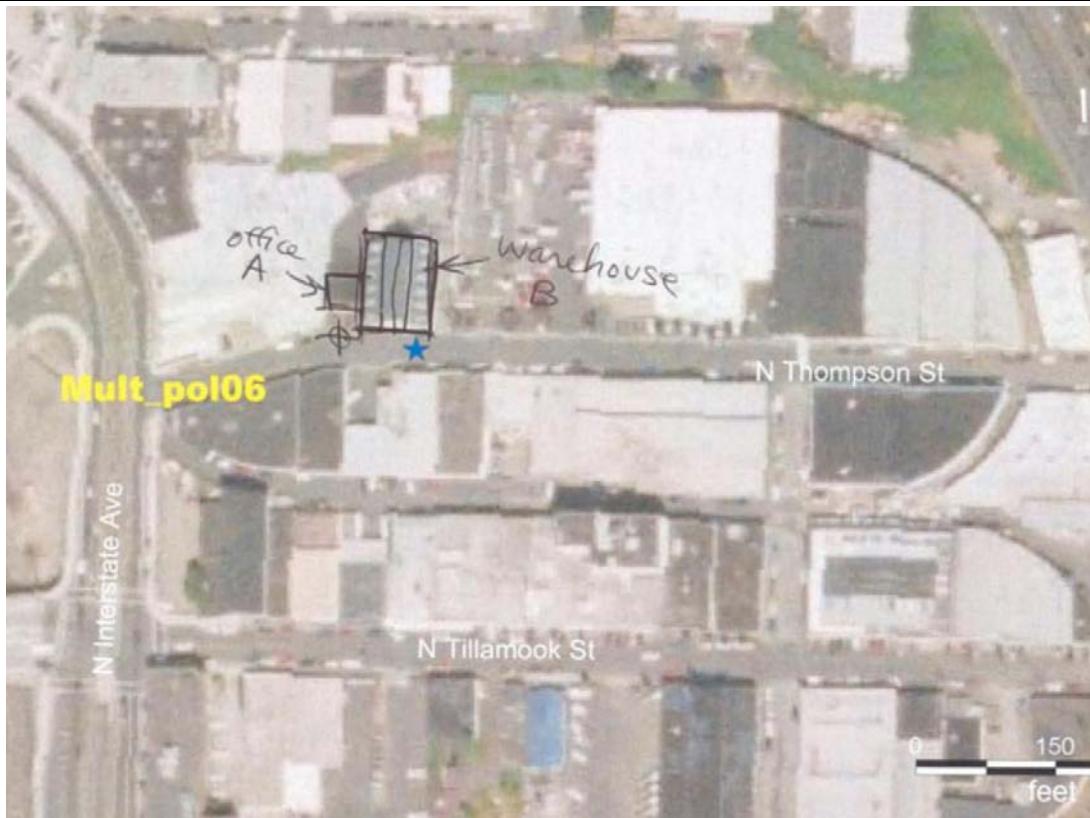
Mult\_pol06B

Type	Basic Score	Vert Irreg	Plan Irreg	Pre-Code	Post-Bench	Soil C	Soil D	Soil E	RVS Score
Primary	C2	2.8	-1	-0.5	-1	0	-0.4	0	0	-0.1
Secondary	W2	3.8	-2	-0.5	-1	0	-0.4	0	0	-0.1
Tertiary	URM	1.8	-1	-0.5	-0.2	0	-0.4	0	0	-0.3

Final Type	Final Score
URM	-0.3

Very High (100%)
