Dallas Police Department

Polk_pol02A

FEMA 154 Rapid Visual Screening Score Card

Rapid Visual Screening - Senate Bill #2 - Seismic Needs Assessment
Oregon Department of Geology and Mineral Industries

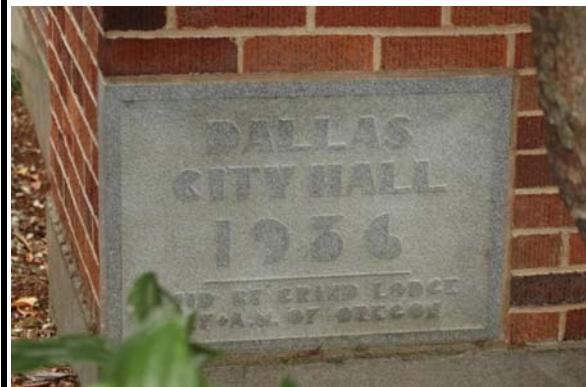
Type	Basic Score	Vert Irreg	Plan Irreg	Pre-Code	Post-Bench	Soil C	Soil D	Soil E	RVS Score
Primary	C2	2.8	-1	-0.5	-1	0	-0.4	0	0	-0.1
Secondary		0	0	0	0	0	0	0	0	0
Tertiary		0	0	0	0	0	0	0	0	0

Final Type	Final Score
C2	-0.1

Very High (100%)

Enrollment	Year Built (Field Verified)	Year Built (Alt. Source)	Est. Decade Built
	1936	1936	1930
Total Area (square ft)	Number of Stories	Basement	Pounding Potential
14650	2	Yes	No
Plan Irregularities		Vertical Irregularities	
Reentrant Corners:Other (Adjacent Build/Entity)		Steps in Elevation View: Single Change (Adjacent Building/Entity)	
None		None	
None		None	
Falling Hazards		Poor Conditions	
Other: Brick Veneer		None	
None		None	
None		None

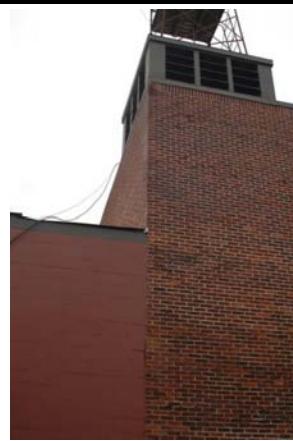
Type	Basic Score	Vert Irreg	Plan Irreg	Pre-Code	Post-Bench	Soil C	Soil D	Soil E	RVS Score
Primary	RM1	2.8	-1	0	0	0	-0.4	0	0	1.4
Secondary		0	0	0	0	0	0	0	0	0
Tertiary		0	0	0	0	0	0	0	0	0

Final Type	Final Score
RM1	1.4

Moderate (>1%)

Enrollment	Year Built (Field Verified)	Year Built (Alt. Source)	Est. Decade Built
		1936	1960
Total Area (square ft)	Number of Stories	Basement	Pounding Potential
	3	No	No
Plan Irregularities		Vertical Irregularities	
Reentrant Corners:Other (Adjacent Build/Entity)		Steps in Elevation View: Single Change (Adjacent Building/Entity)	
None		None	
None		None	
Falling Hazards		Poor Conditions	
Other: Brick Veneer		None	
None		None	
None		None
