Whitworth Elementary School

Dallas SD 2

FEMA 154 Rapid Visual Screening Score Card

Rapid Visual Screening - Senate Bill #2 - Seismic Needs Assessment
Oregon Department of Geology and Mineral Industries

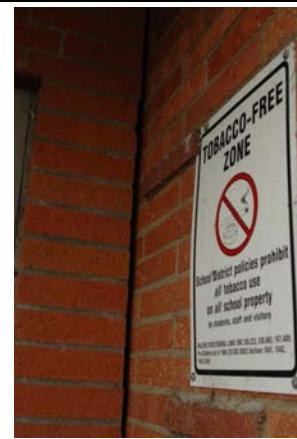
Polk_sch12A

Type	Basic Score	Vert Irreg	Plan Irreg	Pre-Code	Post-Bench	Soil C	Soil D	Soil E	RVS Score
Primary	W2	3.8	-2	-0.5	0	0	-0.4	0	0	0.9
Secondary	C2	2.8	-1	-0.5	0	0	-0.4	0	0	0.9
Tertiary		0	0	0	0	0	0	0	0	0

Final Type	Final Score
W2	0.9

High (>10%)

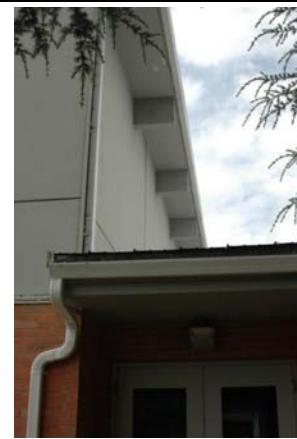
Polk_sch12B

Type	Basic Score	Vert Irreg	Plan Irreg	Pre-Code	Post-Bench	Soil C	Soil D	Soil E	RVS Score
Primary	PC1	2.6	0	0	0	0	-0.4	0	0	2.2
Secondary	C2	2.8	0	0	0	2.4	-0.4	0	0	4.8
Tertiary		0	0	0	0	0	0	0	0	0

Final Type	Final Score
PC1	2.2

Low (<1%)

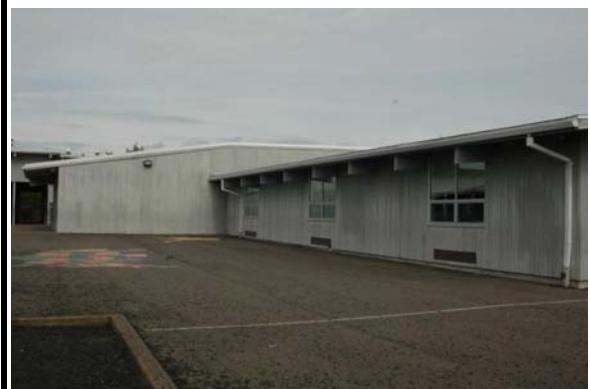
Polk_sch12C

Type	Basic Score	Vert Irreg	Plan Irreg	Pre-Code	Post-Bench	Soil C	Soil D	Soil E	RVS Score
Primary	W2	3.8	-2	-0.5	0	0	-0.4	0	0	0.9
Secondary		0	0	0	0	0	0	0	0	0
Tertiary		0	0	0	0	0	0	0	0	0

Final Type	Final Score
W2	0.9

High (>10%)
