Sherman County Sheriff Courthouse

Sher_pol01A

FEMA 154 Rapid Visual Screening Score Card

Rapid Visual Screening - Senate Bill #2 - Seismic Needs Assessment
Oregon Department of Geology and Mineral Industries

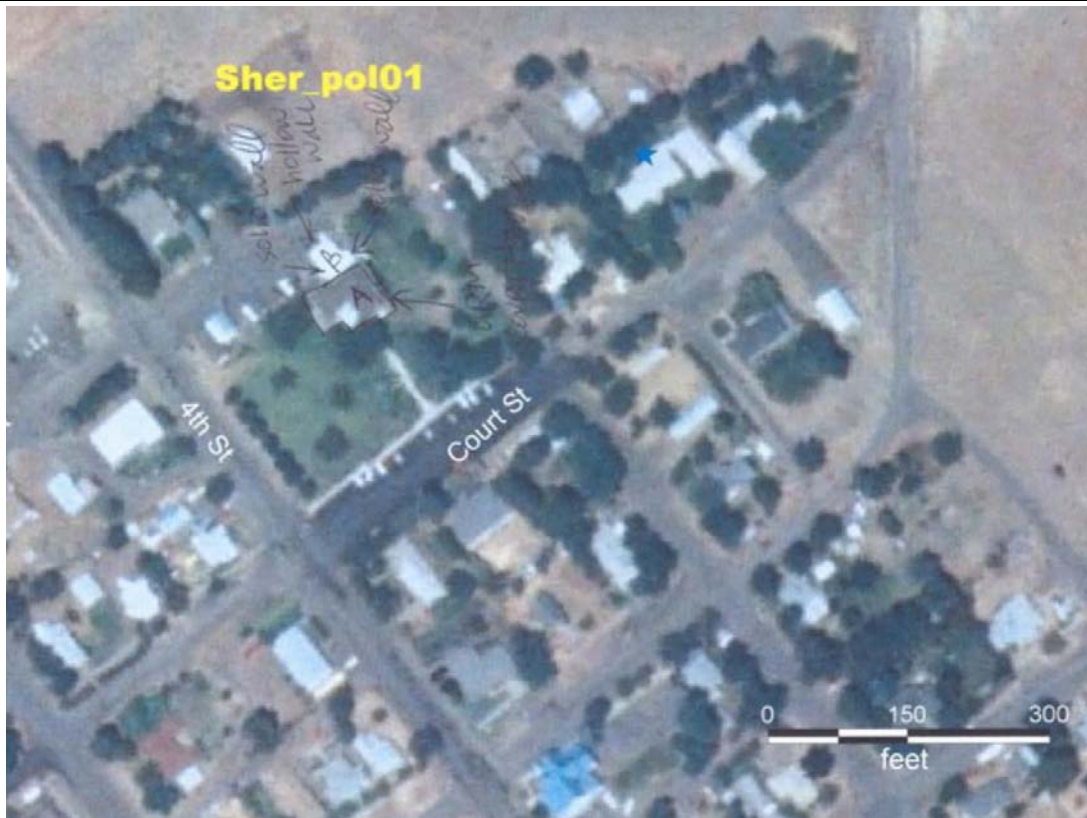
Type	Basic Score	Vert Irreg	Plan Irreg	Pre-Code	Post-Bench	Soil C	Soil D	Soil E	RVS Score
Primary	URM	3.4	-1.5	-0.5	-0.4	0	-0.4	0	0	0.6
Secondary		0	0	0	0	0	0	0	0	0
Tertiary		0	0	0	0	0	0	0	0	0

Final RVS Score

URM

0.6

High (>10%)
