# Bay City Fire Department

Till\_fir02A

## FEMA 154 Rapid Visual Screening Score Card

Rapid Visual Screening - Senate Bill #2 - Seismic Needs Assessment  
Oregon Department of Geology and Mineral Industries

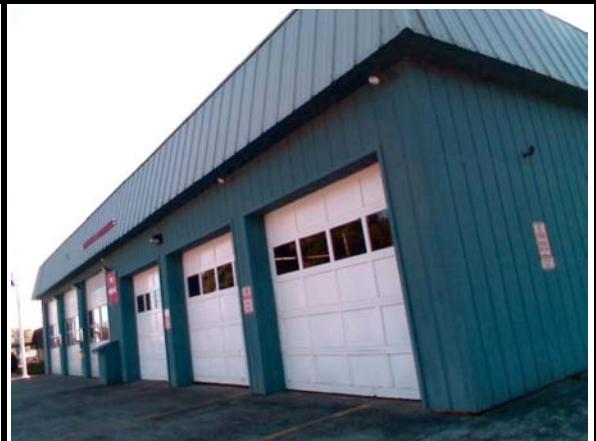
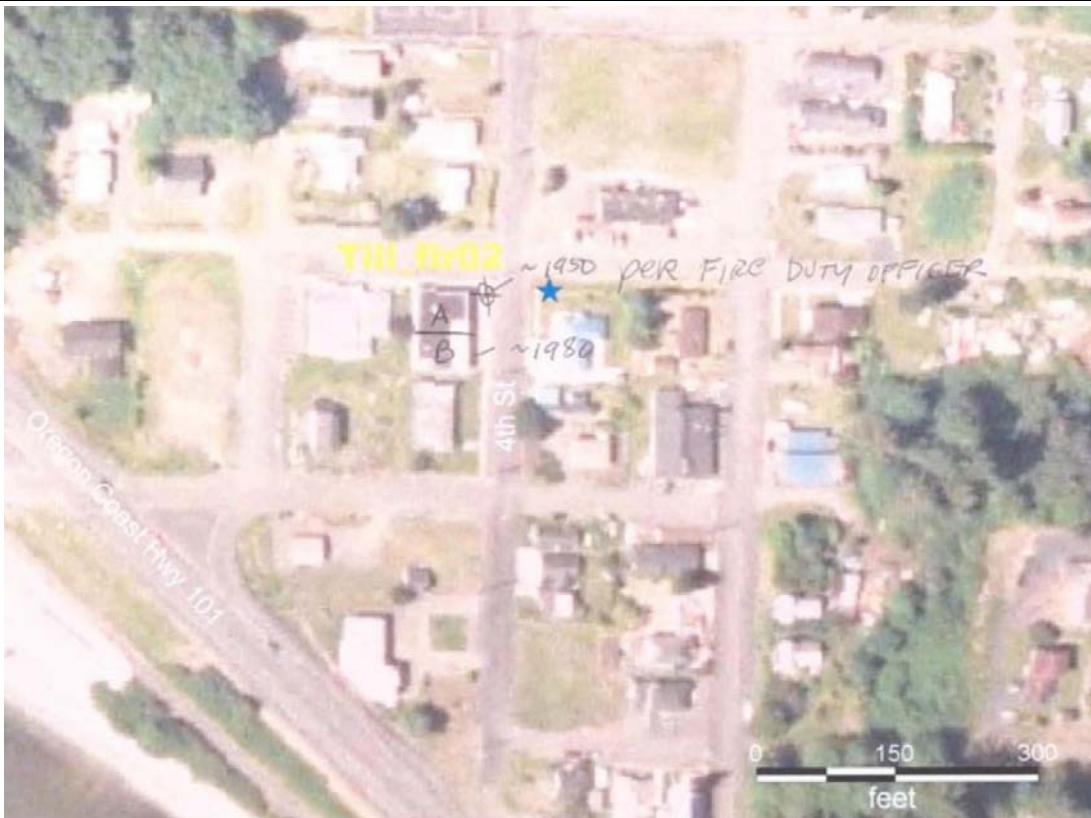
Type	Basic Score	Vert Irreg	Plan Irreg	Pre-Code	Post-Bench	Soil C	Soil D	Soil E	RVS Score
Primary	RM1	2.8	0	-0.5	0	0	0	-0.6	0	1.7
Secondary		0	0	0	0	0	0	0	0	0
Tertiary		0	0	0	0	0	0	0	0	0

Final Type	Final Score
RM1	1.7

Moderate (>1%)

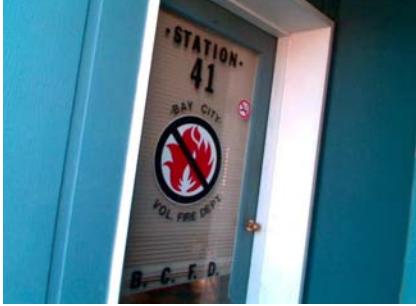
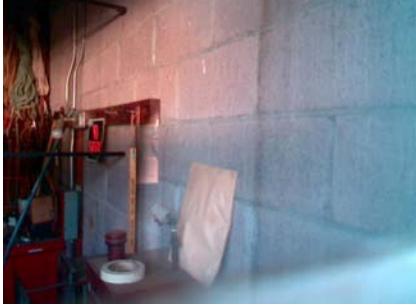
NW Elevation View

Enrollment	Year Built (Field Verified)	Year Built (Alt. Source)	Est. Decade Built
			1950
Total Area (square ft)	Number of Stories	Basement	Pounding Potential
	1	No	Yes
Plan Irregularities		Vertical Irregularities	
Torsion: Eccentric Stiffness		None	
None		None	
None		None	
Falling Hazards		Poor Conditions	
None		None	
None		None	
None		None

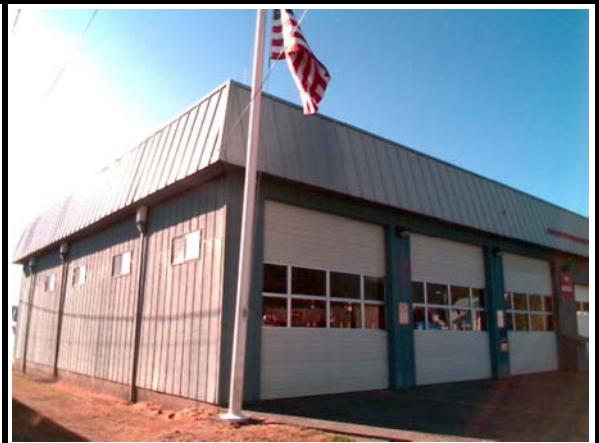
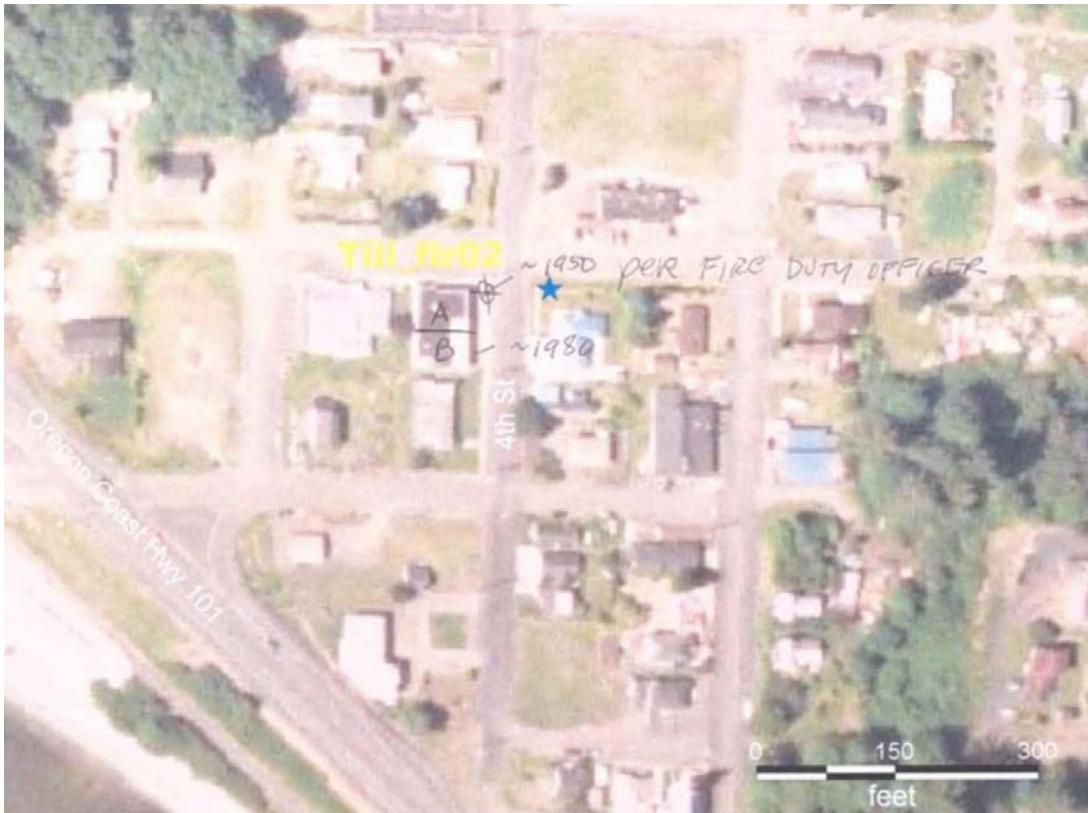
Till\_fir02B

Type	Basic Score	Vert Irreg	Plan Irreg	Pre-Code	Post-Bench	Soil C	Soil D	Soil E	RVS Score
Primary	W1	4.4	0	-0.5	0	2.4	0	0	0	6.3
Secondary		0	0	0	0	0	0	0	0	0
Tertiary		0	0	0	0	0	0	0	0	0

Final Type	Final Score
W1	6.3

Low (<1%)
