# Nestucca RFPD

Till\_fir04A

Rapid Visual Screening - Senate Bill #2 - Seismic Needs Assessment  
Oregon Department of Geology and Mineral Industries

Till\_fir04B

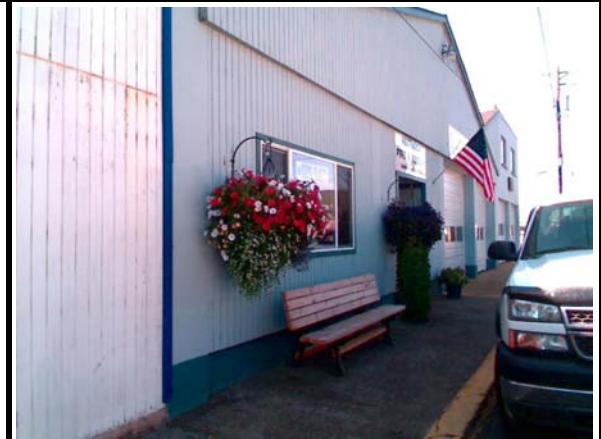
Seismicity Zone: Very High

Final Type	Final Score
C2	-0.1

Very High (100%)

N Primary Structural Type CONC FRAMES - THIS BLDG WAS ORIGINALLY A GARAGE		SW Elevation View LOOKS LIKE A WOOD FRAMED ADDN IN BACK - NOT ACCESSIBLE

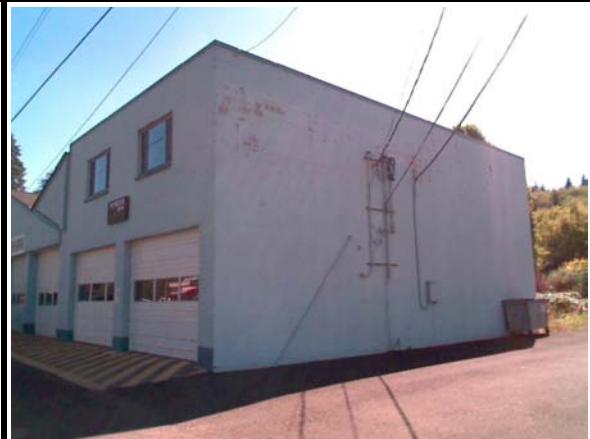
Seismicity Zone: Very High

Final Type	Final Score
RM1	0.7

High (>10%)
