Liberty Elementary School

Tillamook SD 9

FEMA 154 Rapid Visual Screening Score Card

Rapid Visual Screening - Senate Bill #2 - Seismic Needs Assessment
Oregon Department of Geology and Mineral Industries

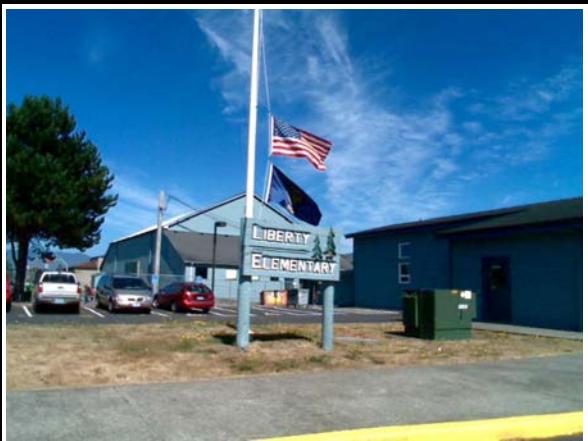
Till_sch11A

Type	Basic Score	Vert Irreg	Plan Irreg	Pre-Code	Post-Bench	Soil C	Soil D	Soil E	RVS Score
Primary	W2	3.8	-2	-0.5	0	0	0	-0.8	0	0.5
Secondary		0	0	0	0	0	0	0	0	0
Tertiary		0	0	0	0	0	0	0	0	0

Final Type	Final Score
W2	0.5

High (>10%)

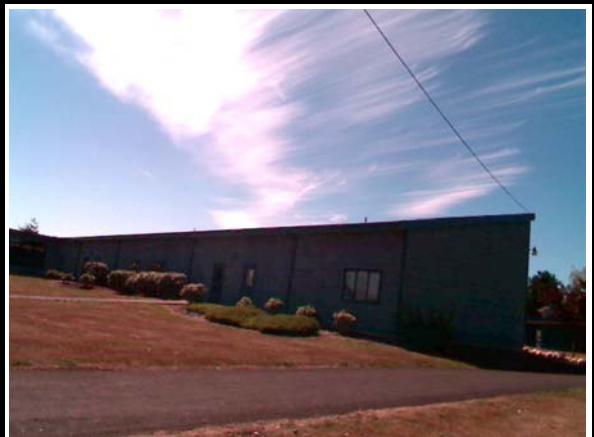
Till_sch1B

Type	Basic Score	Vert Irreg	Plan Irreg	Pre-Code	Post-Bench	Soil C	Soil D	Soil E	RVS Score
Primary	W2	3.8	0	-0.5	0	2.4	0	-0.8	0	4.9
Secondary		0	0	0	0	0	0	0	0	0
Tertiary		0	0	0	0	0	0	0	0	0

Final Type	Final Score
W2	4.9

Low (<1%)

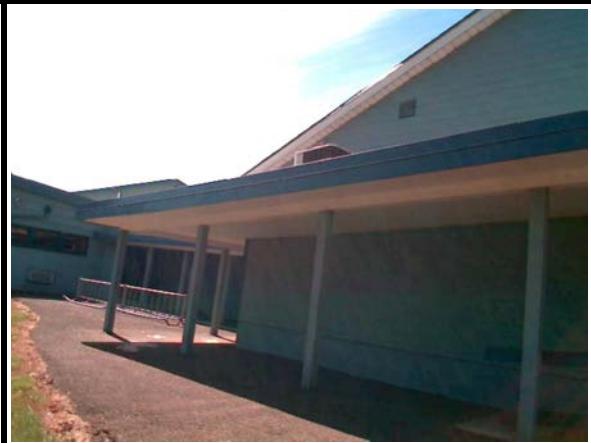
Till_sch11C

Type	Basic Score	Vert Irreg	Plan Irreg	Pre-Code	Post-Bench	Soil C	Soil D	Soil E	RVS Score
Primary	W2	3.8	-2	0	-1	0	0	-0.8	0	0
Secondary		0	0	0	0	0	0	0	0	0
Tertiary		0	0	0	0	0	0	0	0	0

Final Type	Final Score
W2	0

Very High (100%)
