Sherwood Heights Elementary School

Pendleton SD 16

Umat_sch10A

Rapid Visual Screening - Senate Bill #2 - Seismic Needs Assessment
Oregon Department of Geology and Mineral Industries

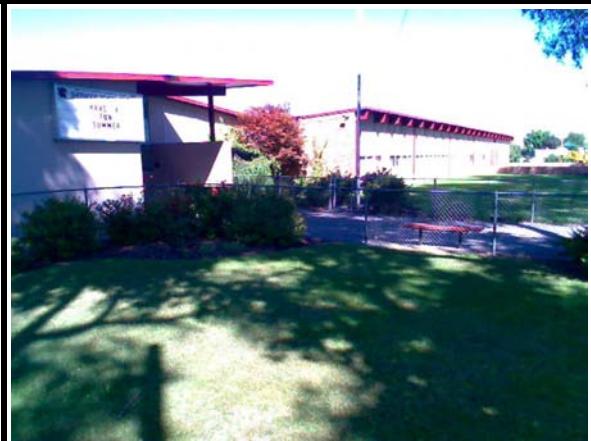
Seismicity Zone: Moderate										
FEMA 154 Rapid Visual Screening Score Card										
	Type	Basic Score	Vert Irreg	Plan Irreg	Pre-Code	Post-Bench	Soil C	Soil D	Soil E	RVS Score
Primary	W2	4.8	-3	-0.5	0	0	0	0	0	1.3
Secondary	RM1	3.6	-2	-0.5	0	0	0	0	0	1.1
Tertiary		0	0	0	0	0	0	0	0	0

Final Type	Final Score
RM1	1.1

Moderate (>1%)

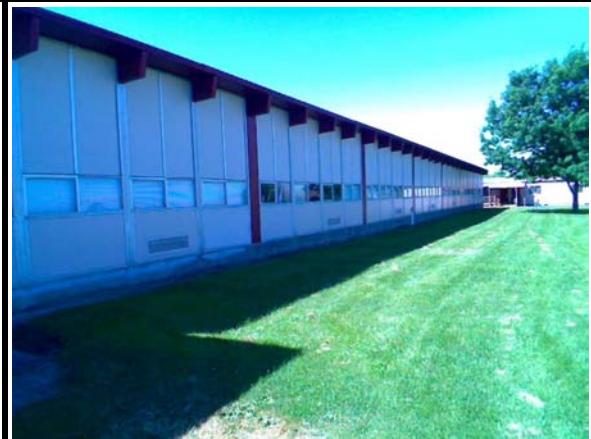
Umat_sch10B

Type	Basic Score	Vert Irreg	Plan Irreg	Pre-Code	Post-Bench	Soil C	Soil D	Soil E	RVS Score
Primary	W2	4.8	-3	-0.5	0	0	0	0	0	1.3
Secondary	RM1	3.6	-2	-0.5	0	0	0	0	0	1.1
Tertiary		0	0	0	0	0	0	0	0	0

Final Type	Final Score
RM1	1.1

Moderate (>1%)

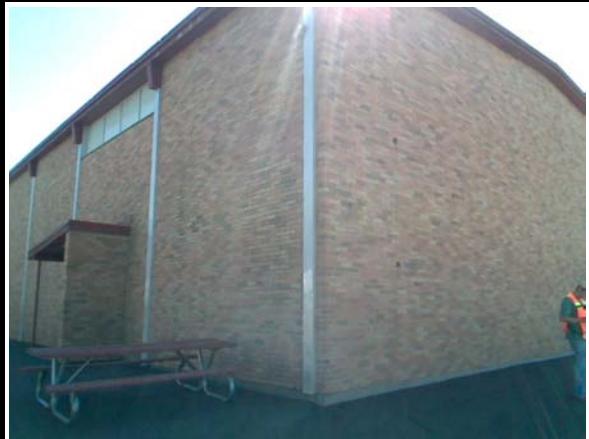
Umat_sch10C

Type	Basic Score	Vert Irreg	Plan Irreg	Pre-Code	Post-Bench	Soil C	Soil D	Soil E	RVS Score
Primary	RM1	3.6	-2	-0.5	0	0	0	0	0	1.1
Secondary	S2	3.6	-2	-0.5	0	0	0	0	0	1.1
Tertiary		0	0	0	0	0	0	0	0	0

Final Type	Final Score
RM1	1.1

Moderate (>1%)

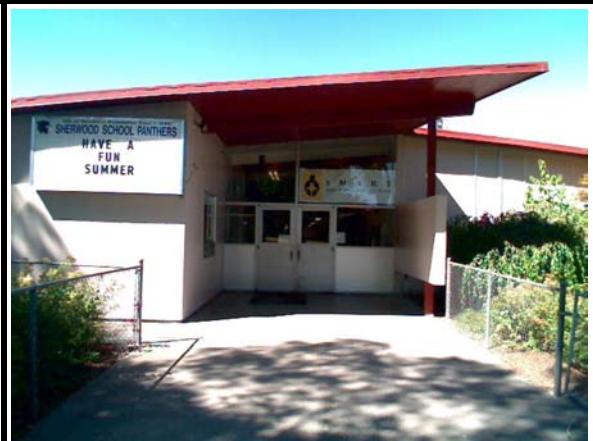
Umat_sch10D

Type	Basic Score	Vert Irreg	Plan Irreg	Pre-Code	Post-Bench	Soil C	Soil D	Soil E	RVS Score
Primary	W1	5.2	-3.5	-0.5	0	0	0	0	0	1.2
Secondary	RM1	3.6	-2	-0.5	0	0	0	0	0	1.1
Tertiary		0	0	0	0	0	0	0	0	0

Final Type	Final Score
RM1	1.1

Moderate (>1%)

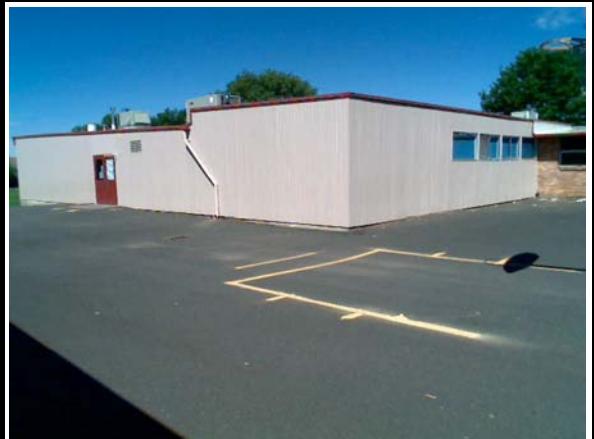
Umat_sch10E

Type	Basic Score	Vert Irreg	Plan Irreg	Pre-Code	Post-Bench	Soil C	Soil D	Soil E	RVS Score
Primary	W2	4.8	-3	-0.5	0	1.6	0	0	0	2.9
Secondary		0	0	0	0	0	0	0	0	0
Tertiary		0	0	0	0	0	0	0	0	0

Final Type	Final Score
W2	2.9

Low (<1%)
