# Freewater Elementary School

Umat\_sch15A

## FEMA 154 Rapid Visual Screening Score Card

Rapid Visual Screening - Senate Bill #2 - Seismic Needs Assessment  
Oregon Department of Geology and Mineral Industries

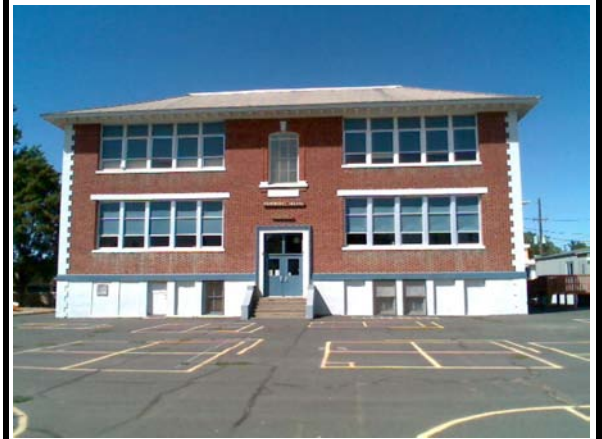
URM

0.2

FEMA-154 Collapse Potential

High (>10%)

Plan Irregularities	Vertical Irregularities
Reentrant Corners: T shaped	Steps in Elevation View: Single Change (Adjacent Building/Entity)
Reentrant Corners: Other	None
None	None

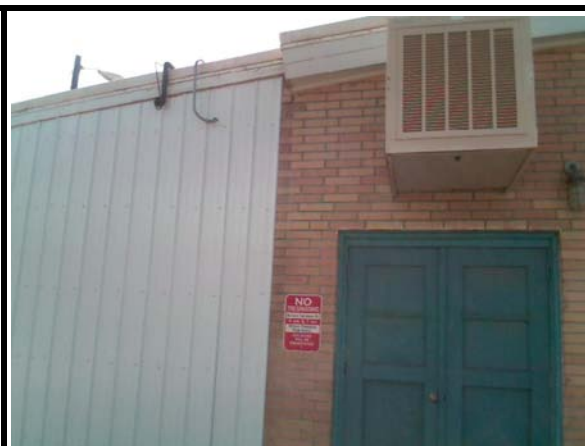
Umat\_sch15B

C1

-0.5

FEMA-154 Collapse Potential

Very High (100%)

Plan Irregularities	Vertical Irregularities
Reentrant Corners: Other	Steps in Elevation View: Single Change
None	Steps in Elevation View: 2 to 3 Changes (Adjacent Building/Entity)
None	None

Falling Hazards	Poor Conditions
Other: Smokestack	None
None	None
None	None

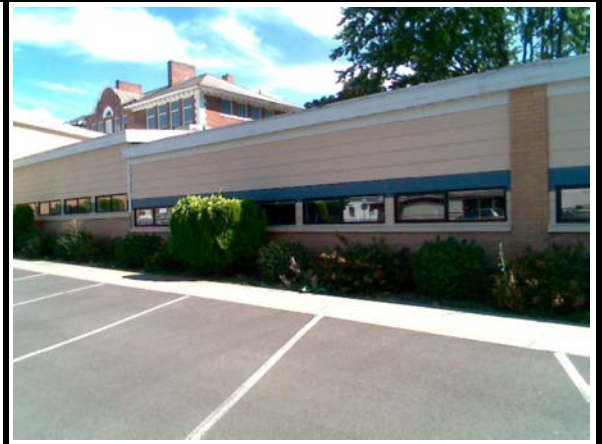
Umat\_sch15C

RM1

0.4

FEMA-154 Collapse Potential

High (>10%)
