Grove Elementary School

Milton-Freewater Unified SD 7

FEMA 154 Rapid Visual Screening Score Card

Rapid Visual Screening - Senate Bill #2 - Seismic Needs Assessment
Oregon Department of Geology and Mineral Industries

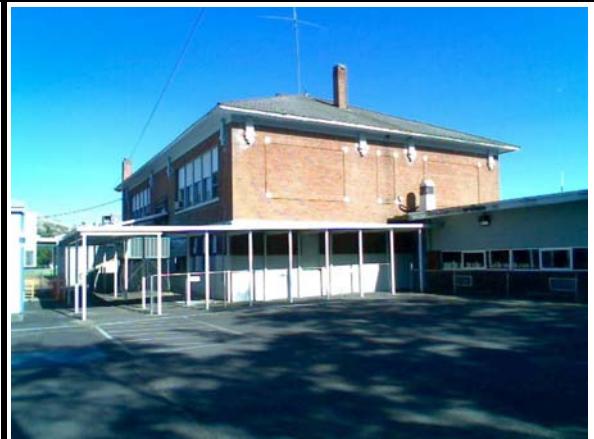
Umat_sch16A

Building Type School	County Umatilla	
Street 129 Se 15th St		
City Milton-Freewater	State OR	Zip 97862
Latitude 45.92203	Longitude 118.37757	
Tracking Code RVS in 2006	Inspection Date 8/2/2006

Type	Basic Score	Vert Irreg	Plan Irreg	Pre-Code	Post-Bench	Soil C	Soil D	Soil E	RVS Score
Primary	URM	3.4	-1.5	-0.5	-0.4	0	-0.4	0	0	0.6
Secondary		0	0	0	0	0	0	0	0	0
Tertiary		0	0	0	0	0	0	0	0	0

Final Type	Final Score
URM	0.6

High (>10%)

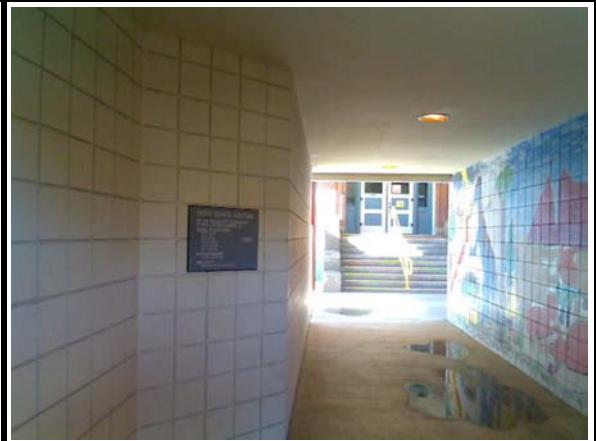
Umat_sch16B

Seismicity Zone: Moderate										
FEMA 154 Rapid Visual Screening Score Card										
	Type	Basic Score	Vert Irreg	Plan Irreg	Pre-Code	Post-Bench	Soil C	Soil D	Soil E	RVS Score
Primary	RM1	3.6	-2	-0.5	0	0	-0.8	0	0	0.3
Secondary		0	0	0	0	0	0	0	0	0
Tertiary		0	0	0	0	0	0	0	0	0

Final Type	Final Score
RM1	0.3

High (>10%)

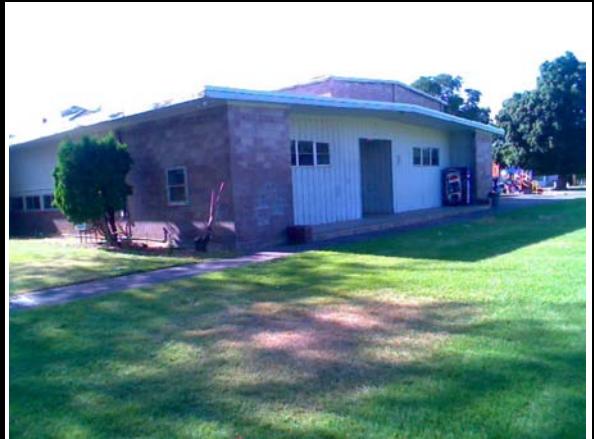
Umat_sch16C

Type	Basic Score	Vert Irreg	Plan Irreg	Pre-Code	Post-Bench	Soil C	Soil D	Soil E	RVS Score
Primary	RM1	3.6	-2	-0.5	0	0	-0.8	0	0	0.3
Secondary		0	0	0	0	0	0	0	0	0
Tertiary		0	0	0	0	0	0	0	0	0

Final Type	Final Score
RM1	0.3

High (>10%)
