Helix School

Umat_sch29A

FEMA 154 Rapid Visual Screening Score Card

Rapid Visual Screening - Senate Bill #2 - Seismic Needs Assessment
Oregon Department of Geology and Mineral Industries

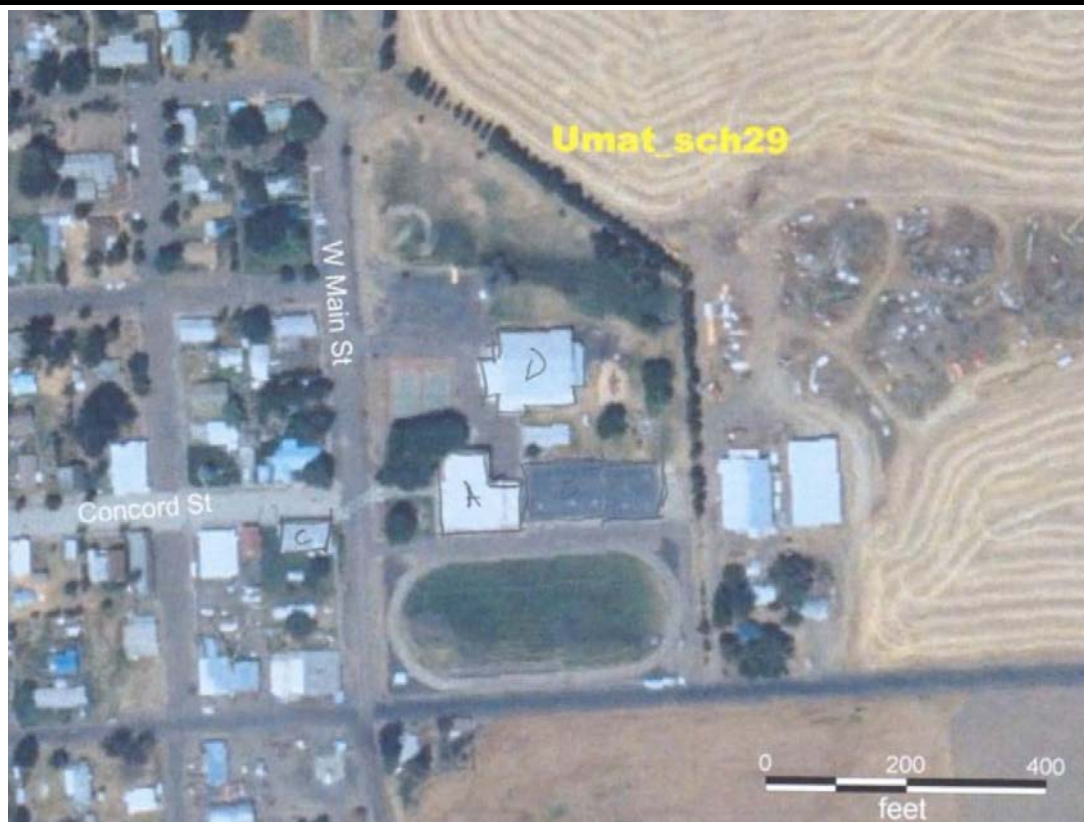
Type	Basic Score	Vert Irreg	Plan Irreg	Pre-Code	Post-Bench	Soil C	Soil D	Soil E	RVS Score
Primary	URM	3.4	-1.5	-0.5	-0.4	0	-0.4	0	0	0.6
Secondary		0	0	0	0	0	0	0	0	0
Tertiary		0	0	0	0	0	0	0	0	0

0.6

High (>10%)

Plan Irregularities	Vertical Irregularities
Reentrant Corners:L shaped	Steps in Elevation View: Single Change
Reentrant Corners:U shaped (Adjacent Build/Entity)	Steps in Elevation View: Single Change (Adjacent Building/Entity)
None	None

Falling Hazards	Poor Conditions
Parapets: Unreinforced Around Entire Building	None
Unreinforced Chimneys	None
None	None

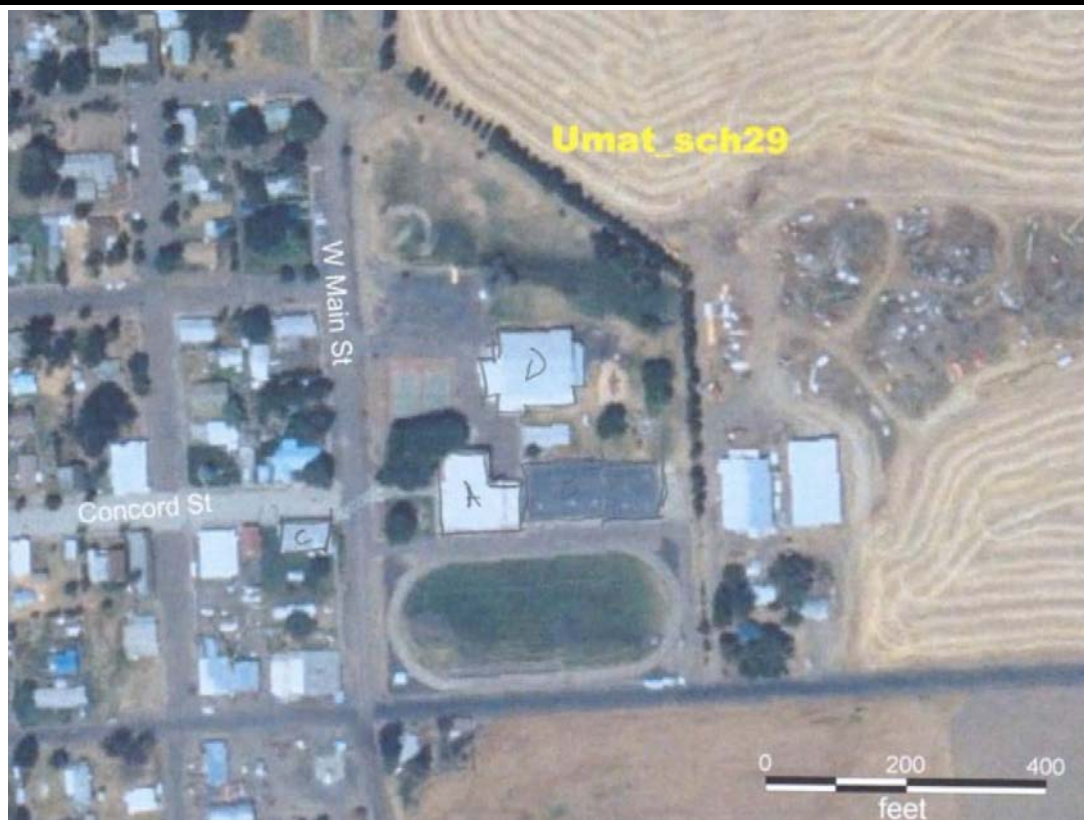
Type	Basic Score	Vert Irreg	Plan Irreg	Pre-Code	Post-Bench	Soil C	Soil D	Soil E	RVS Score
Primary	RM1	3.6	-2	-0.5	0	0	-0.8	0	0	0.3
Secondary	W2	4.8	-3	-0.5	0	0	-0.8	0	0	0.5
Tertiary		0	0	0	0	0	0	0	0	0

0.3

High (>10%)

Plan Irregularities	Vertical Irregularities
Reentrant Corners: Other	Steps in Elevation View: Single Change
Reentrant Corners: U shaped	Steps in Elevation View: Single Change (Adjacent Building/Entity)
None	None
