Union High School

Unio_sch05A

Rapid Visual Screening - Senate Bill #2 - Seismic Needs Assessment
Oregon Department of Geology and Mineral Industries

Unio_sch05B

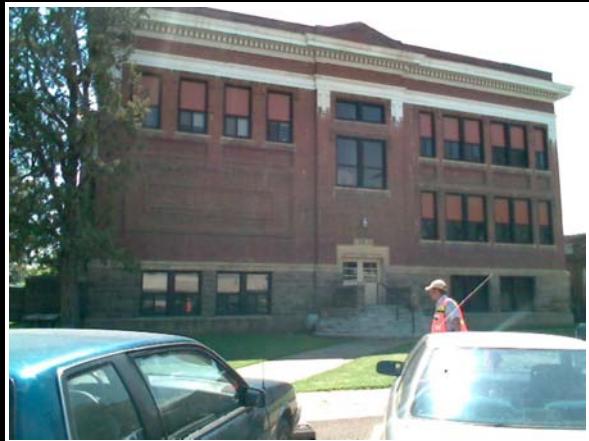
| | Type | Basic Score | Vert Irreg | Plan Irreg | Pre-Code | Post-Bench | Soil C | Soil D | Soil E | RVS Score |
|---|---|---|---|---|---|---|---|---|---|---|
| Primary | URM | 3.4 | -1.5 | -0.5 | -0.4 | 0 | -0.4 | 0 | 0 | 0.6 |

| Final Type | Final Score |
|---|---|
| URM | 0.6 |

High (>10%)

| Out of Plane Lateral-Force-Resistance Elements | | Steps in Elevation View: Single Change (Adjacent Building/Entity) | | | |
| Other: Ornamental Hazard Over Exit | | None | | | |
| Other: Heavy cornice or other overhead decoration | | None | | | |
| Parapets: Unreinforced Around Entire Building | | None | | | |

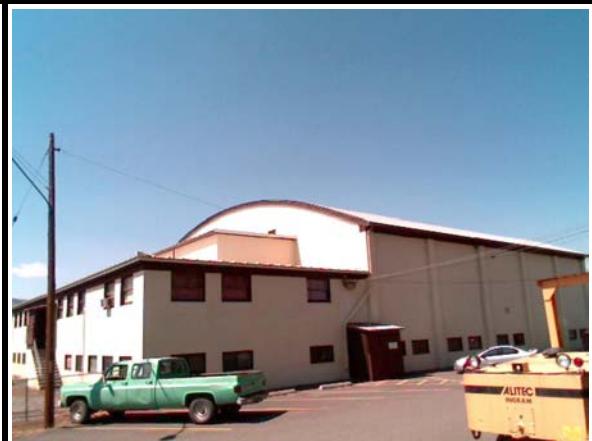
| | Type | Basic Score | Vert Irreg | Plan Irreg | Pre-Code | Post-Bench | Soil C | Soil D | Soil E | RVS Score |
|---|---|---|---|---|---|---|---|---|---|---|
| Primary | C2 | 3.6 | -2 | -0.5 | -0.4 | 0 | -0.8 | 0 | 0 | -0.1 |
| Secondary | RM1 | 3.6 | -2 | -0.5 | -0.4 | 0 | -0.8 | 0 | 0 | -0.1 |

| Final Type | Final Score |
|---|---|
| C2 | -0.1 |

Very High (100%)

| Falling Hazards Other: Heavy cornice or other overhead decoration None None | | Poor Conditions None None None | |
