TVF & R - Station 68 Oak Hills (House)

FEMA 154 Rapid Visual Screening Score Card

Rapid Visual Screening - Senate Bill #2 - Seismic Needs Assessment
Oregon Department of Geology and Mineral Industries

TVF & R - Station 68 Oak Hills (Apparatus)

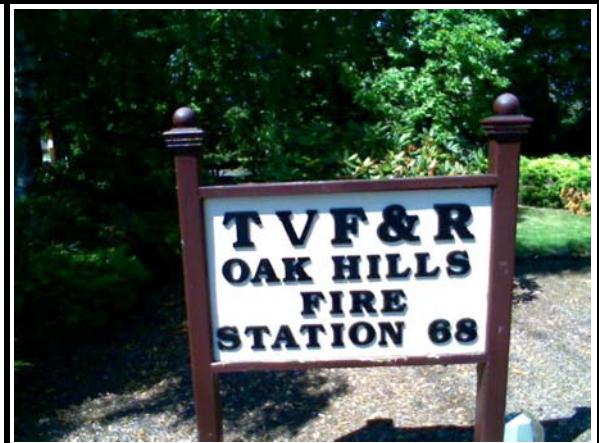
Seismicity Zone: High

Type	Basic Score	Vert Irreg	Plan Irreg	Pre-Code	Post-Bench	Soil C	Soil D	Soil E	RVS Score
Primary	W1	4.4	0	0	0	0	0	0	0	4.4
Secondary		0	0	0	0	0	0	0	0	0
Tertiary		0	0	0	0	0	0	0	0	0

Final Type	Final Score
W1	4.4

Low (<1%)

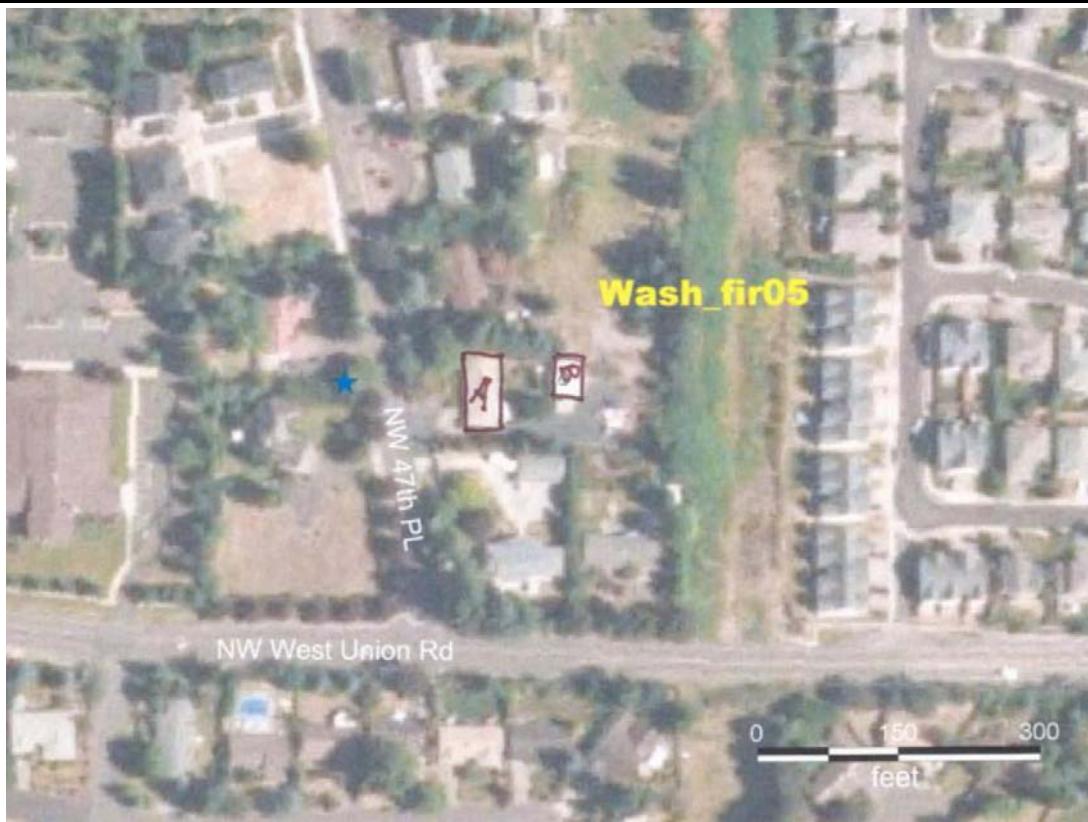
Enrollment	Year Built (Field Verified)	Year Built (Alt. Source)	Est. Decade Built
		1970	1970
Total Area (square ft)	Number of Stories	Basement	Pounding Potential
2328	1	No	No
Plan Irregularities		Vertical Irregularities	
None		None	
None		None	
None		None	
Falling Hazards		Poor Conditions	
Unreinforced Chimneys		None	
None		None	
Other: Ornamental Hazard Over Exit		None

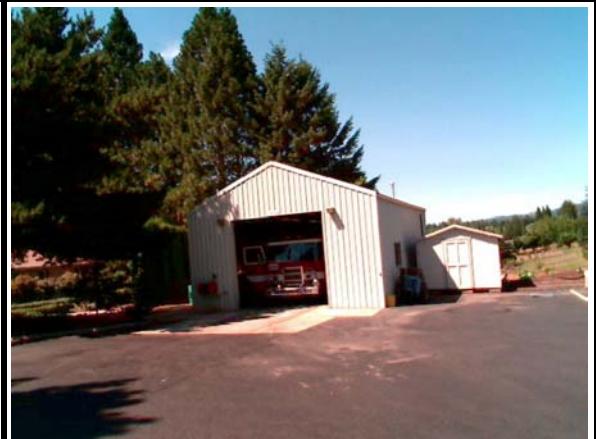
Seismicity Zone: High

Type	Basic Score	Vert Irreg	Plan Irreg	Pre-Code	Post-Bench	Soil C	Soil D	Soil E	RVS Score
Primary	S3	3.2	0	0	0	0	-0.4	0	0	2.8
Secondary		0	0	0	0	0	0	0	0	0
Tertiary		0	0	0	0	0	0	0	0	0

Final Type	Final Score
S3	2.8

Low (<1%)

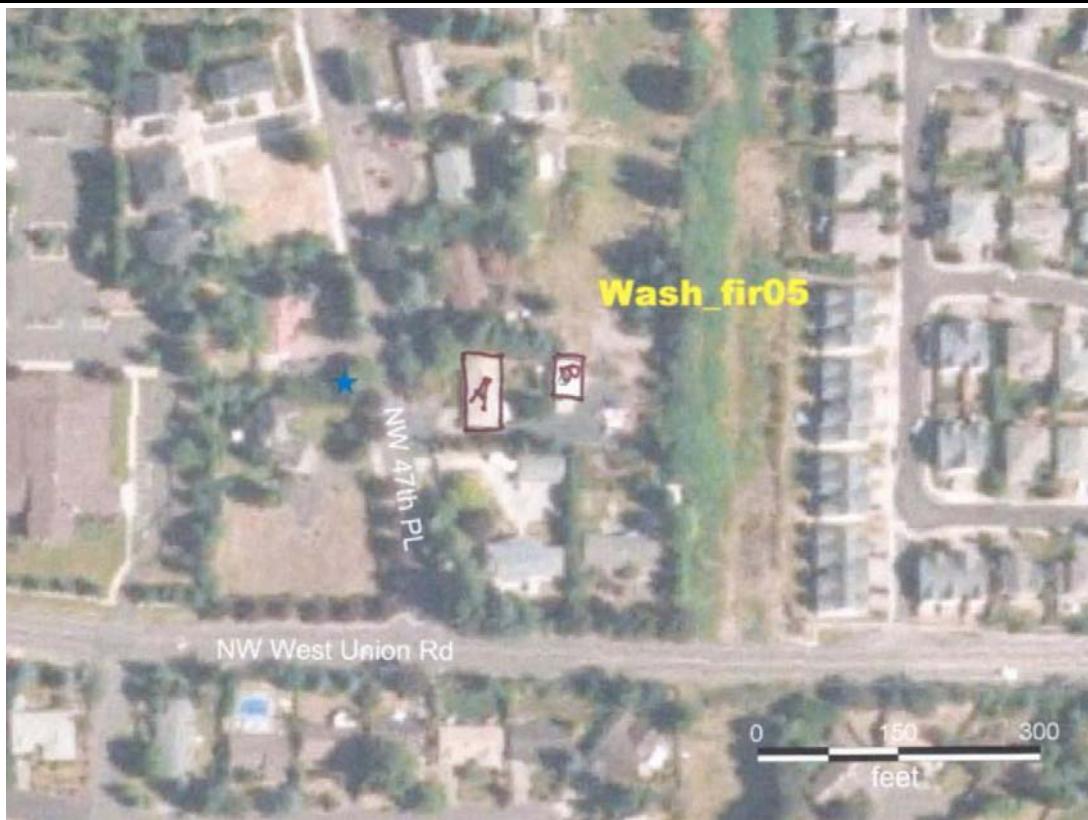
Enrollment	Year Built (Field Verified)	Year Built (Alt. Source)	Est. Decade Built
		1970	1970
Total Area (square ft)	Number of Stories	Basement	Pounding Potential
882	1	No	No
Plan Irregularities		Vertical Irregularities	
None		None	
None		None	
None		None	
Falling Hazards		Poor Conditions	
None		None	
None		None	
None		None
