Gaston RFPD

Wash_fir20A

| Tracking Code RVS in 2006 | Inspection Date 7/6/2006 | |

FEMA 154 Rapid Visual Screening Score Card

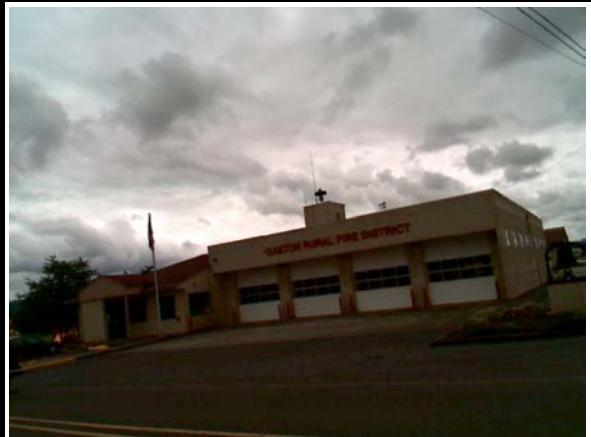
Seismicity Zone: High

| | Type | Basic Score | Vert Irreg | Plan Irreg | Pre-Code | Post-Bench | Soil C | Soil D | Soil E | RVS Score |
|---|---|---|---|---|---|---|---|---|---|---|
| Primary | RM1 | 2.8 | -1 | 0 | 0 | 0 | -0.4 | 0 | 0 | 1.4 |

Final RVS Score

| Final Type | Final Score |
|---|---|
| RM1 | 1.4 |

FEMA-154 Collapse Potential

Moderate (>1%)

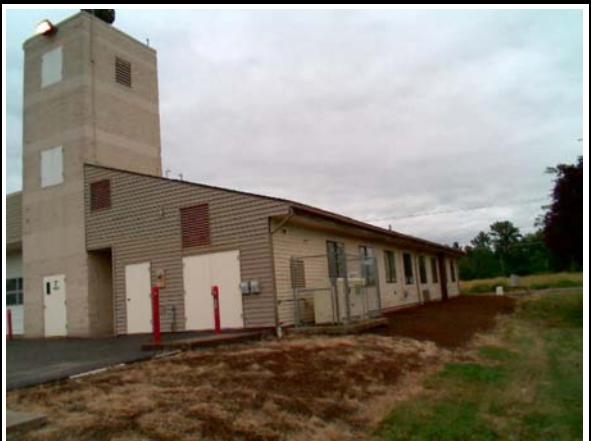
Seismicity Zone: High

| | Type | Basic Score | Vert Irreg | Plan Irreg | Pre-Code | Post-Bench | Soil C | Soil D | Soil E | RVS Score |
|---|---|---|---|---|---|---|---|---|---|---|
| Primary | W1 | 4.4 | 0 | 0 | 0 | 2.4 | 0 | 0 | 0 | 6.8 |

| Final Type | Final Score |
|---|---|
| W1 | 6.8 |

FEMA-154 Collapse Potential

Low (<1%)
