Washington County RFPD 2

| 31370 Nw Commercial St | | |

FEMA 154 Rapid Visual Screening Score Card

Rapid Visual Screening - Senate Bill #2 - Seismic Needs Assessment
Oregon Department of Geology and Mineral Industries

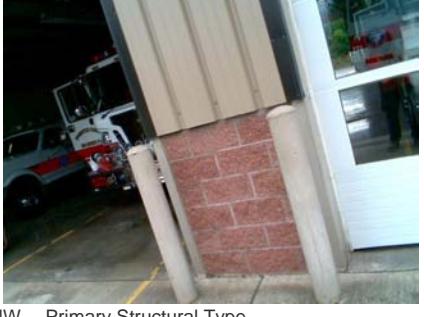
| NW Elevation View | NW Primary Structural Type front side of doors | SE Primary Structural Type steel w-flange column. | |

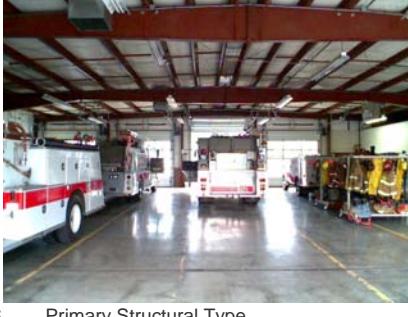
| S Primary Structural Type RM1 does not go to ceiling, and does not appear to connect to steel frame. | SE Primary Structural Type base of column | S Primary Structural Type | |
