Dundee Fire & Rescue

Yamh_fir07A

FEMA 154 Rapid Visual Screening Score Card

Rapid Visual Screening - Senate Bill #2 - Seismic Needs Assessment
Oregon Department of Geology and Mineral Industries

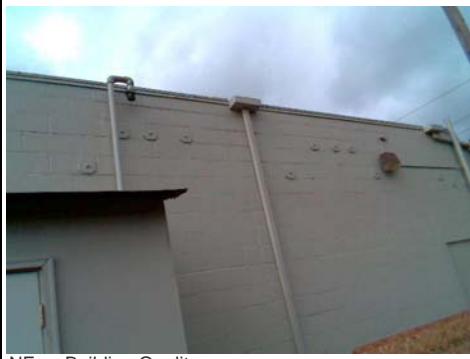
NE Building Quality

There is a steel plate behind the drain pipe that covers a gap where the RM1 wall on the right has p

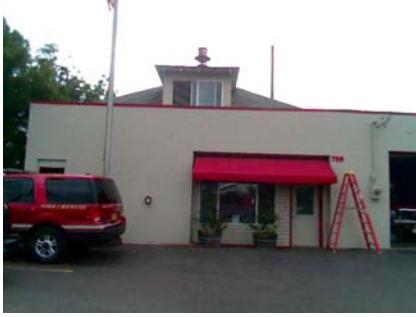
W	Elevation View	N	Falling Hazard RM1 wall infront of bldg
