Dayton High School

Yamh_sch01A

FEMA 154 Rapid Visual Screening Score Card

Rapid Visual Screening - Senate Bill #2 - Seismic Needs Assessment
Oregon Department of Geology and Mineral Industries

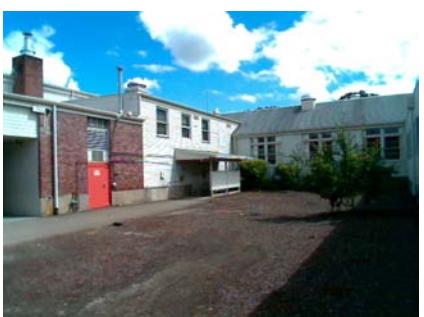
SE Falling Hazard	W Elevation View	N Elevation View

Enrollment 345	Year Built (Field Verified) 1963	Year Built (Alt. Source) 1963	Est. Decade Built 1940
Total Area (square ft) 30212	Number of Stories 1	Basement	Pounding Potential Yes
Plan Irregularities Reentrant Corners:Other (Adjacent Build/Entity) Reentrant Corners: U shaped None		Vertical Irregularities Steps in Elevation View: 2 to 3 Changes (Adjacent Building/Entity) None None	
Falling Hazards Other: Heavy cornice or other overhead decoration Other: Brick Veneer None		Poor Conditions None None None

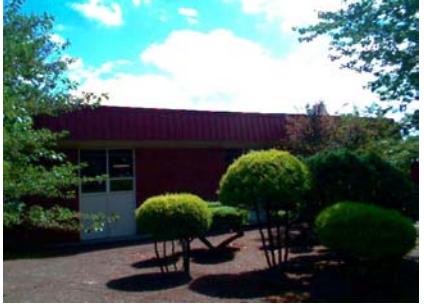
E Pounding Potential Covered walk way on right.		NW Elevation View
