Item G, Attachment 2

Public Comments on Biglow Canyon Windfarm RFA4 and Proposed Order

When Wind Towers Fall Apart

Portland General Electric's (PGE) Biglow Canyon

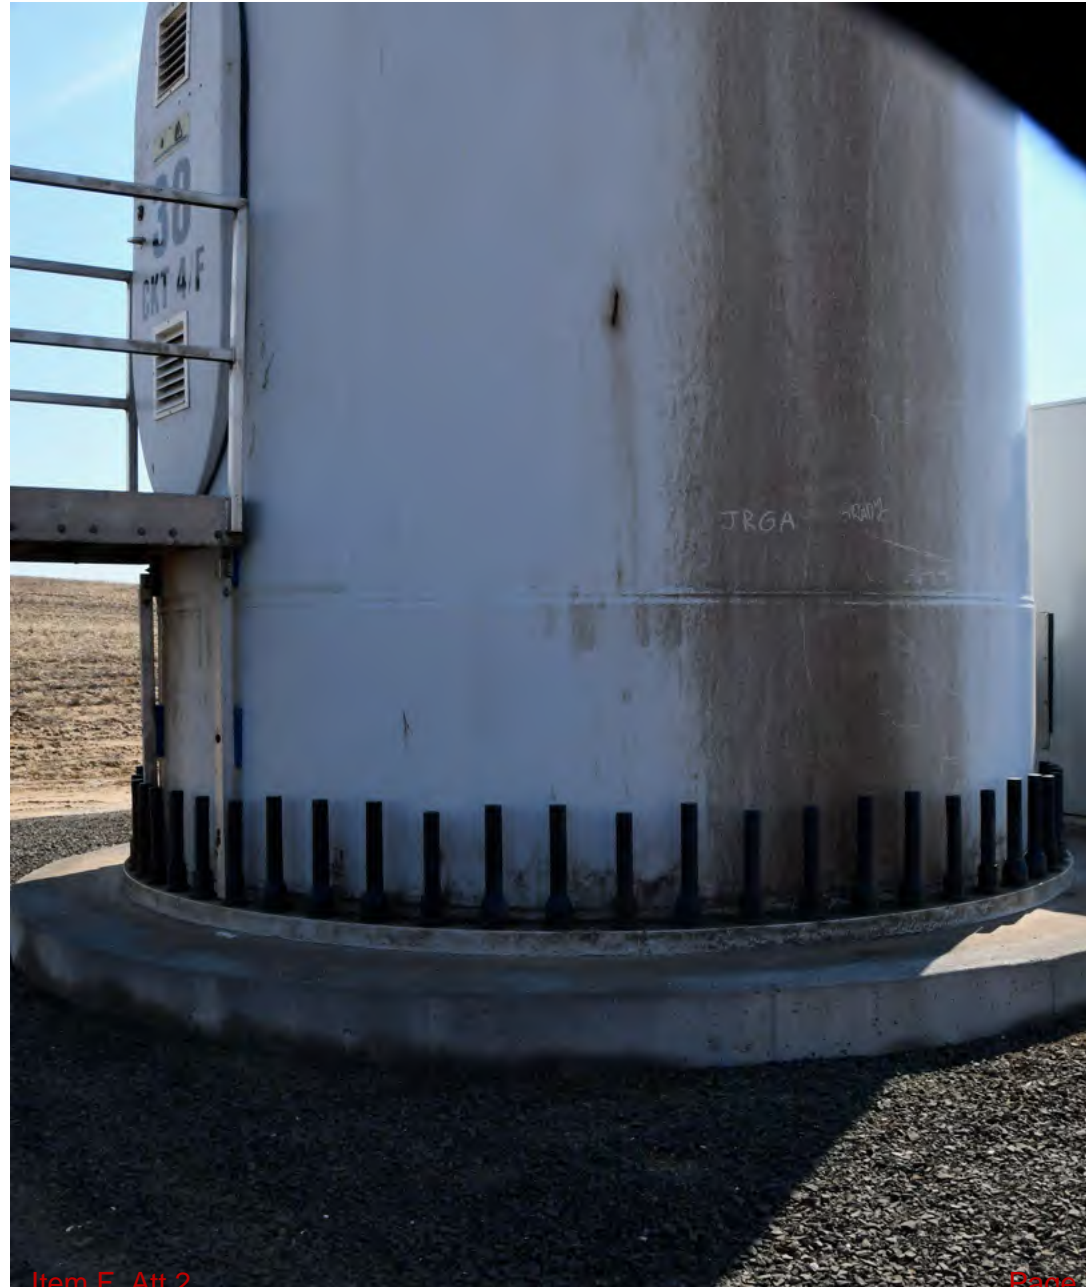
There are 76
Vestas in this
project, and over
half of them are
leaky, oily
messes.

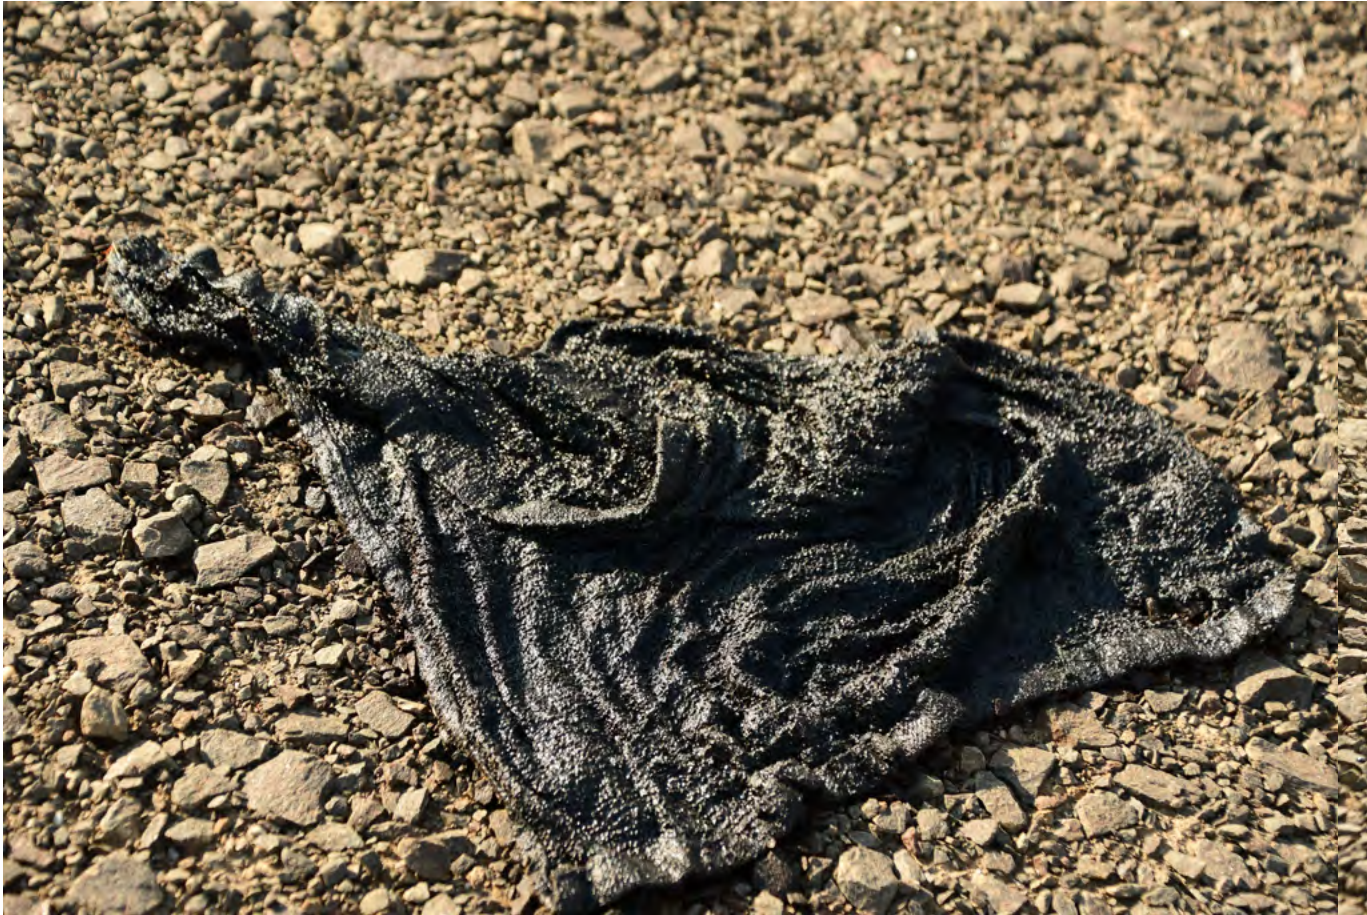
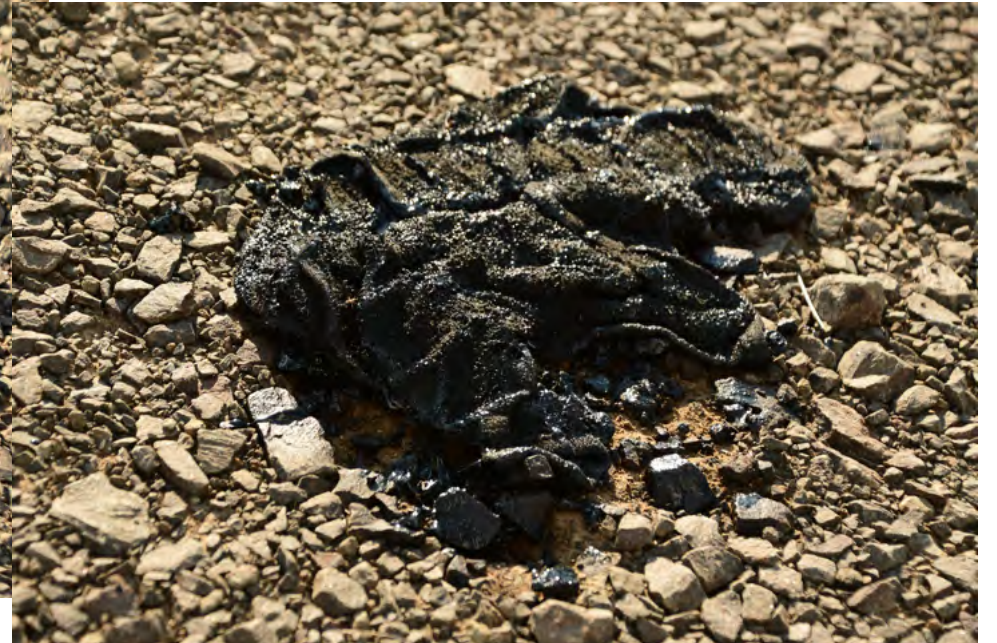
Oily rags show just how dirty it is up there.

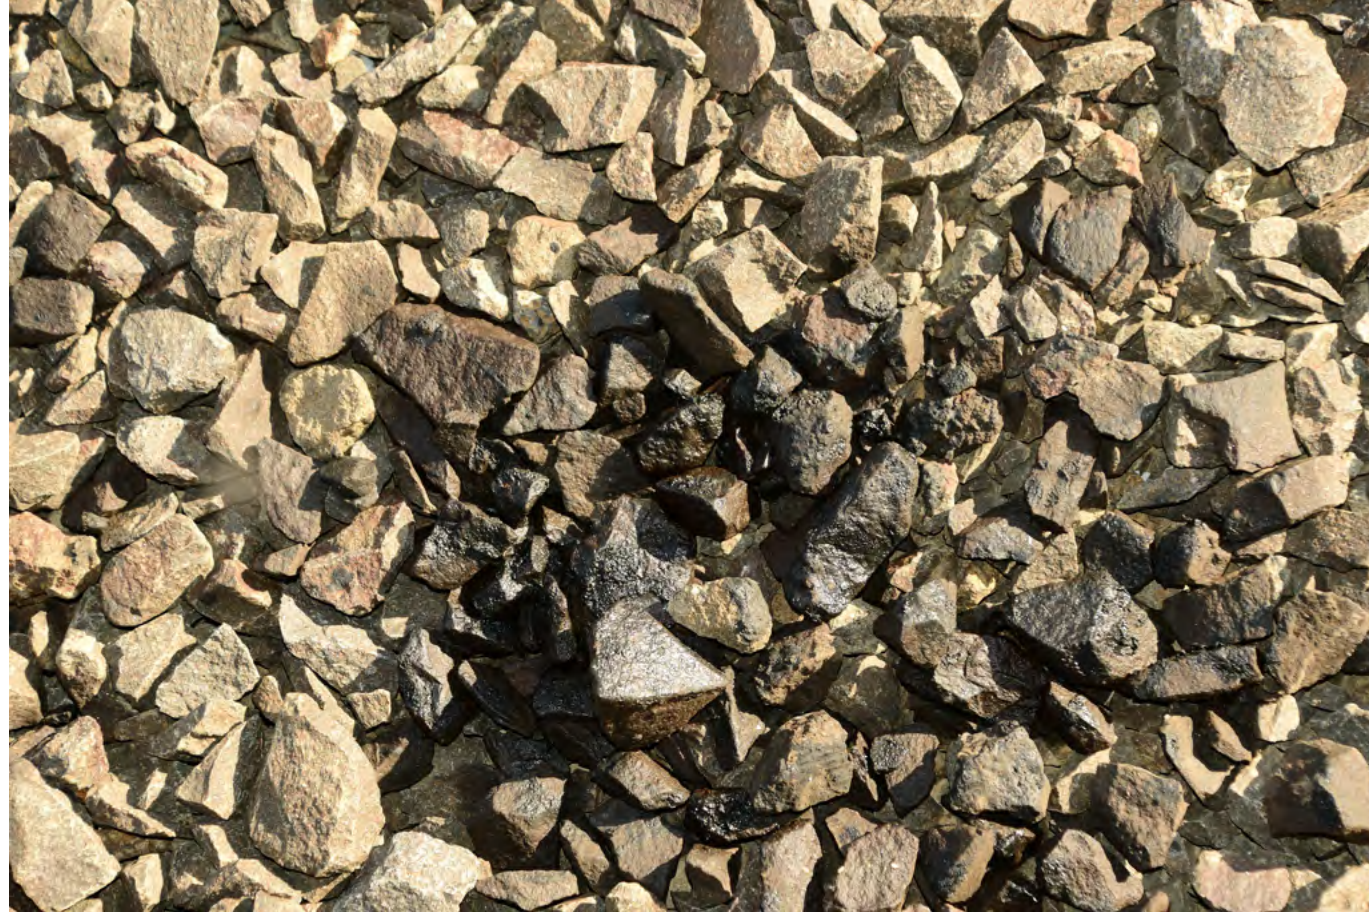
Oil all over the ground.

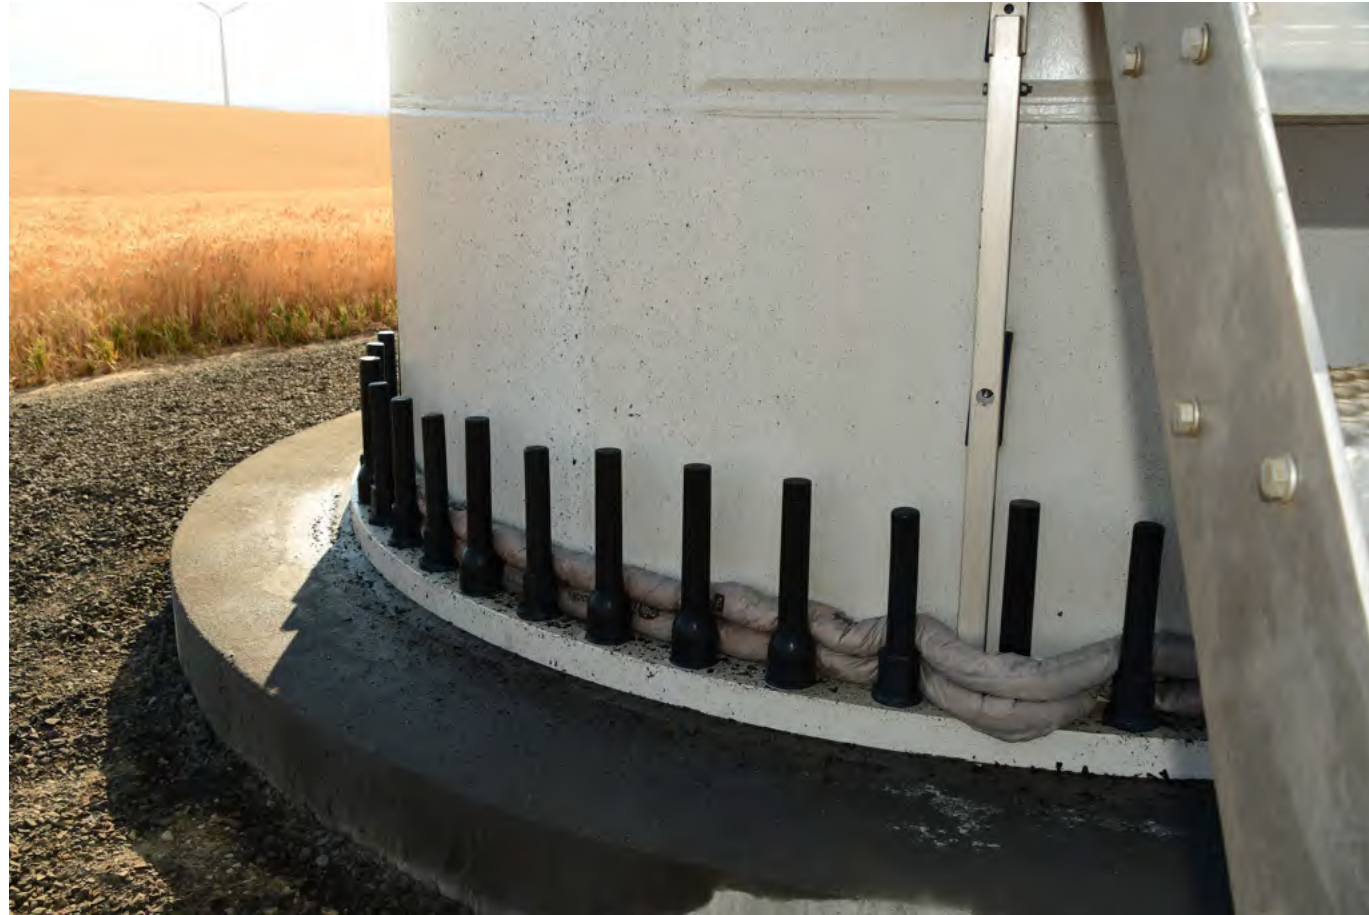
PGE puts oil pads around some of the bases to soak up the excess oil.

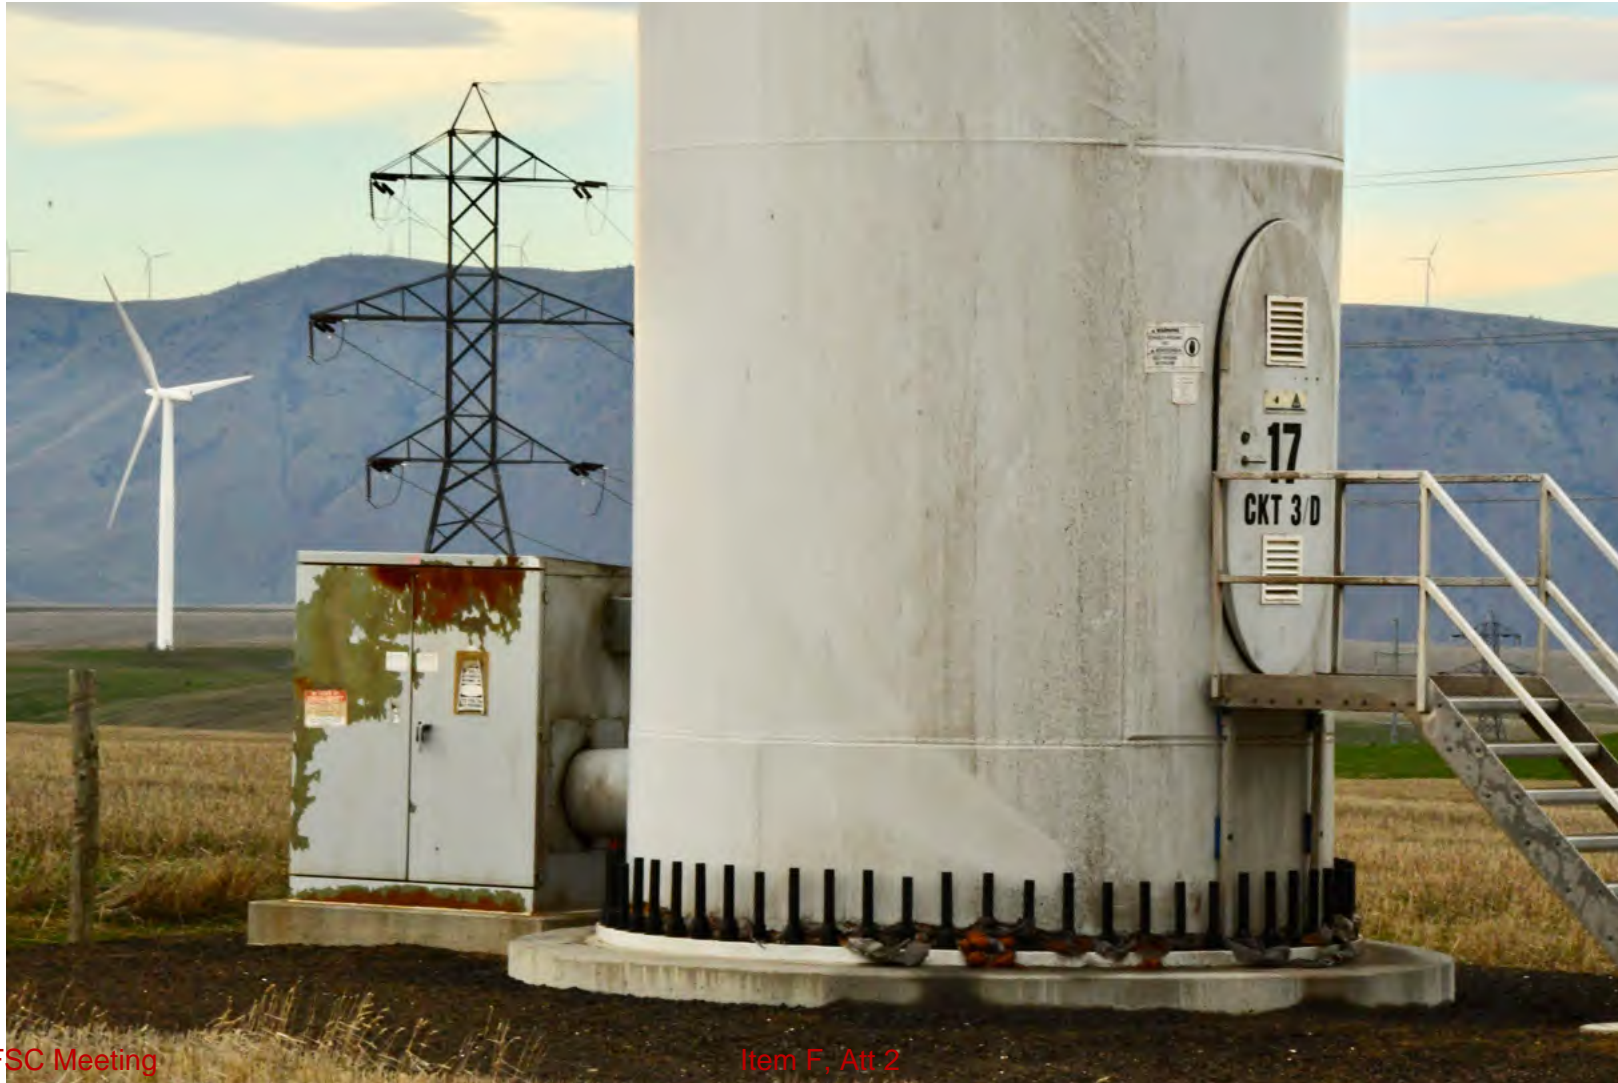
This is one of the "vegetable oil" transformers.
Vegetable oil still has a flashpoint...!

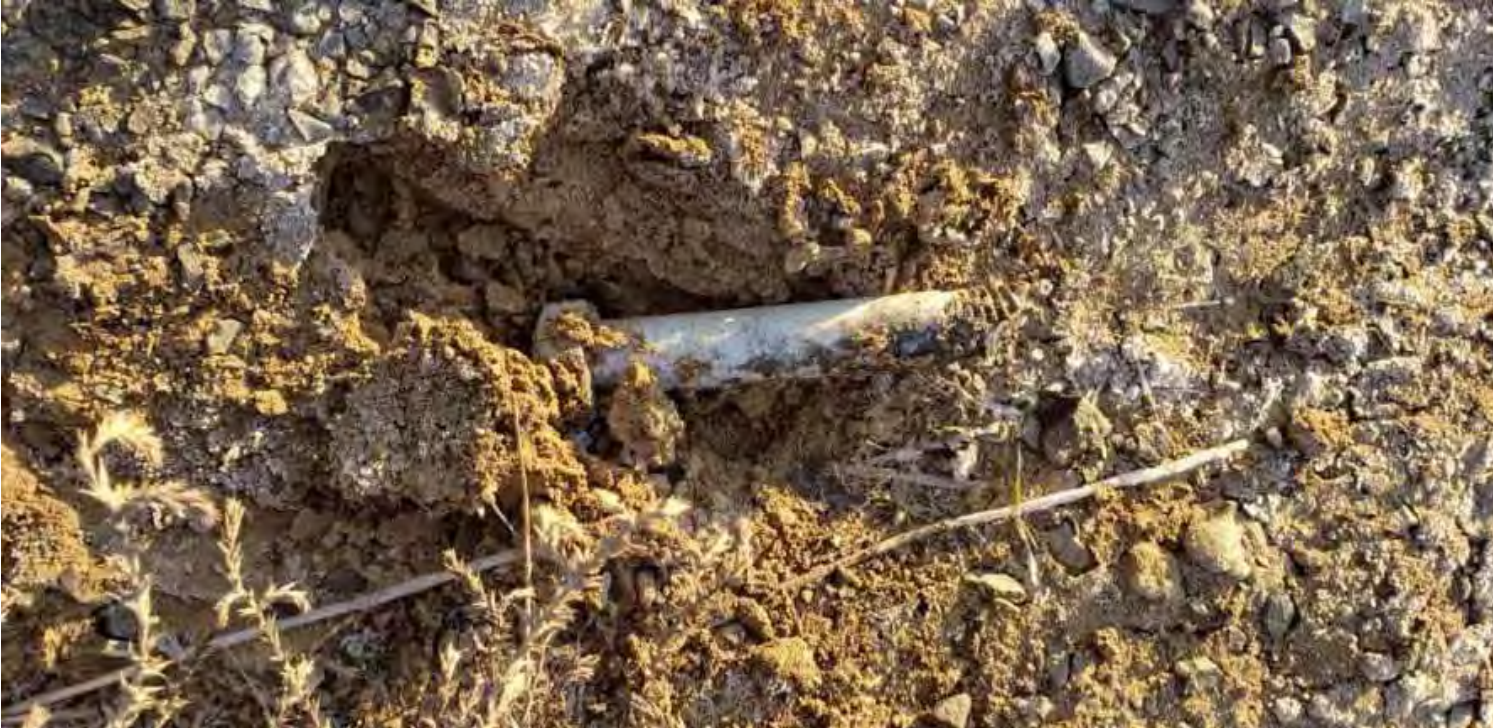
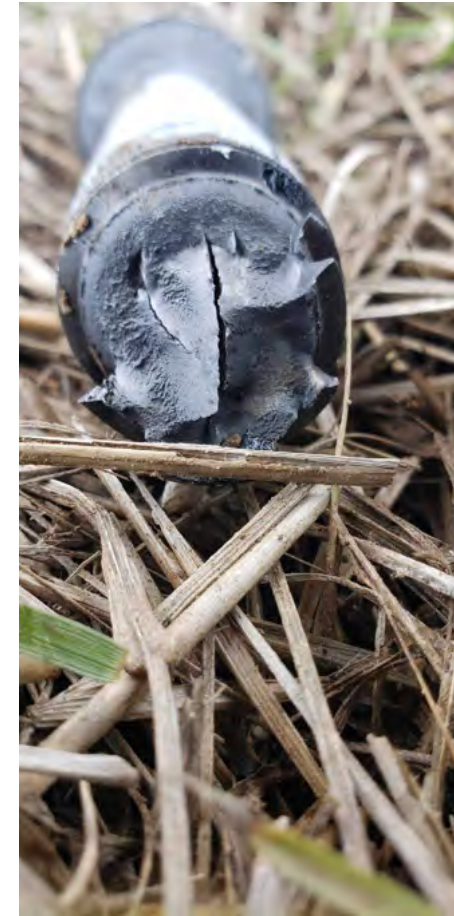
Then the biosolid spreaders and PGE technicians started finding bolts on the ground.
Sheared off.

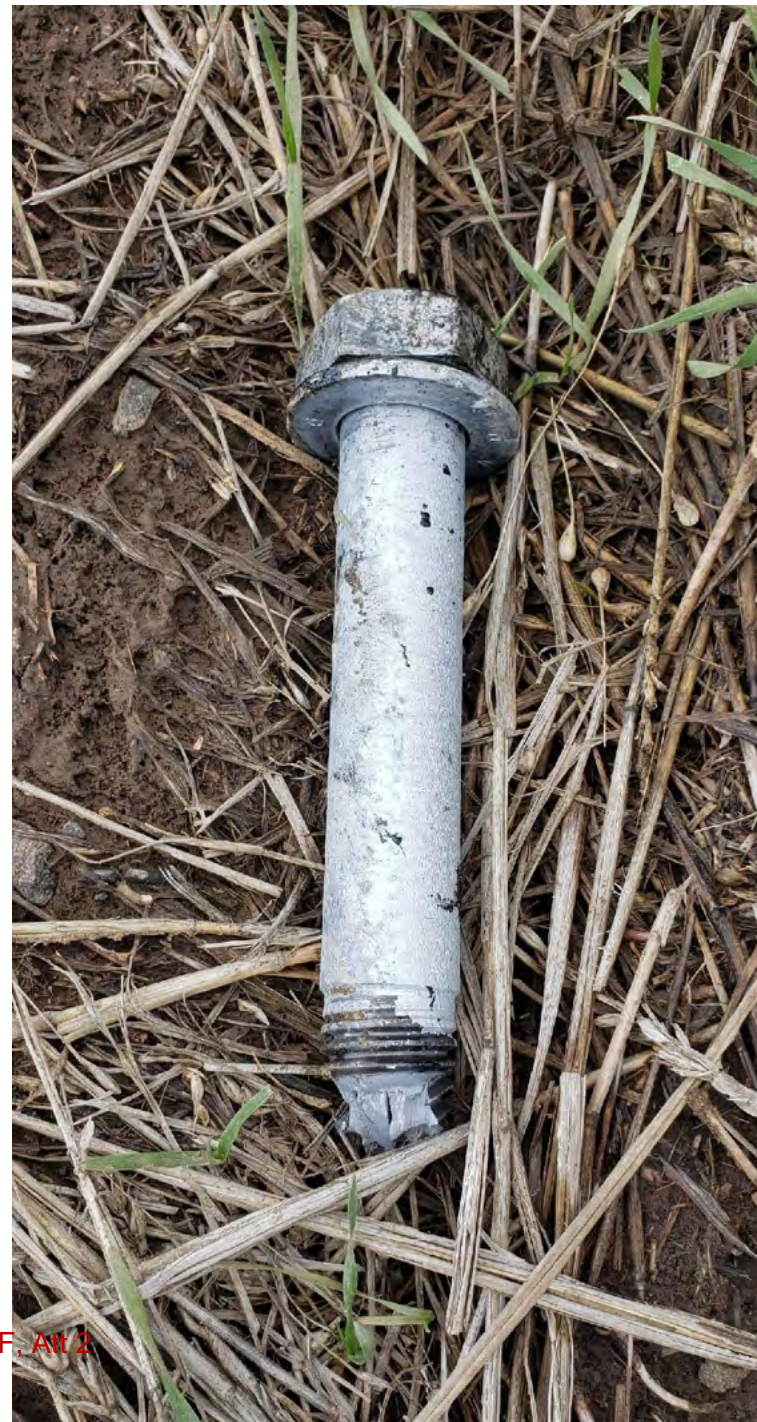
Oregon Department of Energy (ODOE) says anything that falls from 265 feet can be deadly, especially since it can reach a velocity up to 130 feet per second.

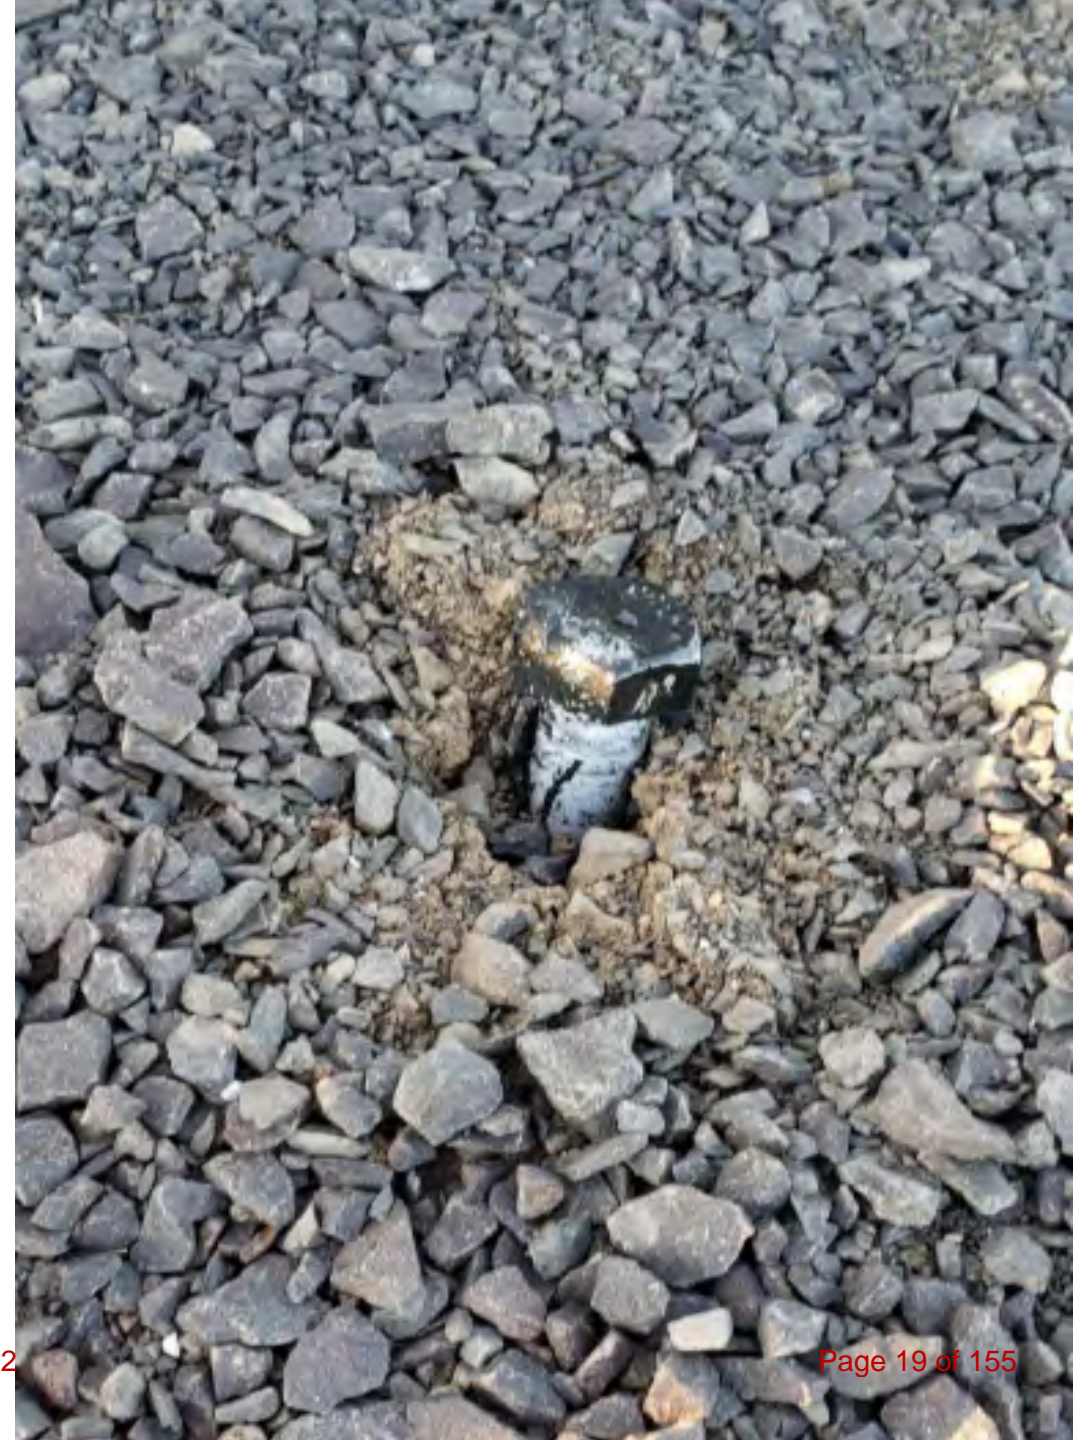
Some of the bolts are almost two feet long.

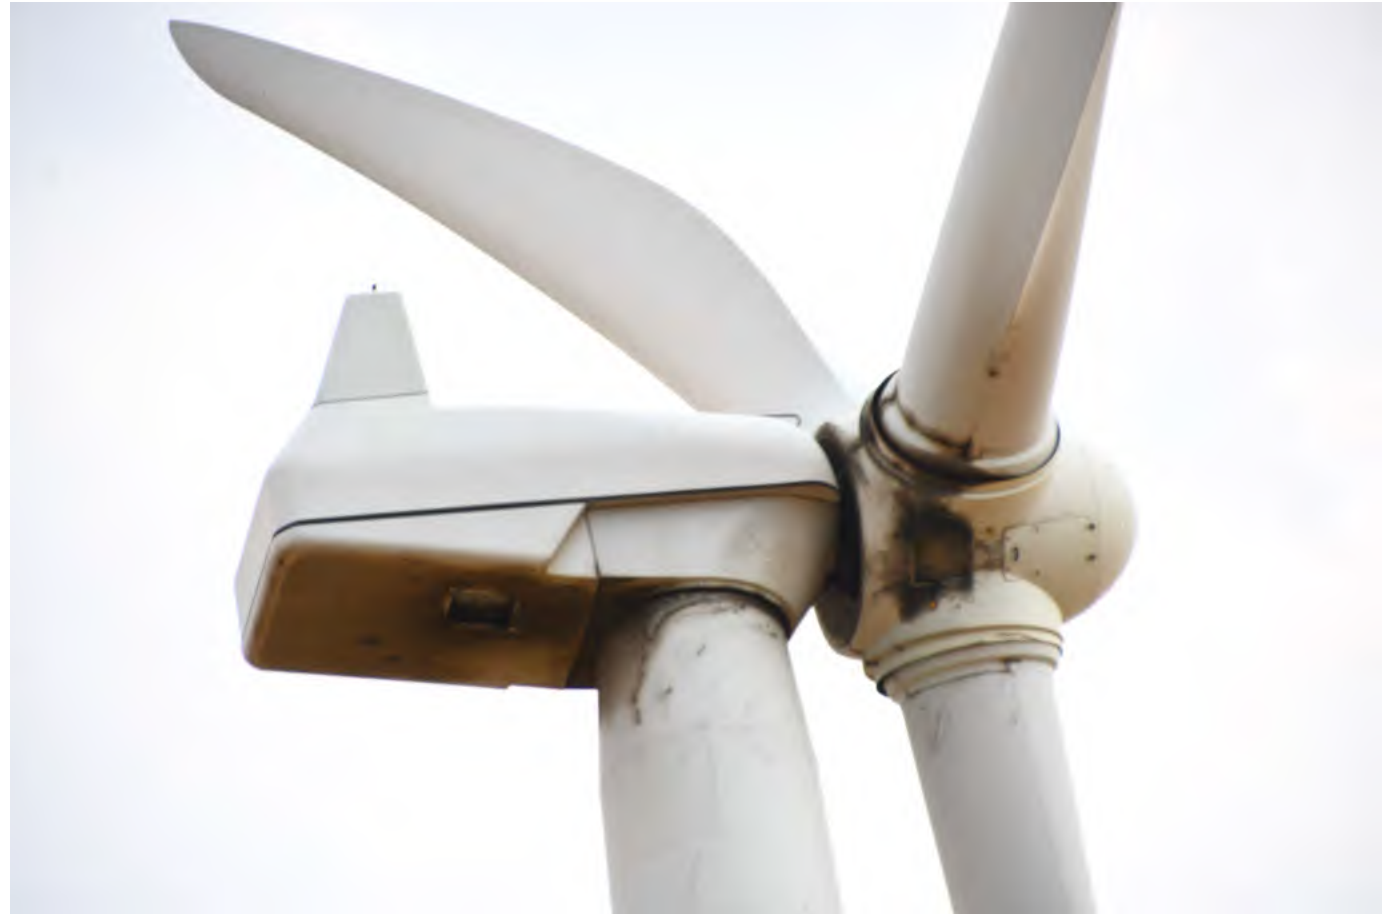
This one is missing a door. In fact, a lot of these towers are missing hatch doors, and the guys find them in our fields "all the time."

(Zoom in, it's hard to see with all the oil).

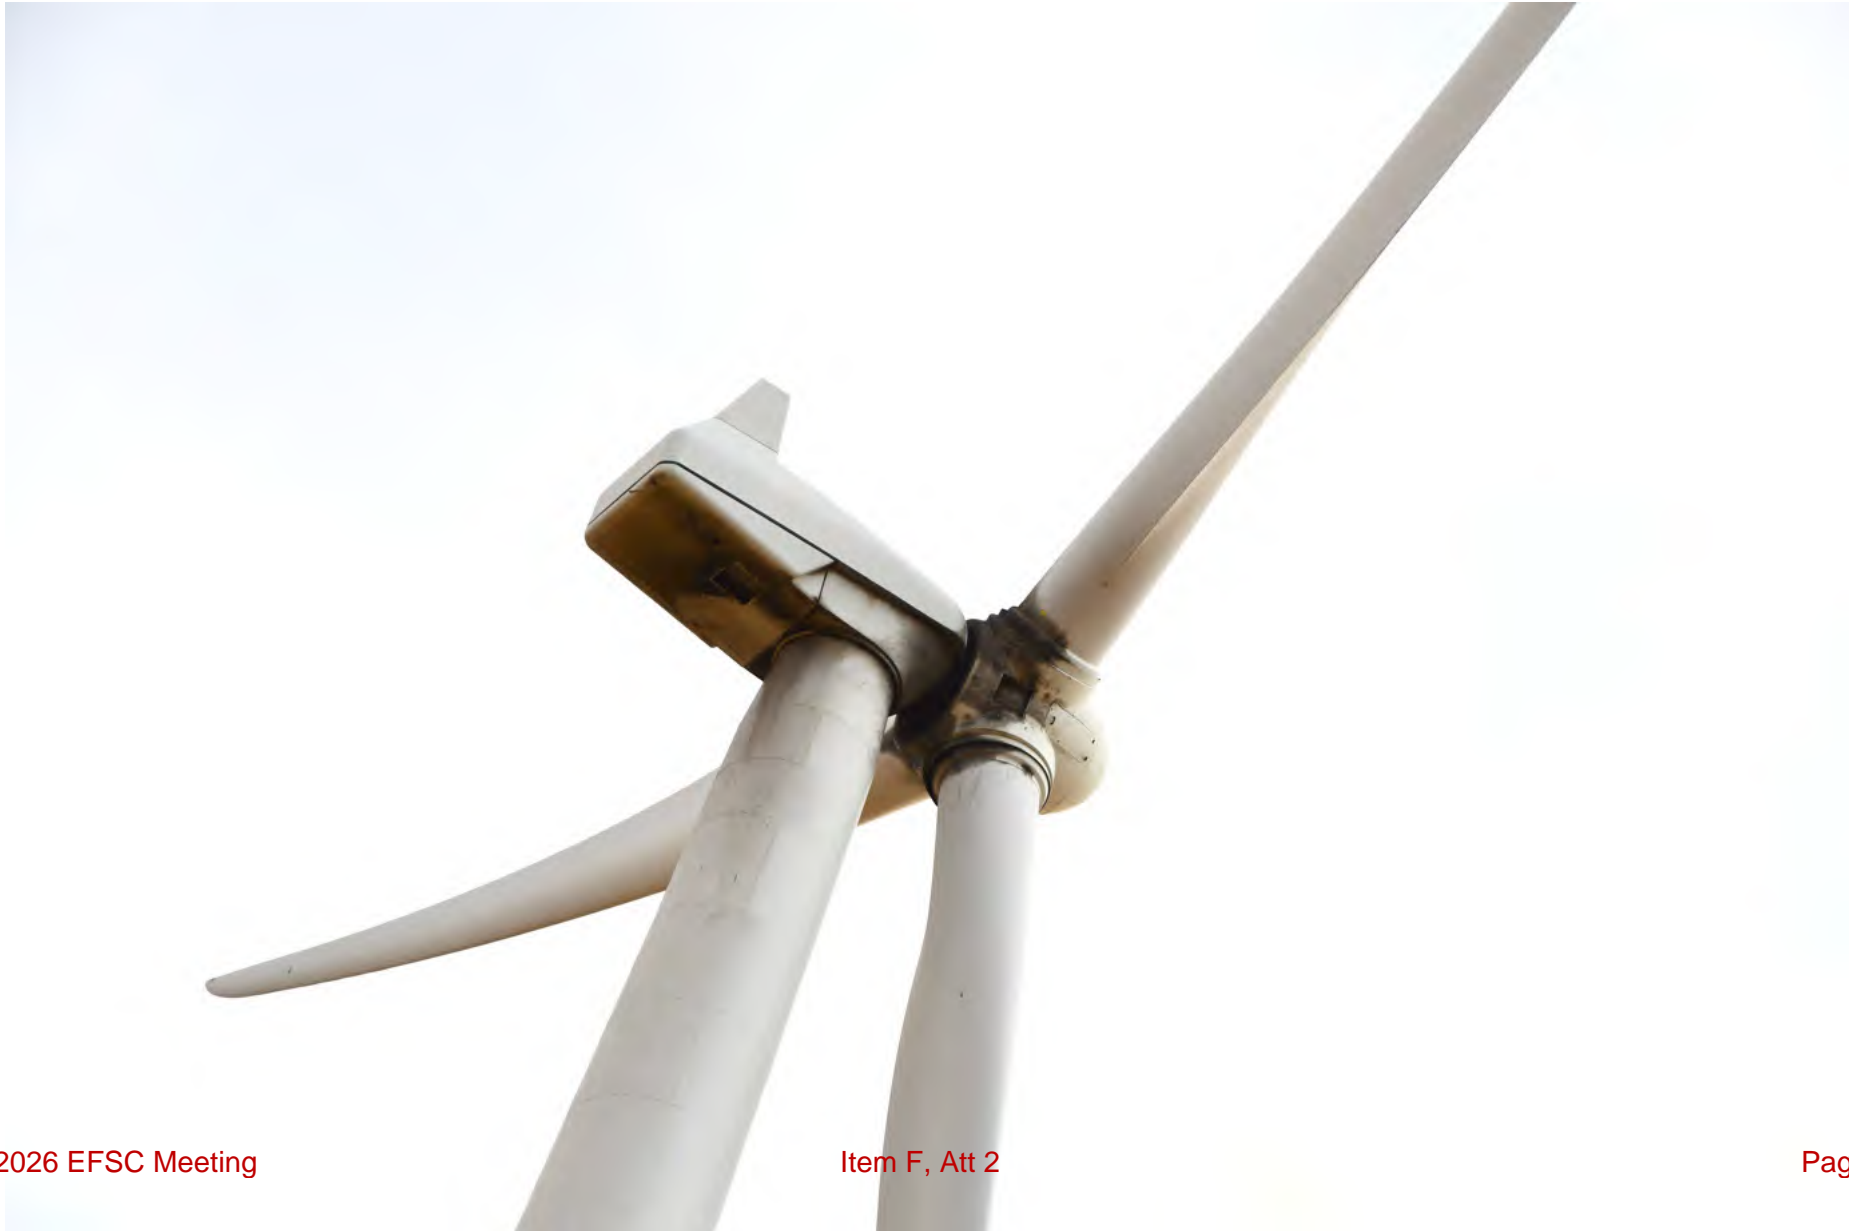
When a tower is this greasy, how can you see a problem?

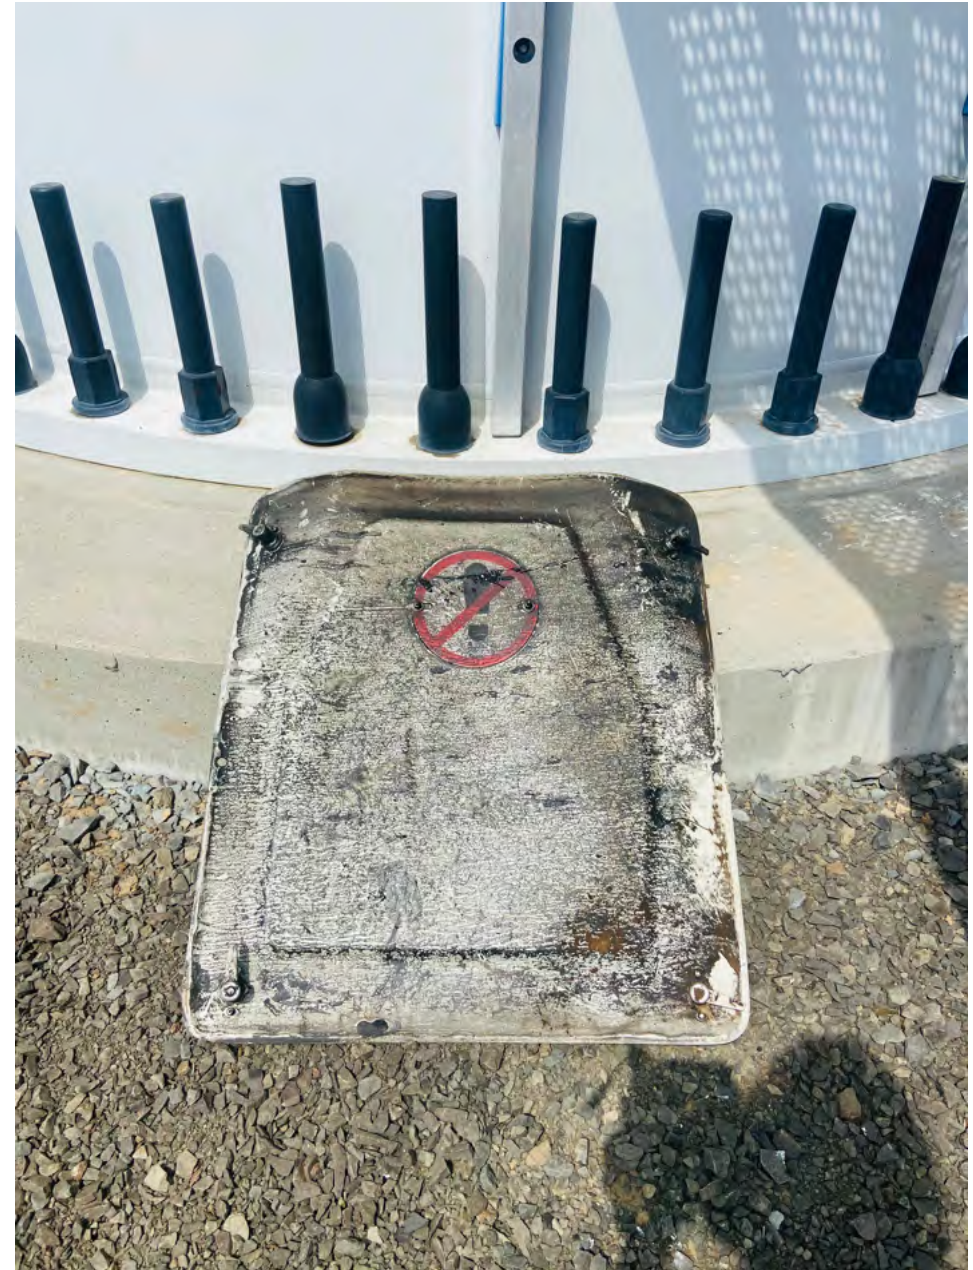
This is a hatch door.
We pick them up out
of the fields and lean
them against the
towers - or take them
over to the PGE
building.

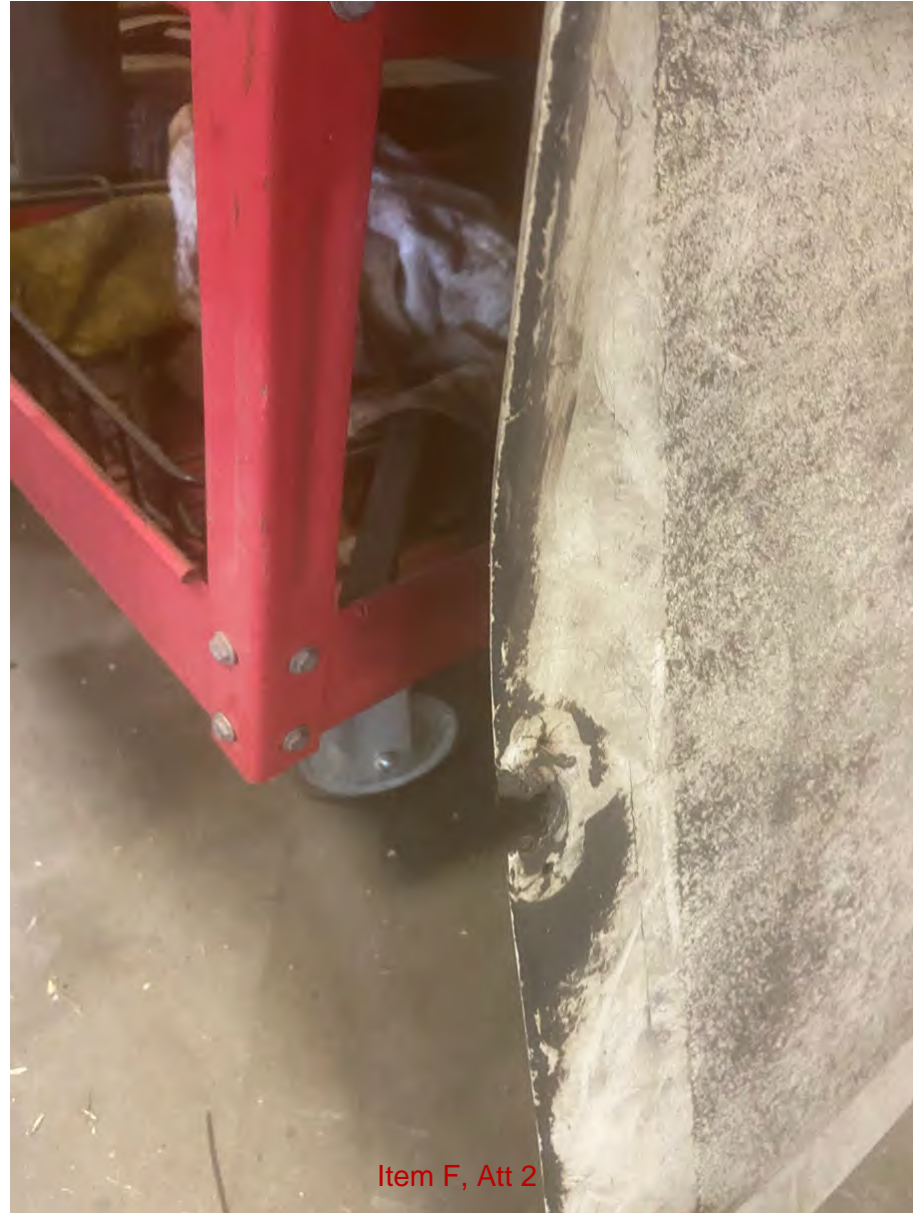
See the hole? You can see where it broke away.

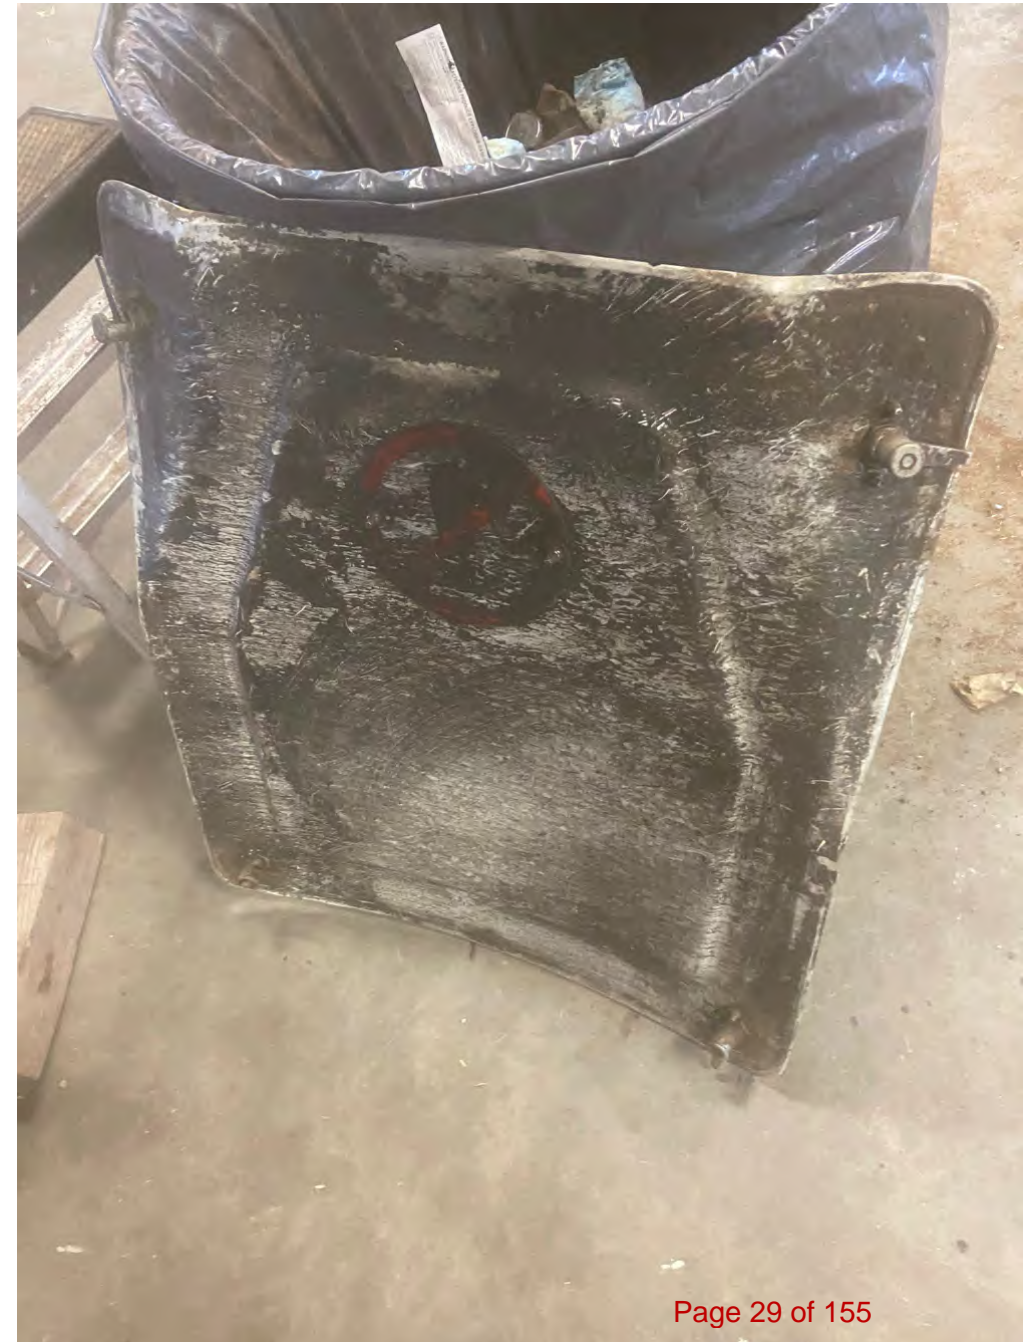
The backside of the door.
Really greasy on the inside,
of course.

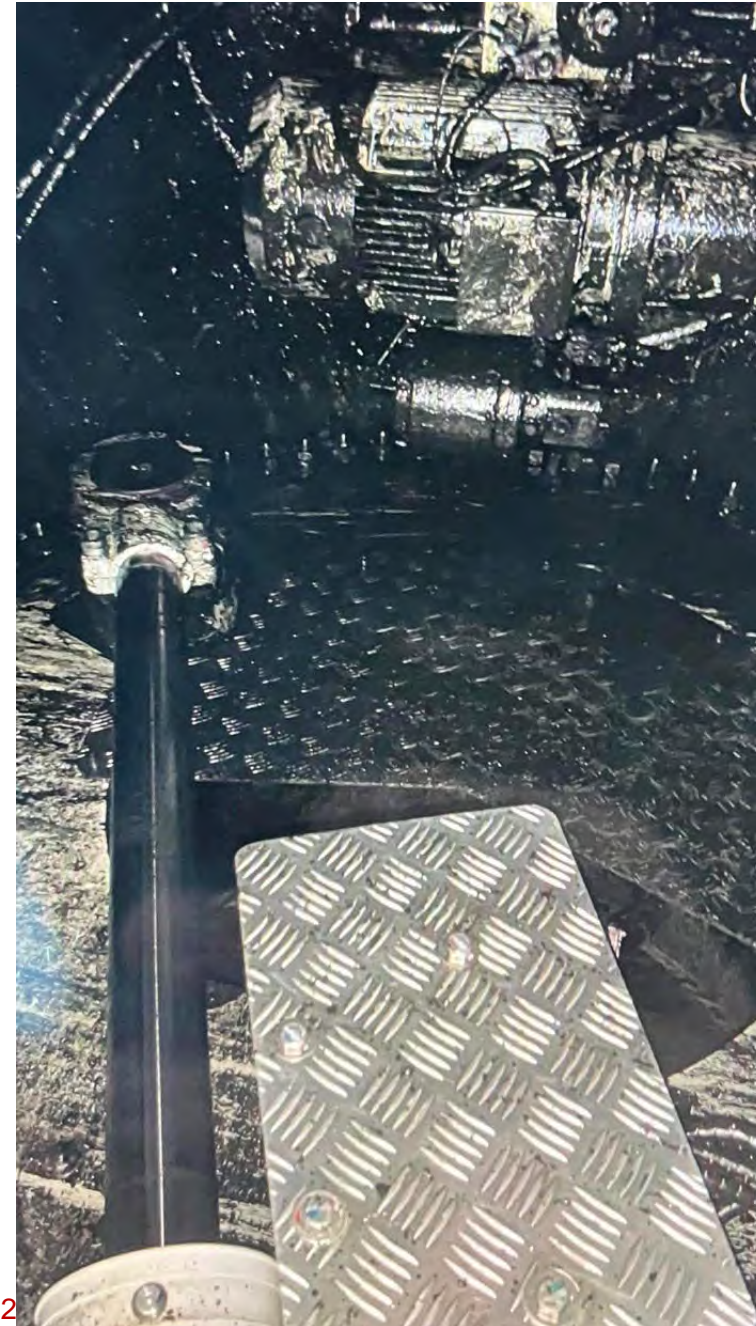
This is what they actually look like in the ones that haven't been cleaned lately.

The trouble is, without fixing the problem, they keep leaking and within a couple weeks they are disgusting again.

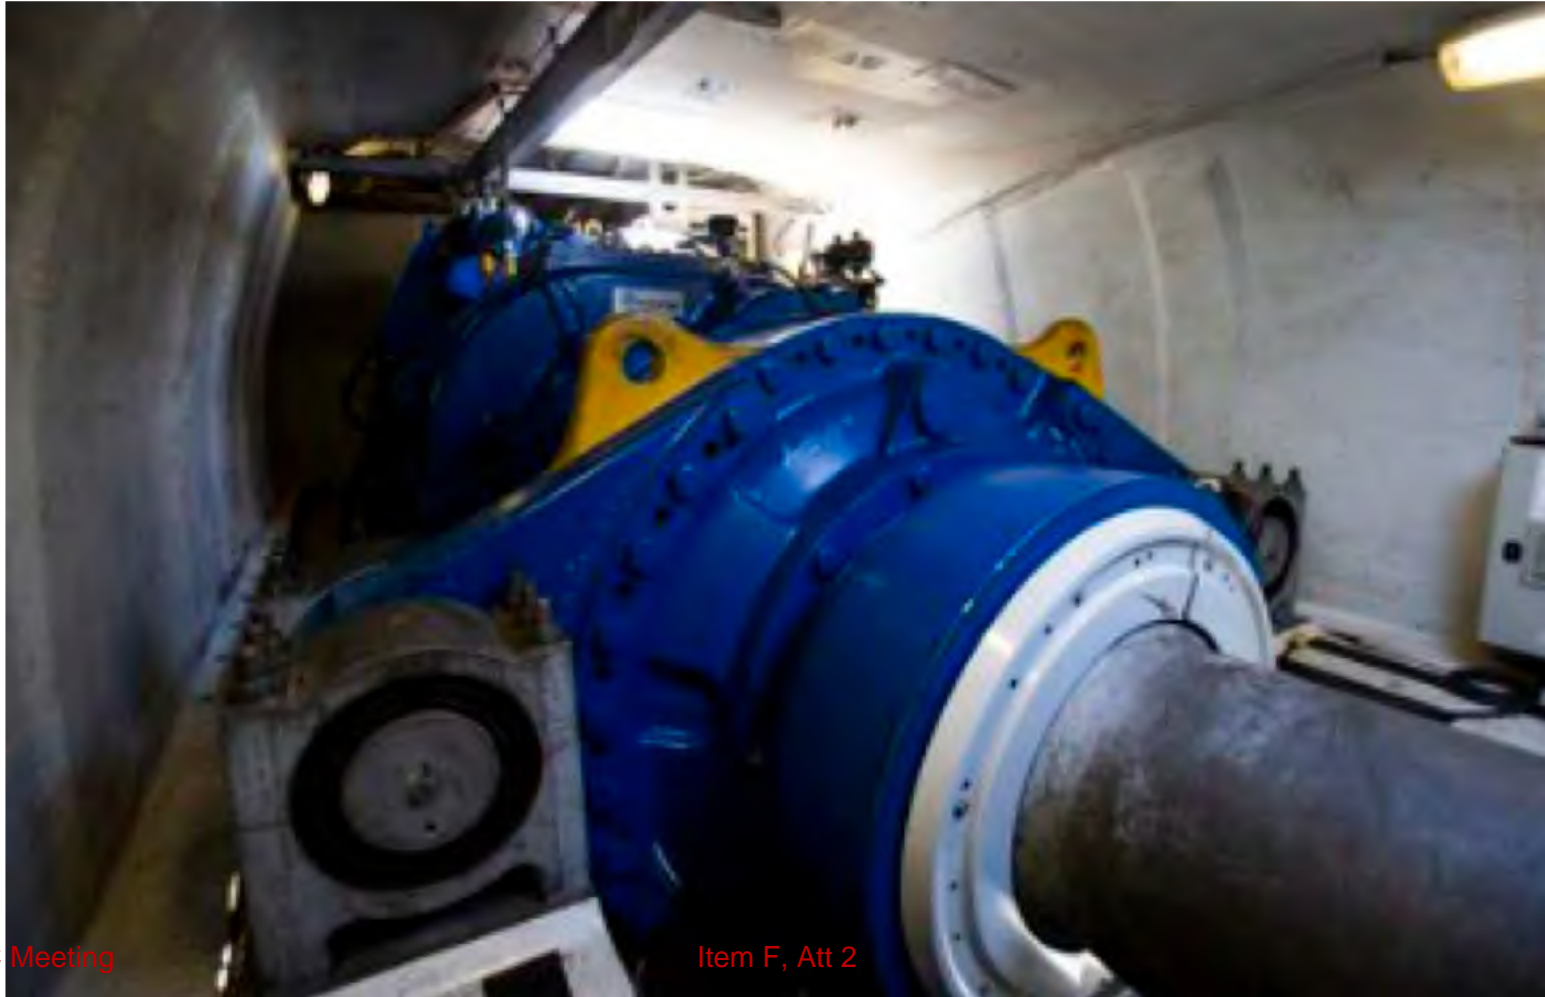
This is a cleaned-up one, and what they should all look like inside.

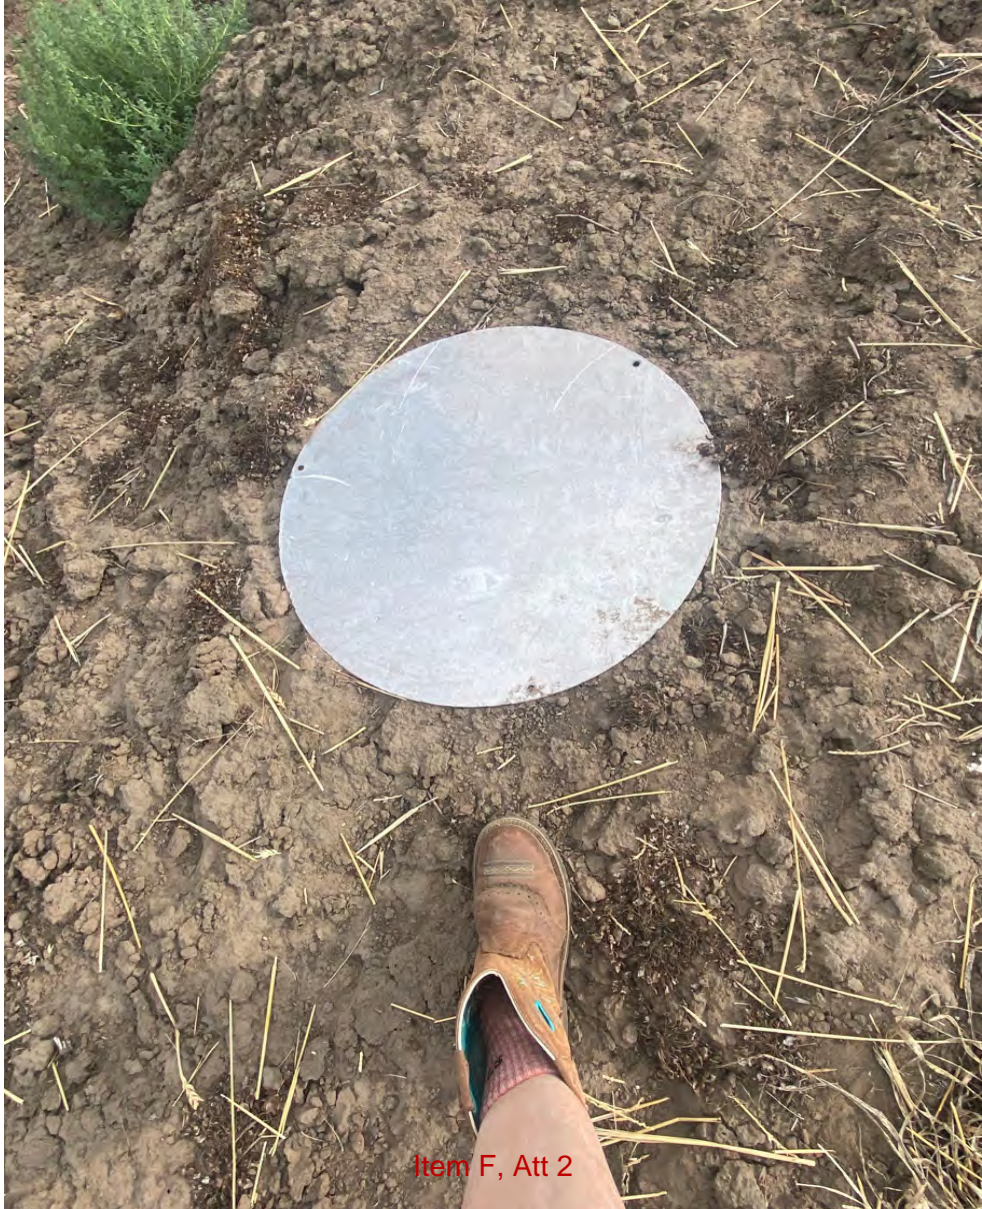
This disk is a big flying saucer that weighs ten pounds.
