Item G, Attachment 2

Public Comments on Biglow Canyon Windfarm RFA4 and Proposed Order

When Wind Towers Fall Apart

Portland General Electric's (PGE) Biglow Canyon

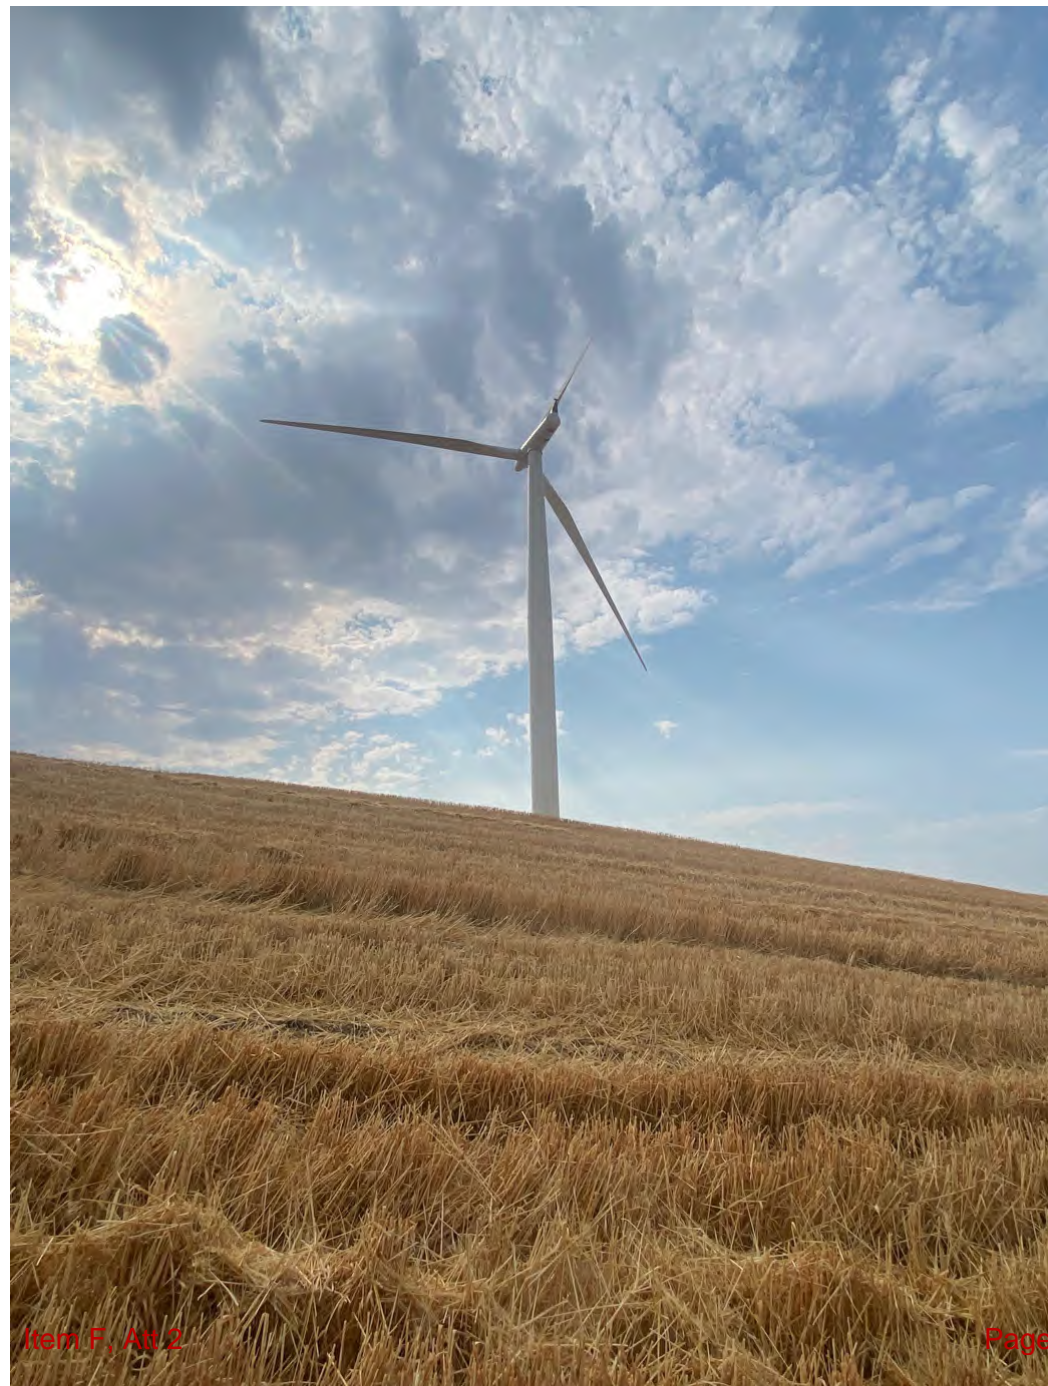
About 100 yards
away in a gully
the guys found
a disk from a
Siemens tower.

So it isn't just the
Vestas that have
maintenance
issues.

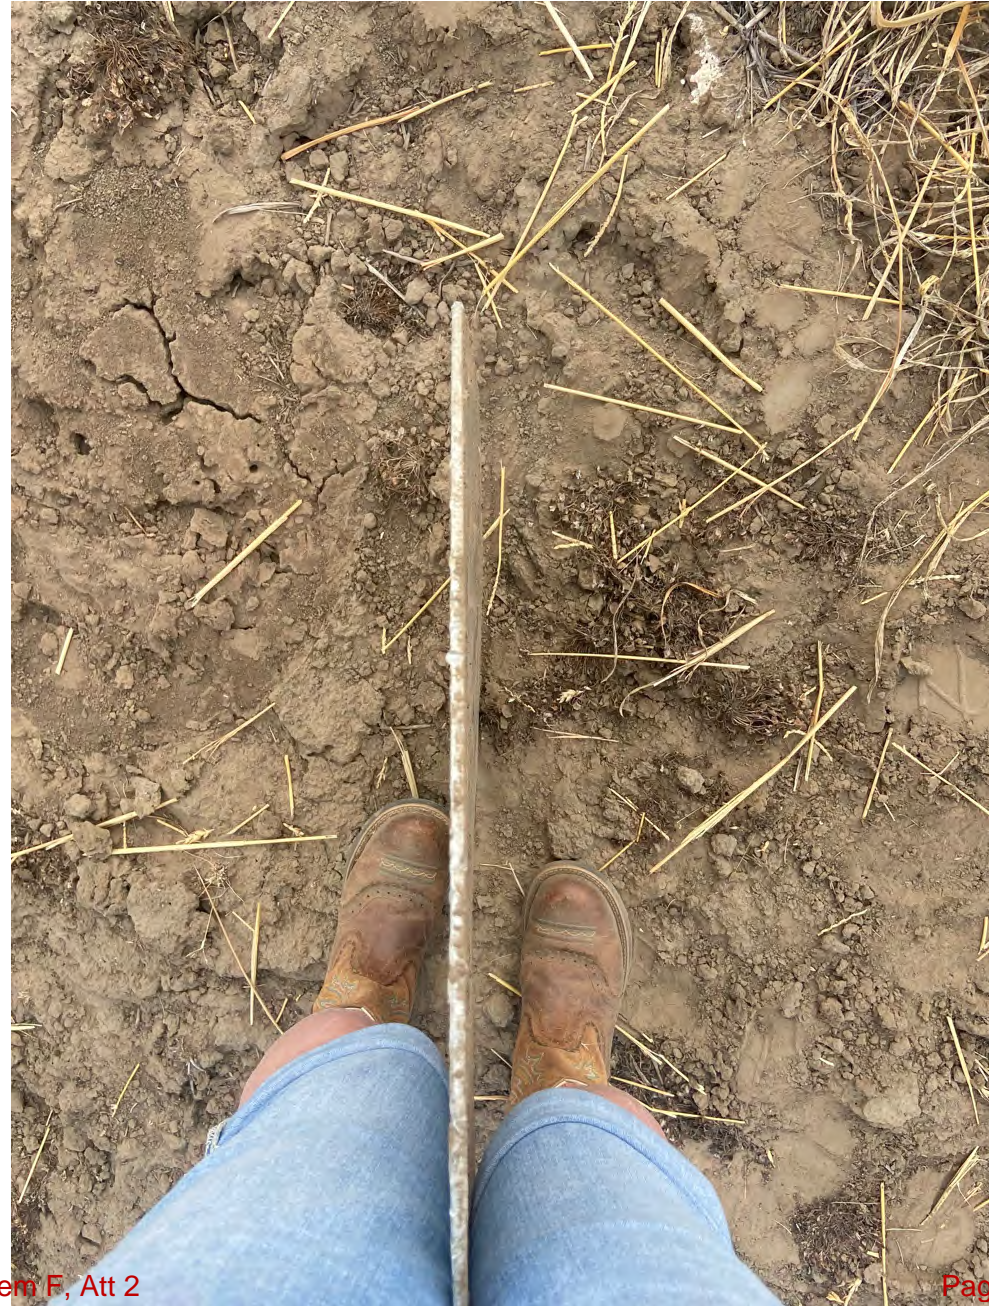
It is metal, and it is thick.
It belongs up in the hub...
vibrations loosen them
and they fly like a saucer
through the air!

They basically plug a hole,
a wind technician friend
of mine says. But if you
don't get it screwed in
properly...

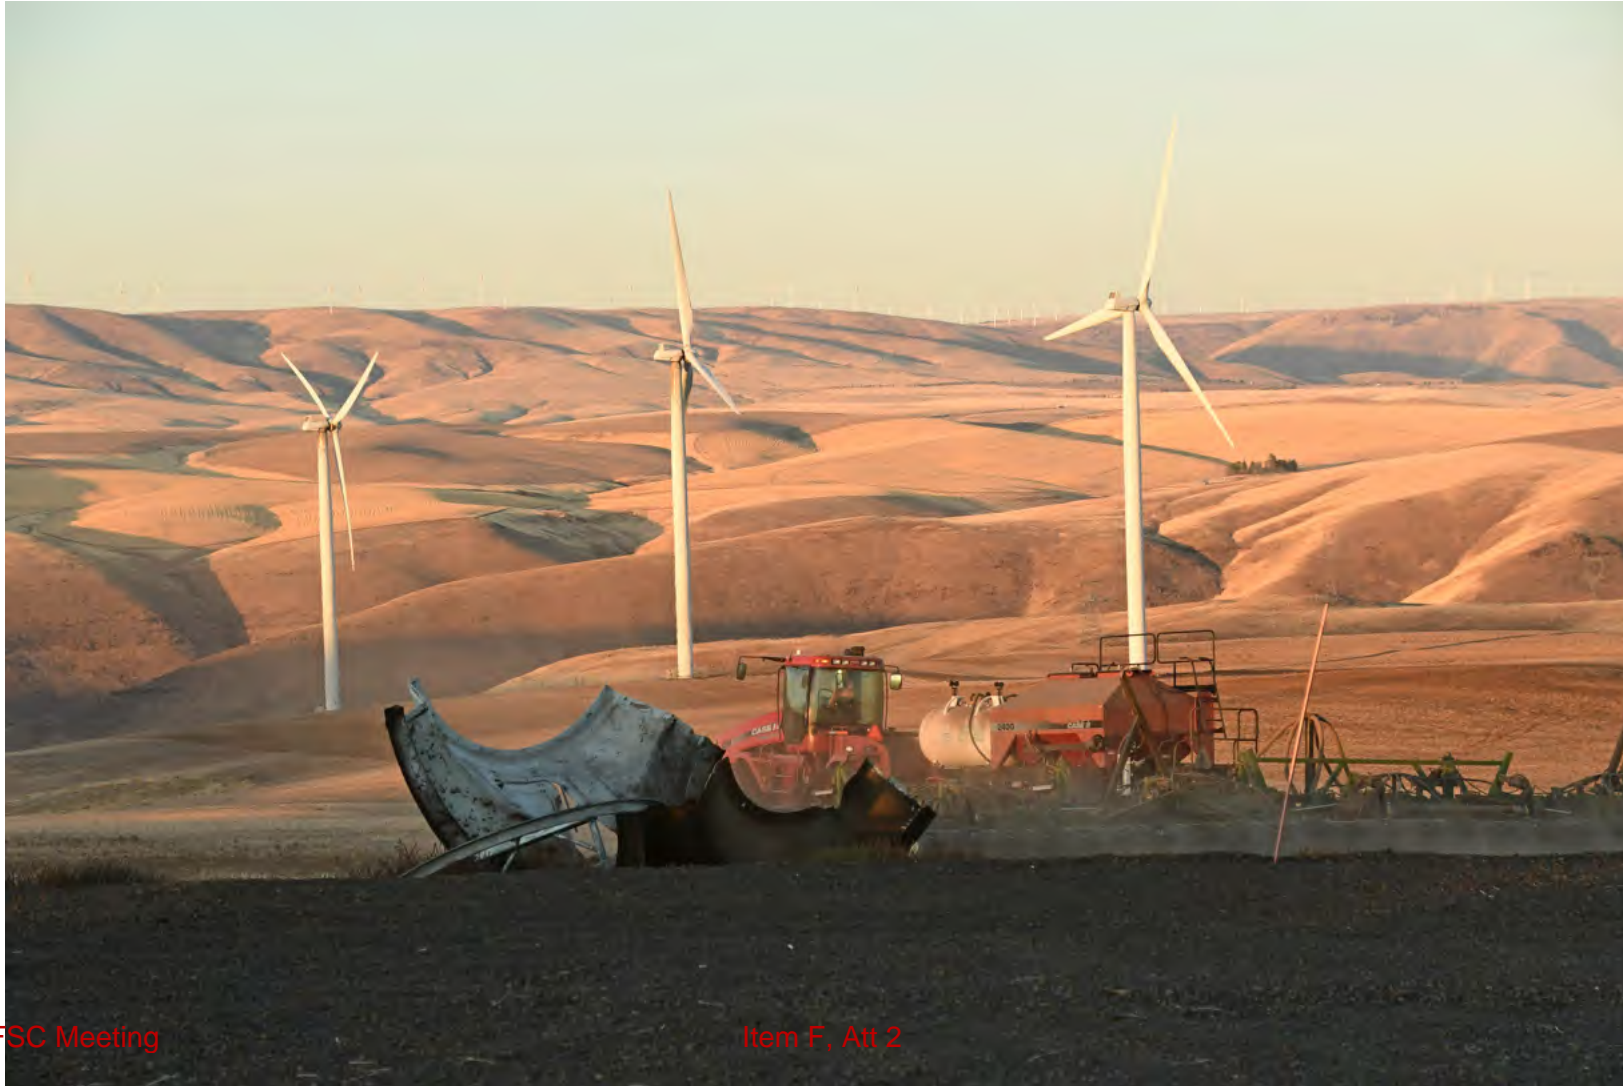
A year ago, April 2021, part of a nose cone fell off. PGE took the rest of the nose cone down and left it.

We were seeding October 7 and it was still there.

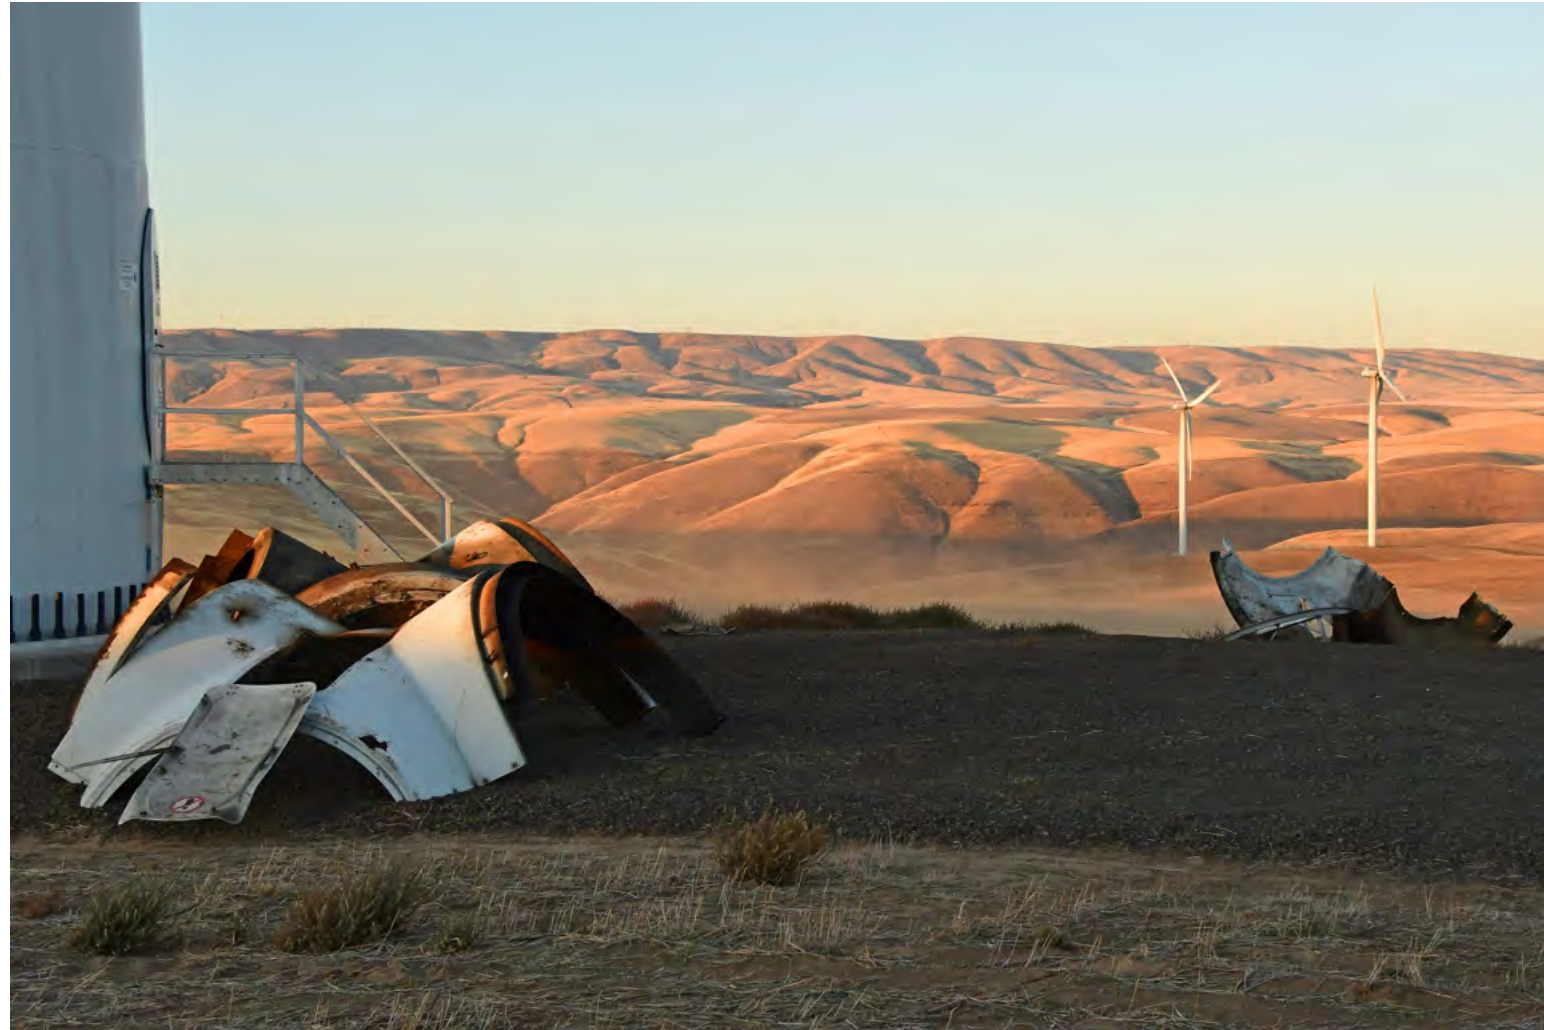
We picked up the 3+ pieces that had dropped in the field and placed them under the tower.

When the blade fell off February 1, 2022, all the pieces were still there!
(You can't see the nose cone in the gully)

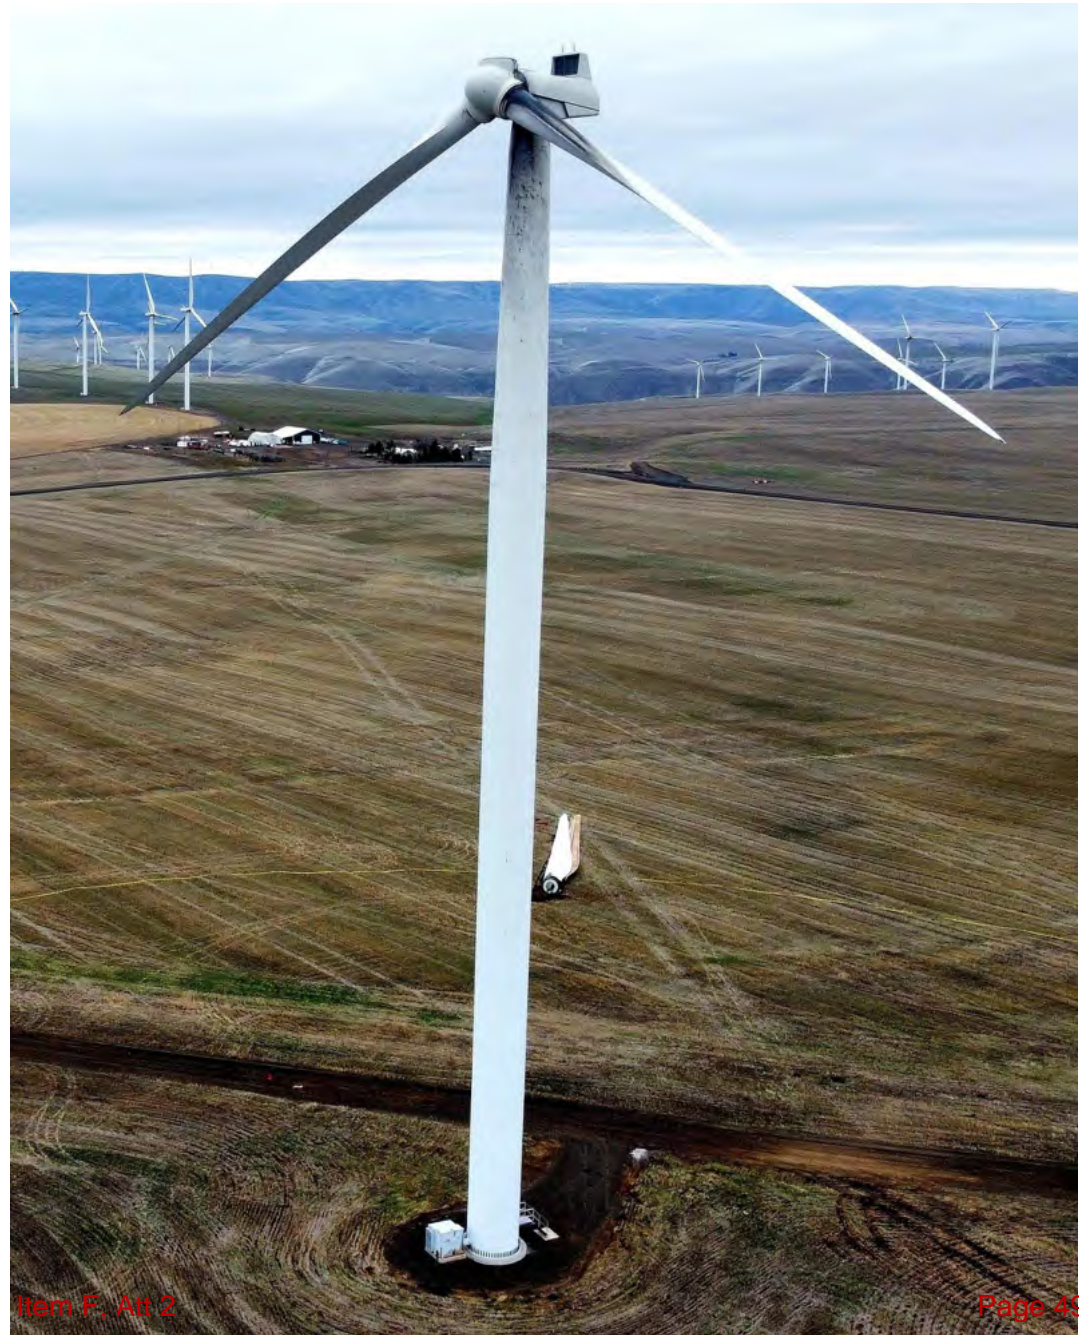
A blade falls off.
That is our house
in the
background.

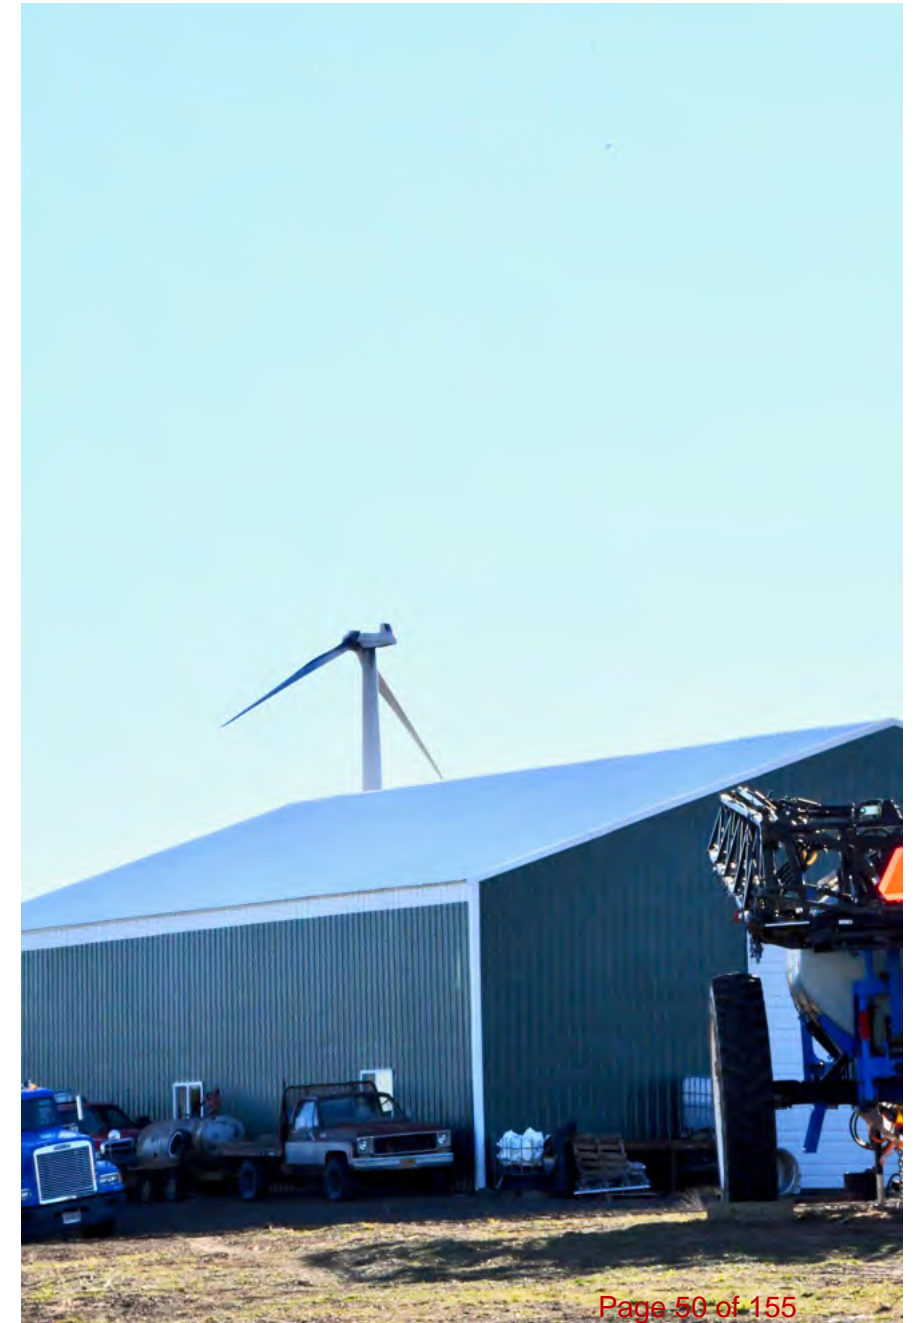
The blade fell off at 2:13 AM, and the thump woke Kevin and our dog, Turbo. It landed 300 feet away from the tower.

There was a load of biosolids delivered in this field by this tower at 10:30PM. It could have fallen then. And killed someone.

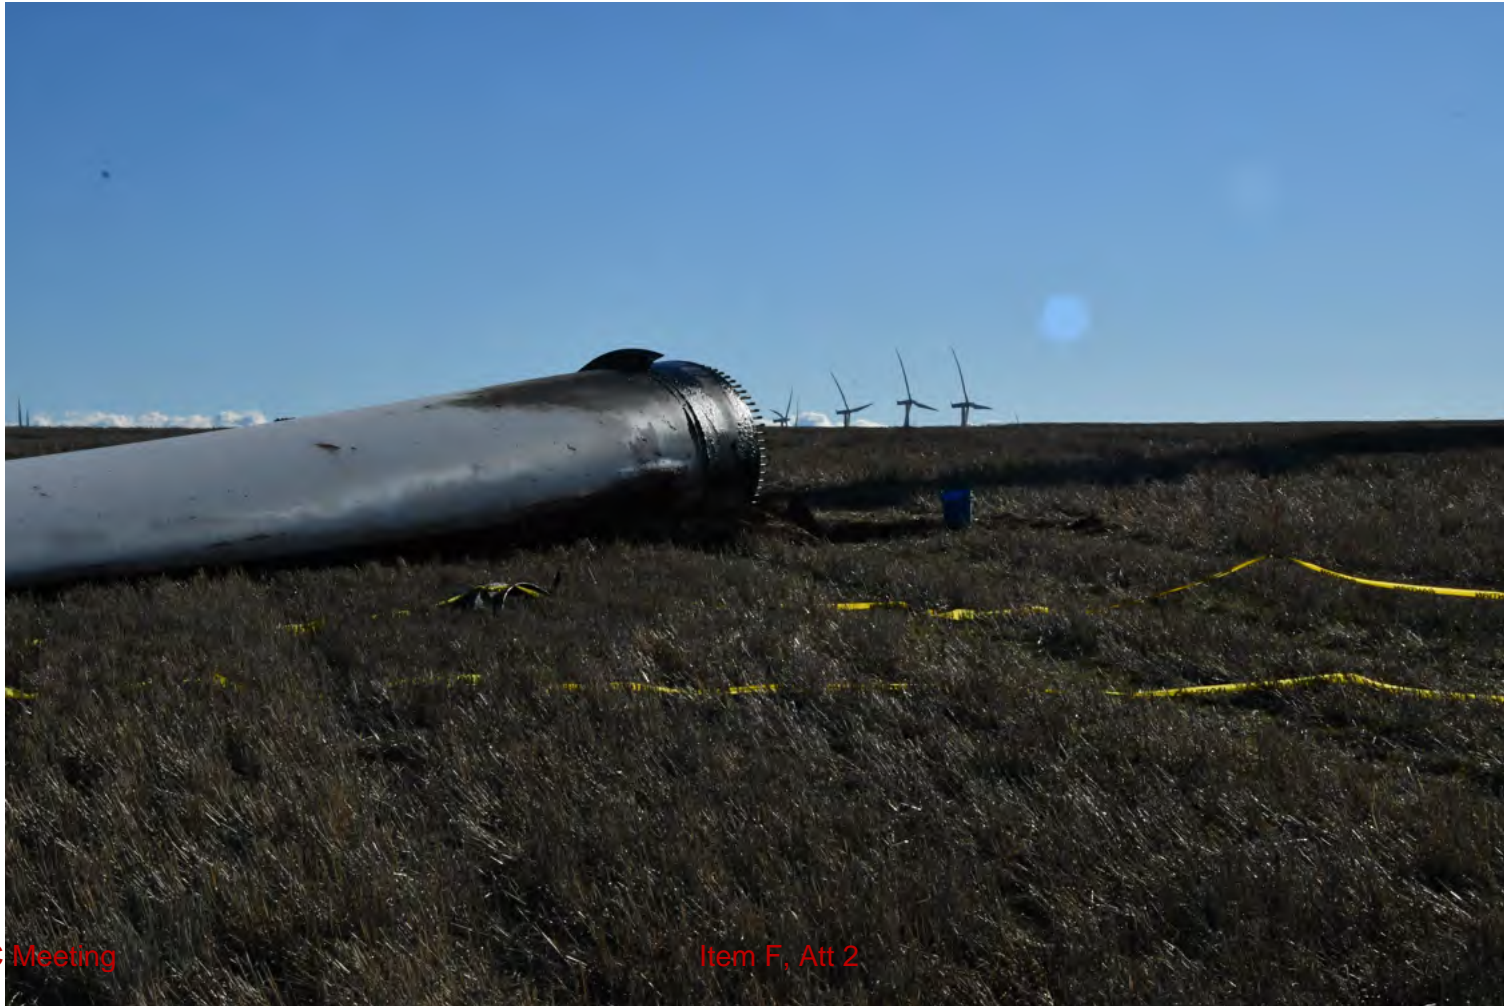
Grease & oil, bolts,
doors, disks, nose cone
pieces, and blades.

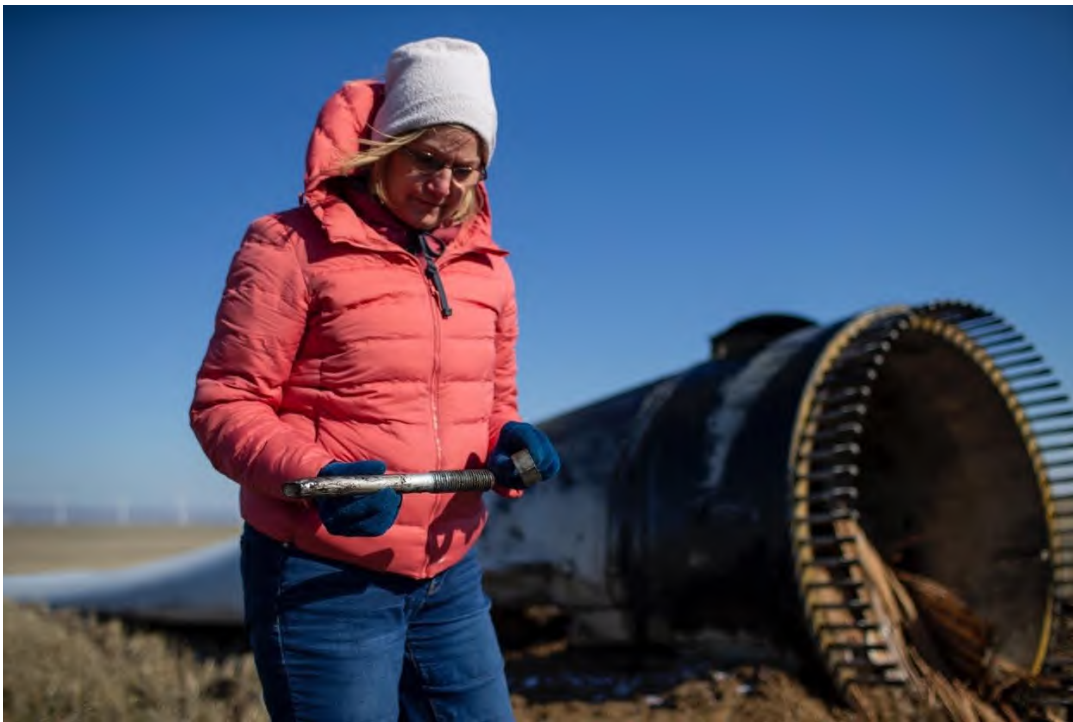
Kathryn McCullough, a Sherman County landowner, examines a bolt off the blade that was thrown from a turbine at PGE’s Biglow Canyon wind farm on Feb. 1. “Someone could have been killed or badly injured,” she said.

Seven months into that review, PGE told The Oregonian/OregonLive that preliminary results suggest the connection between the turbine blade and its hub was “not well clamped,” a problem likely caused by “bolts becoming loose and experiencing fatigue damage over time.”

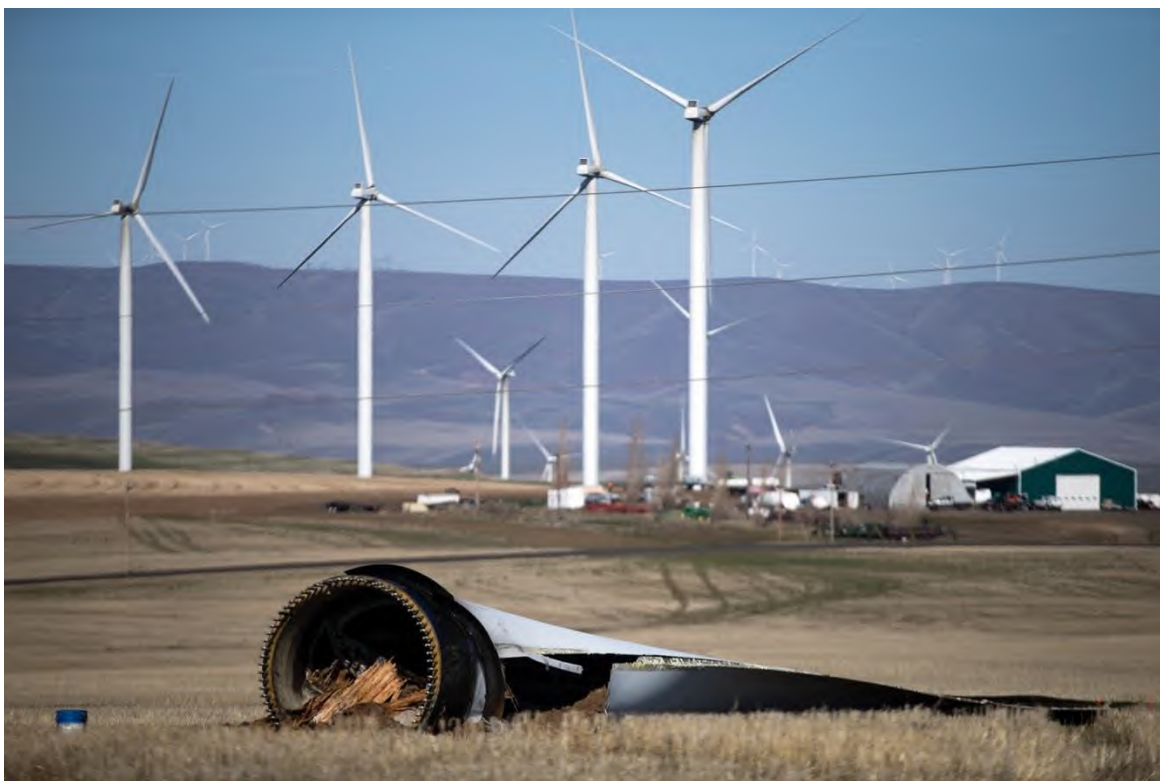
The blade thrown from a turbine at PGE's Biglow Canyon wind farm on Feb 1. An outbuilding next to the McCullough's residence is shown in the background.

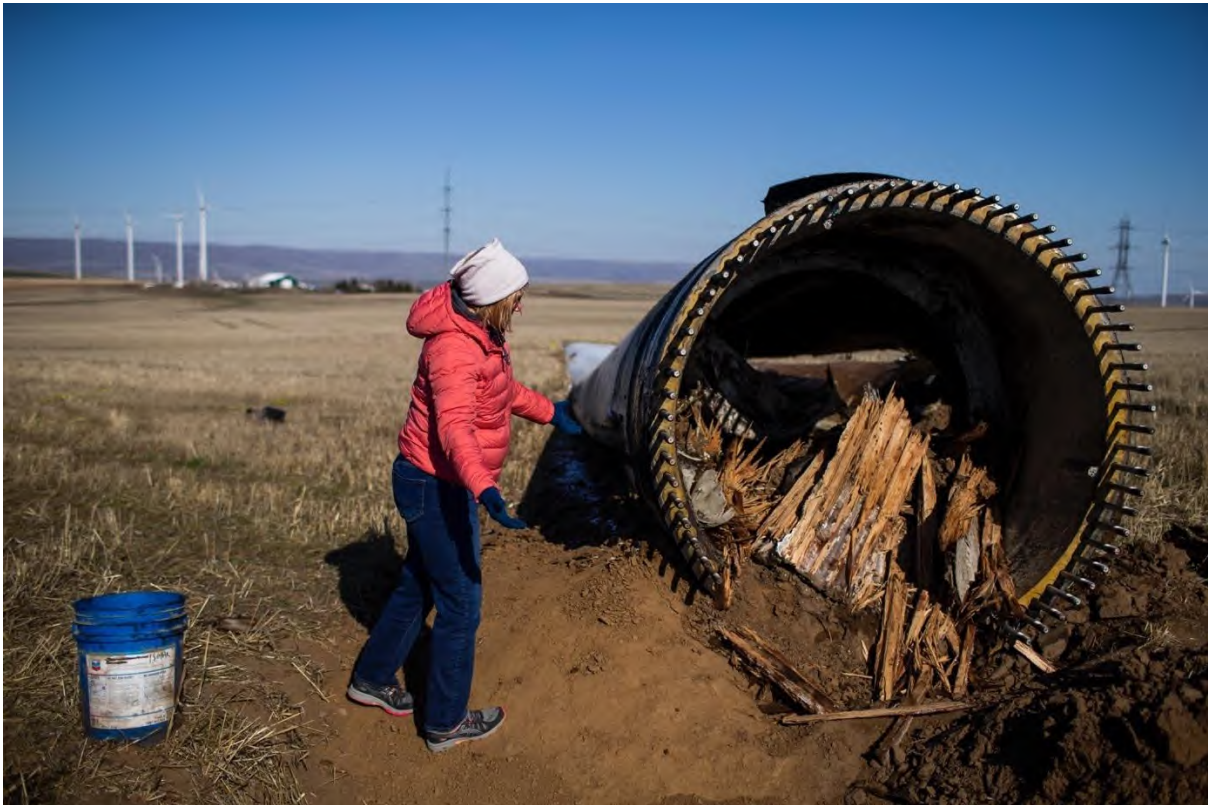
Kathryn McCullough, a Sherman County landowner, examines the blade that was thrown from a turbine at PGE's Biglow Canyon wind farm on Feb. 1. Her husband, Kevin McCullough, farms wheat under about half the wind farm's 217 turbines, including the one that threw the blade. Thirteen of the wind farm's turbines are on their land.

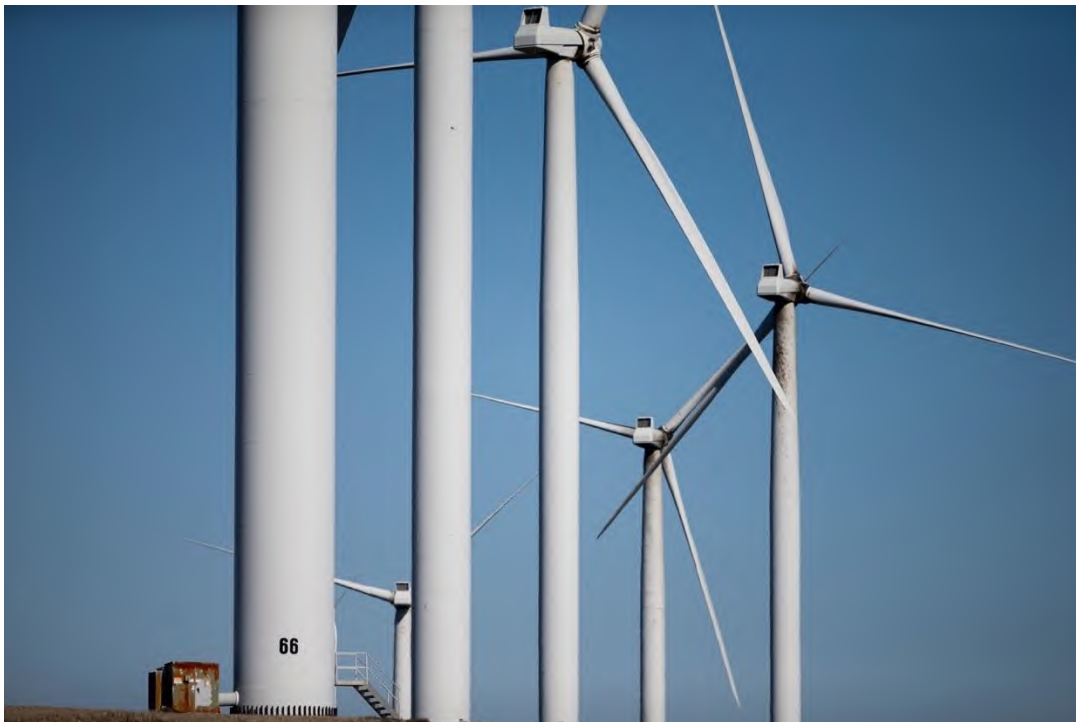
Residents who own land under PGE’s Biglow Canyon wind farm worry that regular leaks of oil and lubricants from turbines pose fire and environmental hazards.

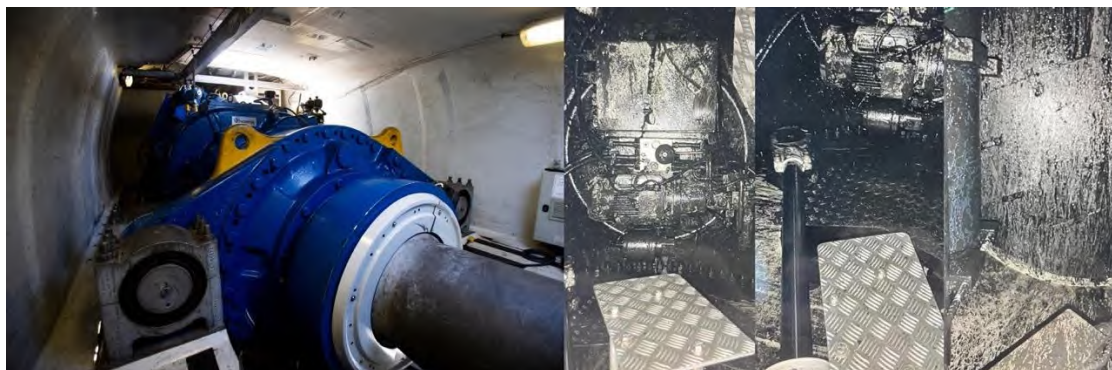
Portland General Electric provided a look inside the spotless nacelle of a Vestas turbines (left) at Biglow Canyon wind farm during a tour in late June. Kathryn McCullough sent the pictures at right to U.S. Sen. Ron Wyden, which she said shows the oil-coated nacelle of a Vestas turbine this spring at Biglow Canyon. (Photos courtesy PGE, left, and Courtesy Kathryn McCullough, right)

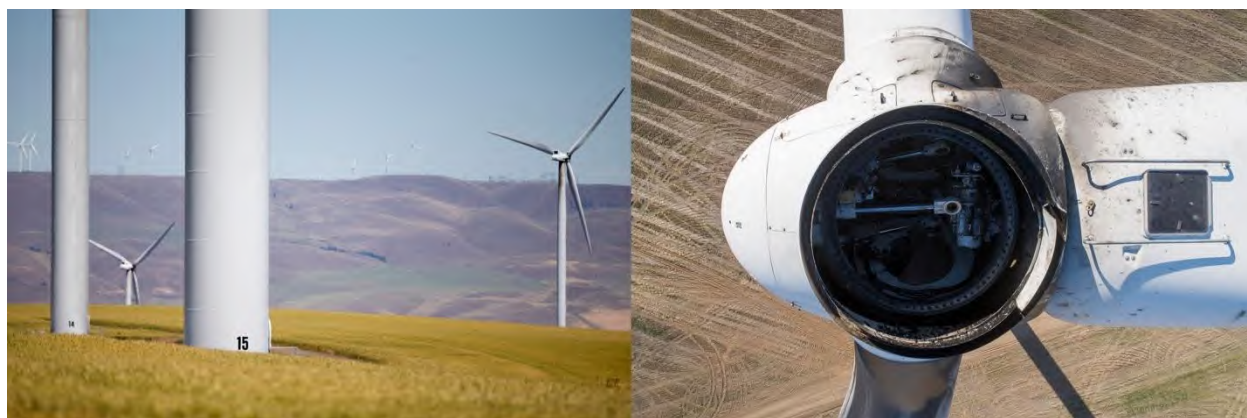
Farmers cultivate wheat right up to the base of wind turbines at Portland General Electric's Biglow Canyon wind farm (left). An aerial shot (right) of a Vestas turbine on Feb. 22, after it threw a blade 100 yards into a field below.
