# North Cascade District – Master Plan

# Project Background

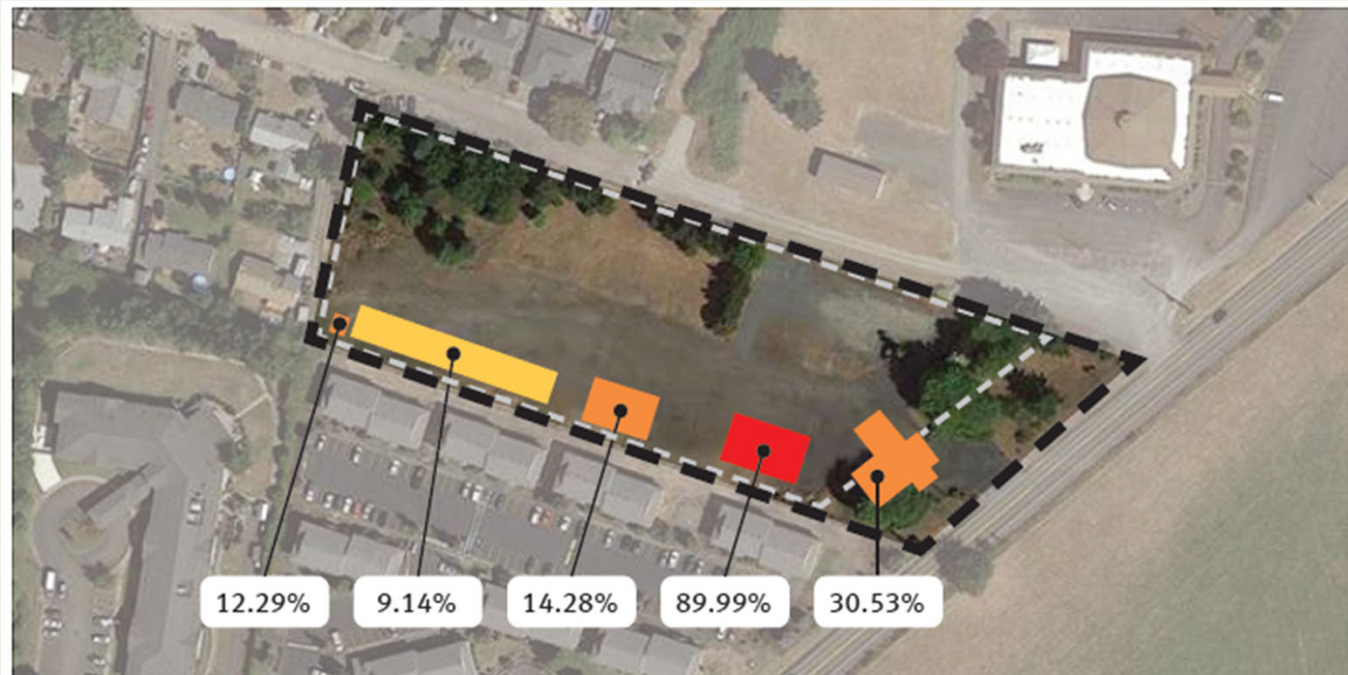
Molalla Building Conditions

The on-site assessment generally confirmed the findings of the Faithful and Gould report, which ranked existing buildings on a scale of “Good” to “Very Poor”, based on an evaluation of cost for repair as compared to replacement value. None of the buildings on either unit office campus ranked above a rating of “Fair”.

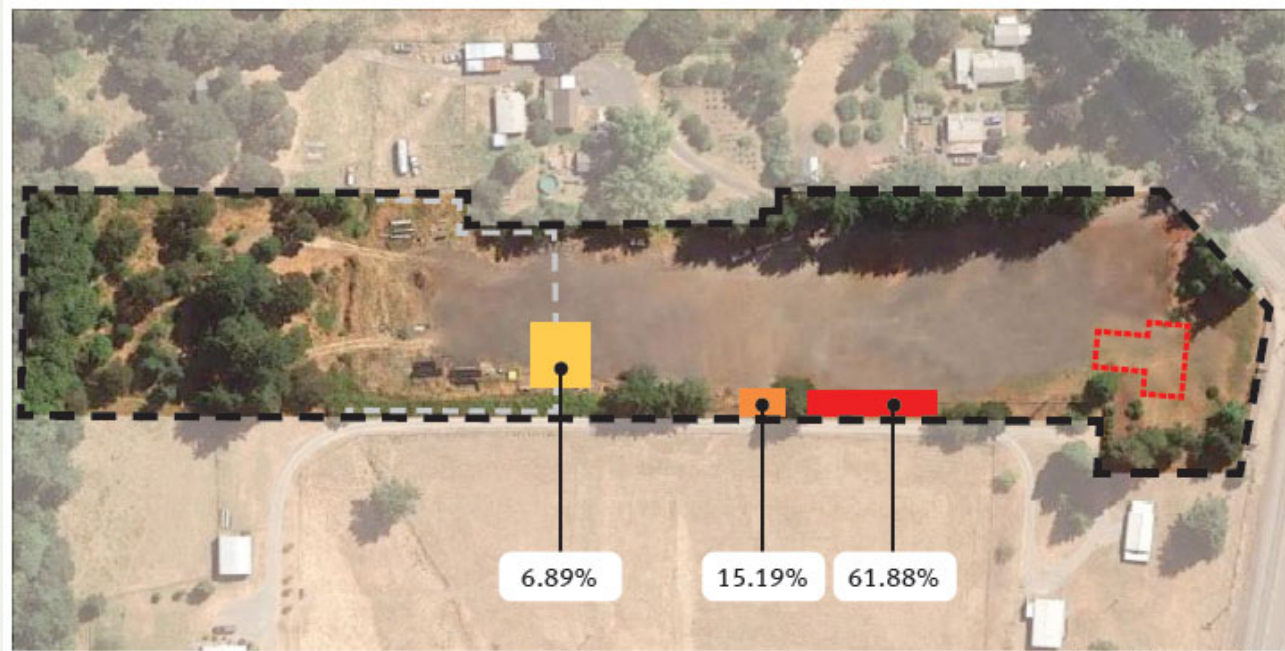
*Santiam Building Conditions*

The on-site assessment generally confirmed the findings of the Faithful and Gould report, which ranked existing buildings on a scale of “Good” to “Very Poor”, based on an evaluation of cost for repair as compared to replacement value. None of the buildings on either unit office campus ranked above a rating of “Fair”.

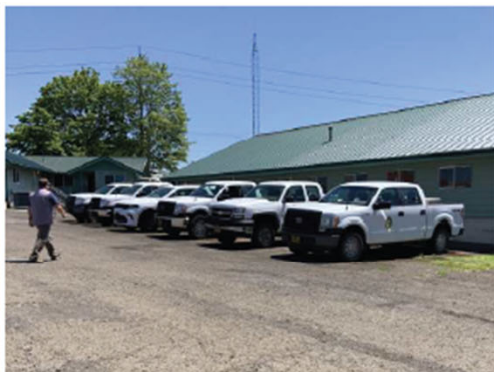
## VEHICLES PARKED OUTSIDE THE FIRE CACHE BUILDING

- The Molalla site is wider and better secured than Santiam, but it is still crowded and susceptible to bottlenecks

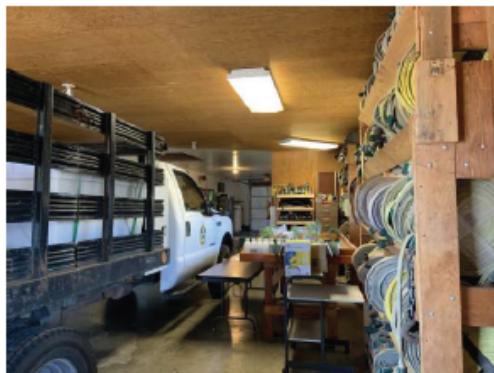
## HOSE STORAGE, SAND TABLE, AND VEHICLE PARKED IN THE FIRE CACHE

- Insufficient space to move around vehicles and access stored items

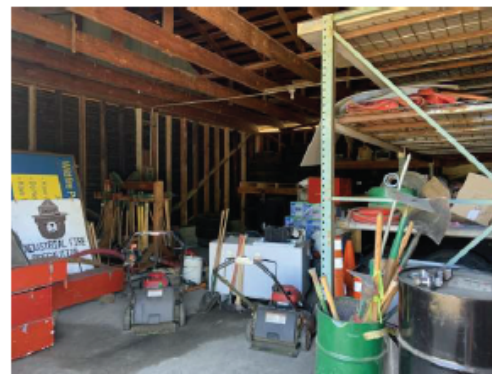
## AGING COVERED STORAGE

- Vehicle bays are neither tall nor deep enough to fit many of ODF's larger vehicles
- Building lacks the ability to be closed off, creating a safety and security risk

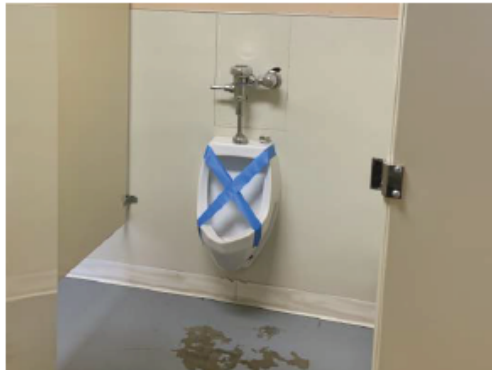
## NON-FUNCTIONING RESTROOM FACILITIES

- Fire Cache Building does not have gender-separated restrooms
- Aging restroom fixtures are frequently out of service and require maintenance

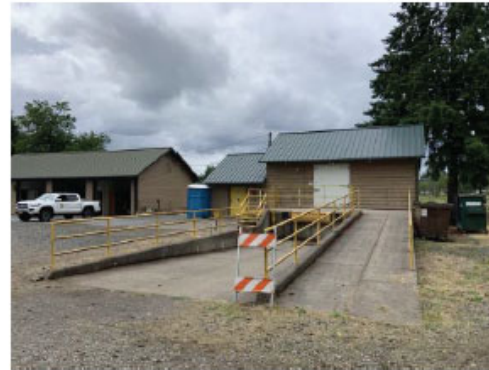
## TRACTOR-TRAILER LOADING DOCK

- The narrowness of the site and space required for the loading dock makes backing in a tractor-trailer challenging
