NORTH CASCADE DISTRICT MASTER PLAN

OREGON DEPARTMENT OF FORESTRY REVISION DATE: 11 FEBRUARY 2022

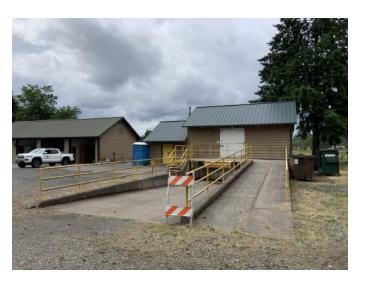
TRACTOR-TRAILER LOADING DOCK

• The narrowness of the site and space required for the loading dock makes backing in a tractor-trailer challenging

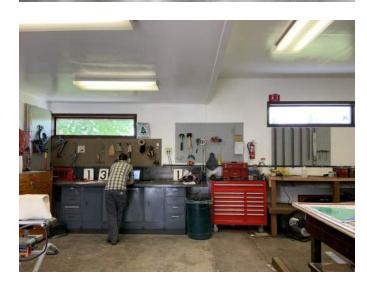
FIRE CREW MEMBER WORKING AT HIS COMPUTER IN THE COMBINED WOOD AND METAL SHOP

- Fire and wood shops should be separated to reduce fire risk
- Several fire crew lockers are also located in this space instead of a cleaner room

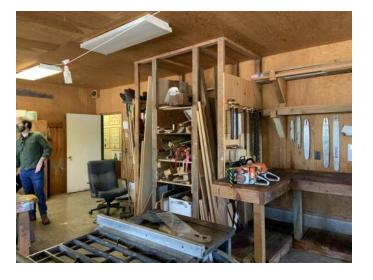
METAL AND WOODSHOP

- Separate the spaces to its specific uses
- Move lockers and other incompatible uses out of shop space
- Picture illustrates condition at Molalla Unit Office

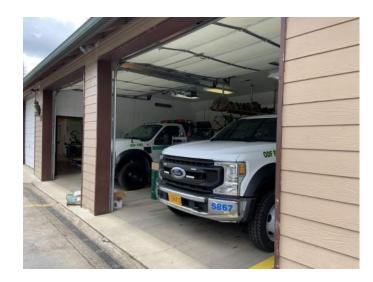
VEHICLE BAYS

- Large enough to fit modern vehicles
- Additional bays to house vehicles
- Pass-through preferred over back-in
- Picture illustrates condition at Molalla Unit
